**BUILDING AND STANDARDS COMMISSION  
STAFF REPORT**

**April 23, 2012**

**Case #1840 – 1700 Pecan Street**

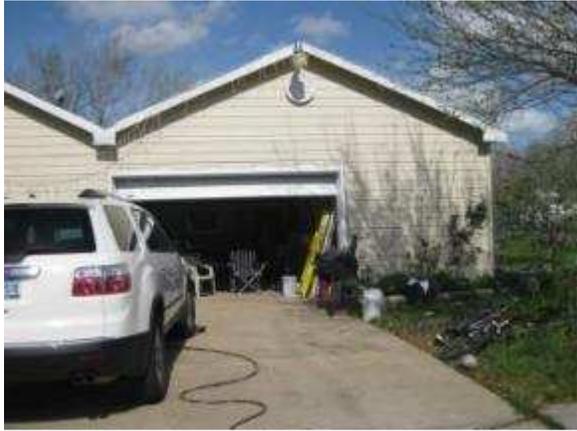
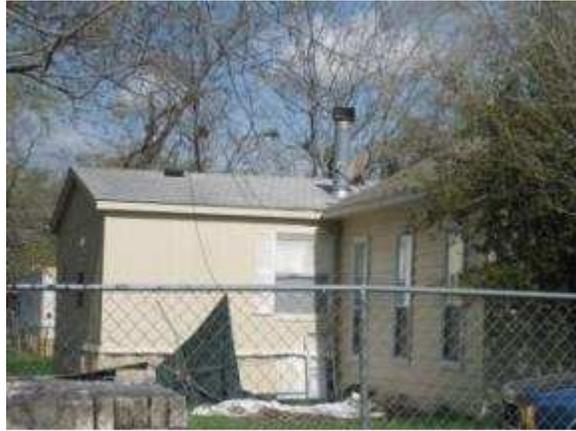
**EAST SIDE OF THE ADDITION IS INDOOR PATIO AREA**

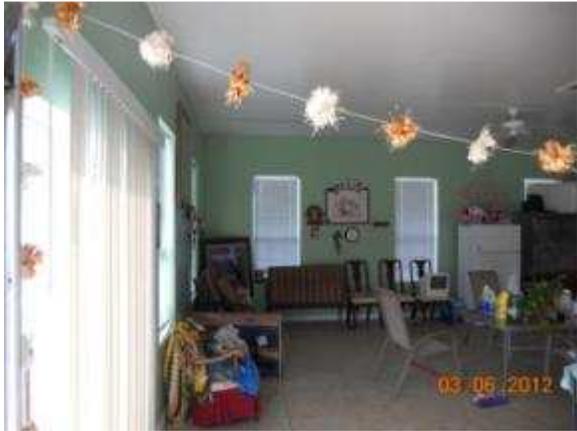
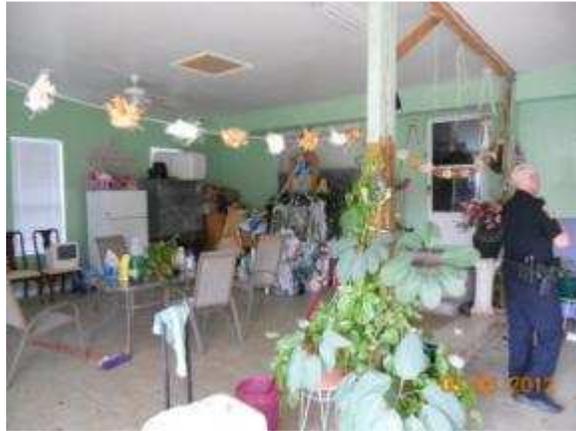
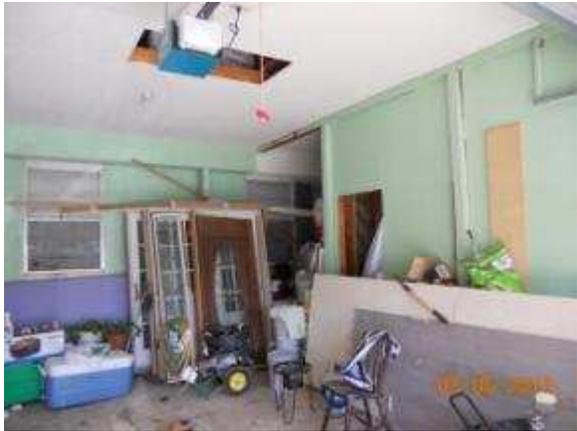
**WEST SIDE OF THE ADDITION IS STORAGE**

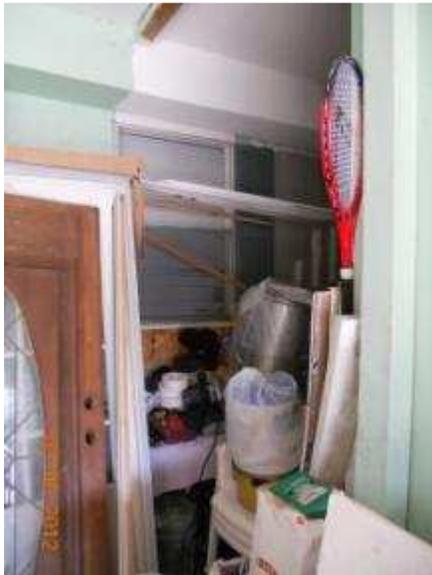
NO EGRESS FROM BEDROOM TO OUTSIDE

(2) 2 EXISTING BEDROOM WINDOWS ARE BLOCKED BY ADDITION - THESE ARE THE ONLY WINDOWS IN THE BEDROOMS.

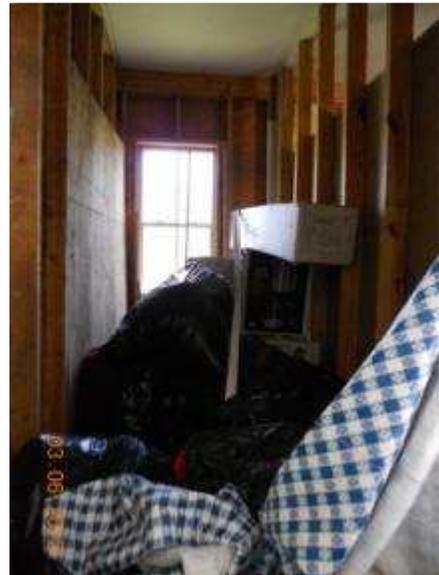
HALL WAY HAS NO ACCESS TO OUTSIDE
