**BUILDING AND STANDARDS COMMISSION  
STAFF REPORT**

**April 23, 2012**

**Case #1720 – 1800 South Texas Avenue**

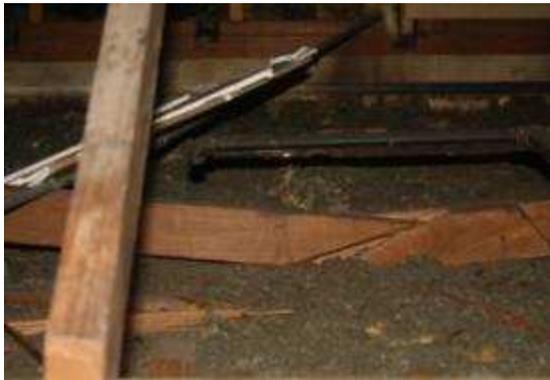
Marijuana found in this unit

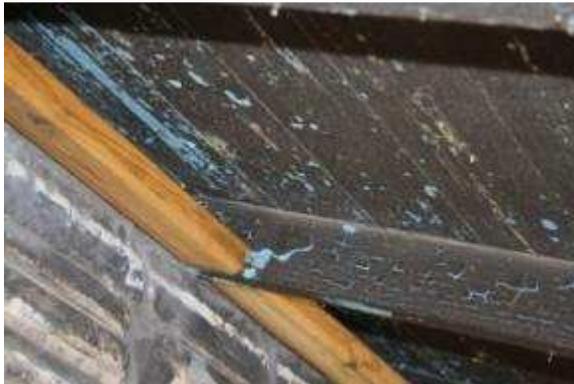
Fire damage found under outside awning

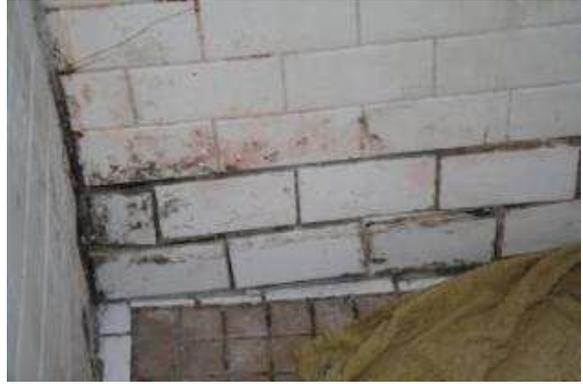
Bathroom floor in shower

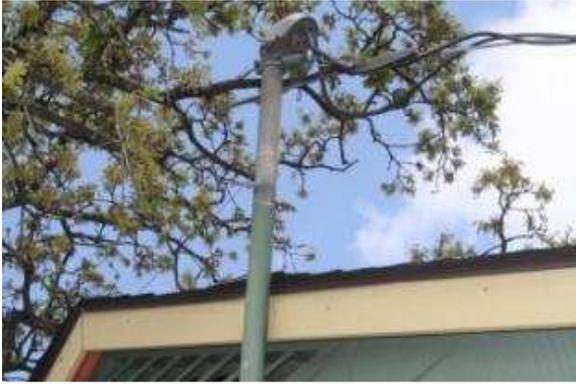
Utilities being supported by tree limb
