**BUILDING AND STANDARDS COMMISSION  
STAFF REPORT**

**June 25, 2012**

**Case #1840 – 1700 Pecan Street**

# Dangerous Structures Survey Report

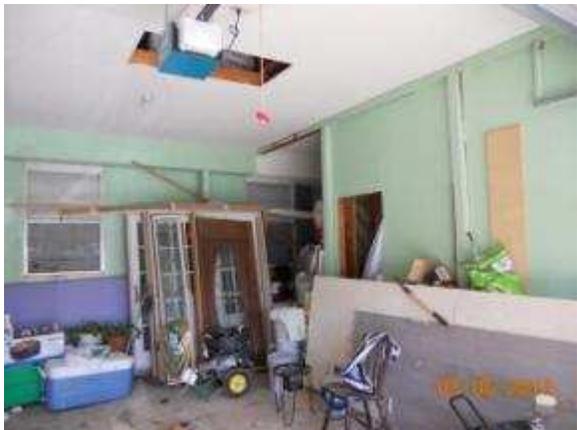
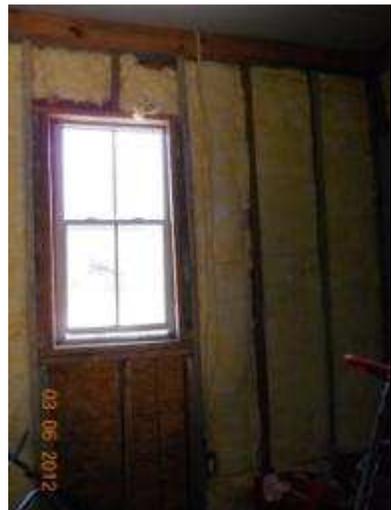
**WEST SIDE OF THE ADDITION IS STORAGE**

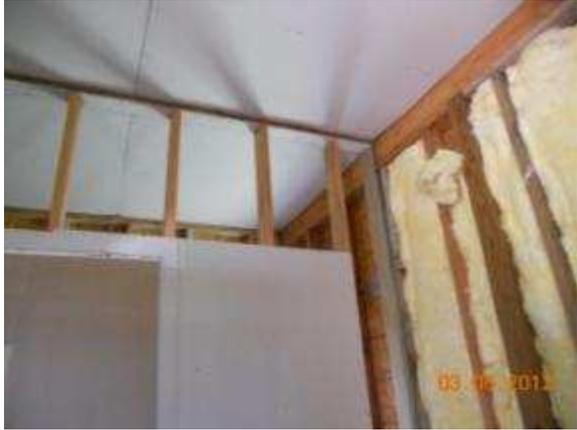
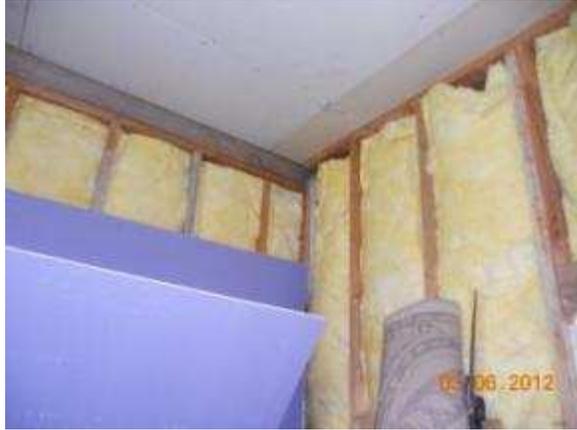
way across the front of the manufactured home without permits and inspections. The original carport and addition was then enclosed without permits and inspections. The addition is blocking the only bedroom windows from two children's bedrooms in the manufactured home.

NO EGRESS FROM BEDROOM TO OUTSIDE
