**BUILDING AND STANDARDS COMMISSION
STAFF REPORT**

September 24, 2012

Case #1840 – 1700 Pecan Street

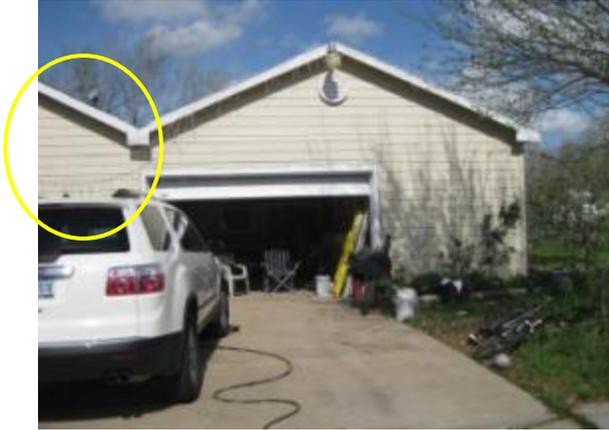
June 4, 2012

A demolition permit was issued on June 1, 2012 and demolition is in progress. As of September 13, 2012, about 50 percent of the structure was removed back to the original carport. Since the 60 days for completing work under the Commission's previous order have expired, **staff recommends that the Commission issue a new order to allow the property owner to finish returning the carport to its originally-permitted state.**

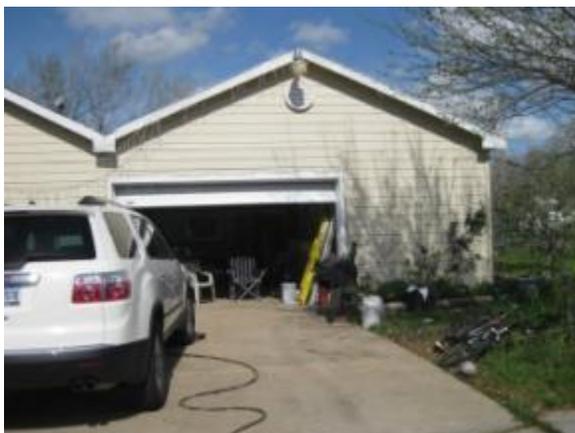
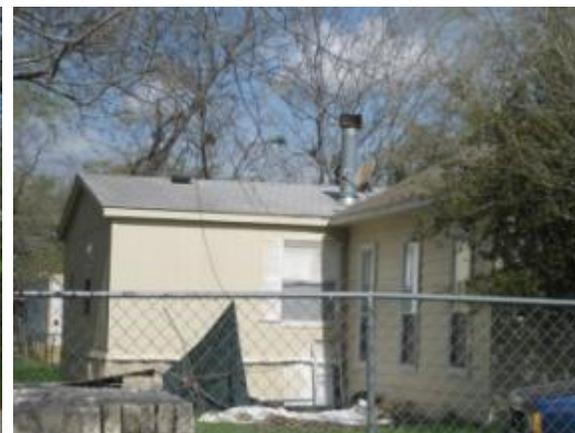
PICTURES: 6-4-12

EAST SIDE OF THE ADDITION IS INDOOR PATIO AREA
