**BUILDING AND STANDARDS COMMISSION  
STAFF REPORT**

November 24, 2014

**Case #1988 – 2000 Kazmeier Plaza**

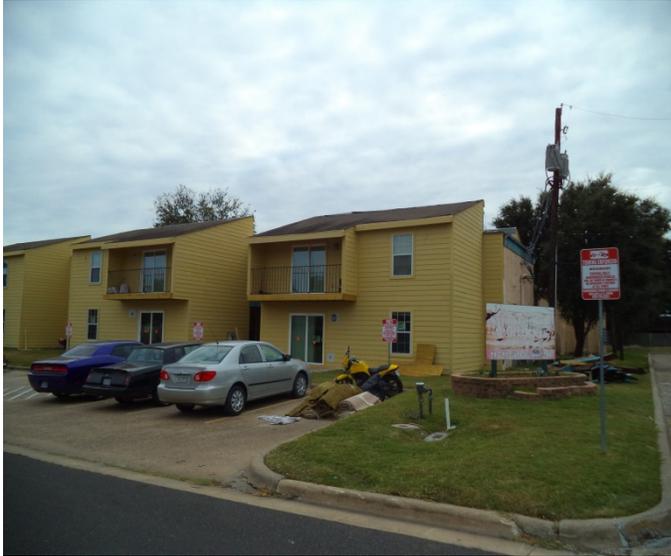
New siding and balconies at building #1

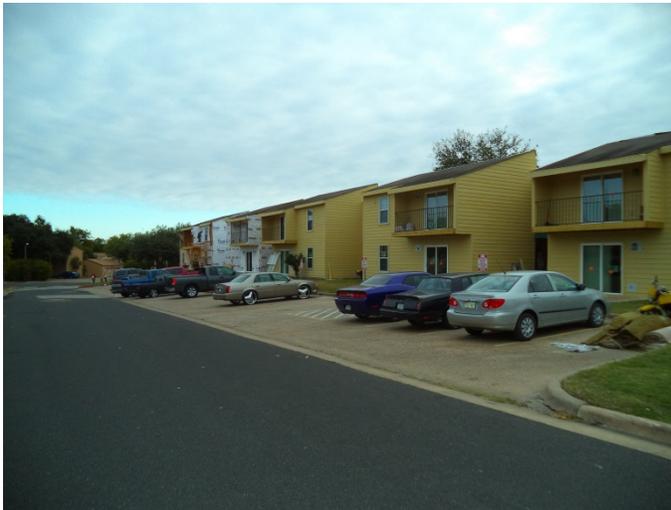
New siding and balconies at building #1

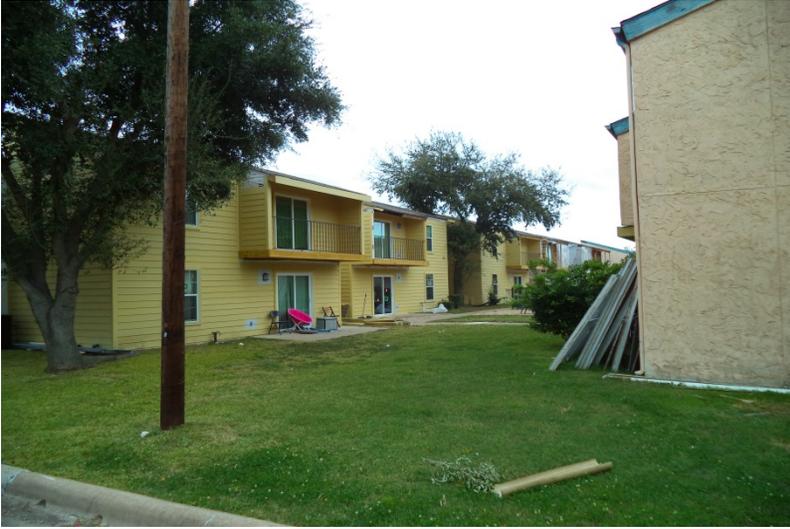
New siding and balconies at building #1

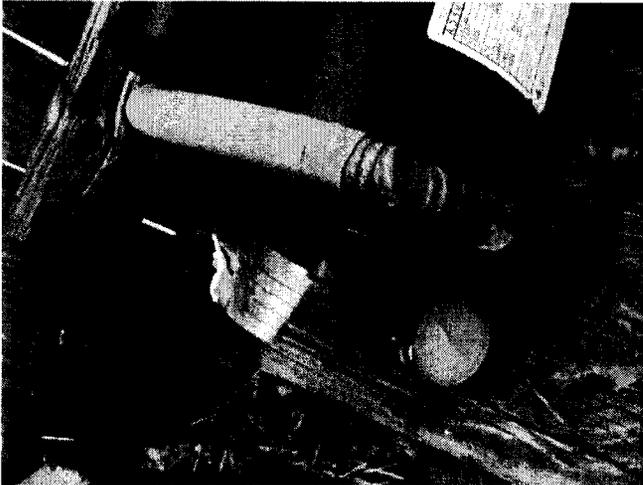
- Area drain missing cover by office (between pool and office)
- Flex on A/C swimming pool pump equipment needs repair

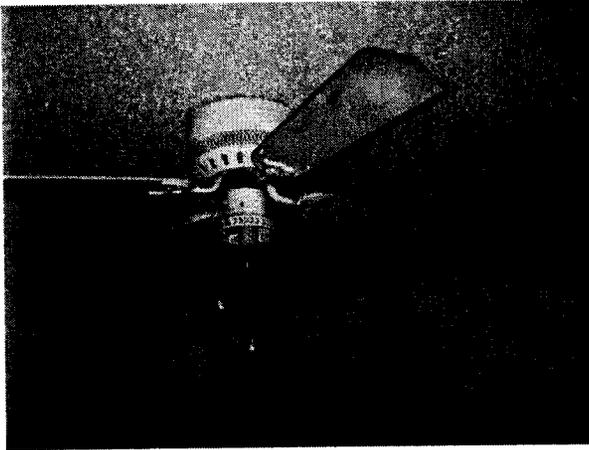
- Fence around patio is loose – needs to be secured so it does not fall over or removed.
- Water spots on bath room ceiling (unit #2 above has signs of roof leaks)
- Ceiling fan missing light bulb cover - needs to be replaced/reinstalled.

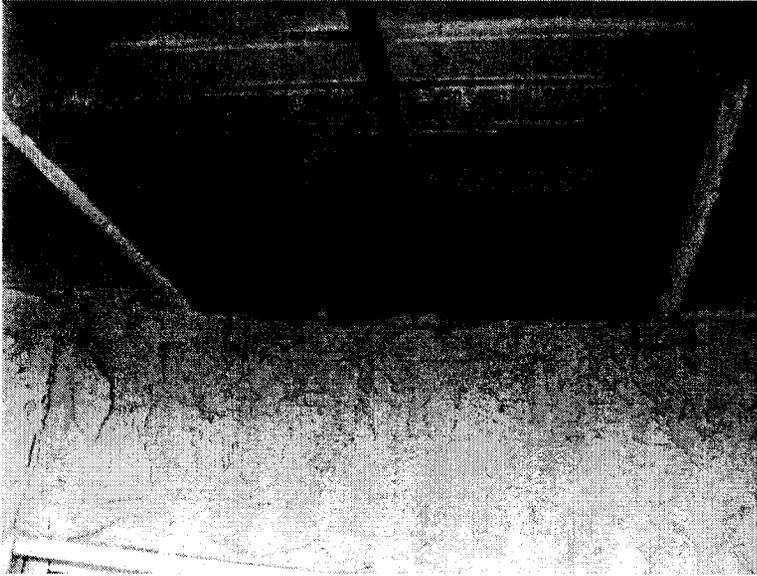
**Unit #5:** Two bedroom unit

- SD too far from ceiling
- No GFI in kitchen /bathroom
- Missing joist at balcony – open framing

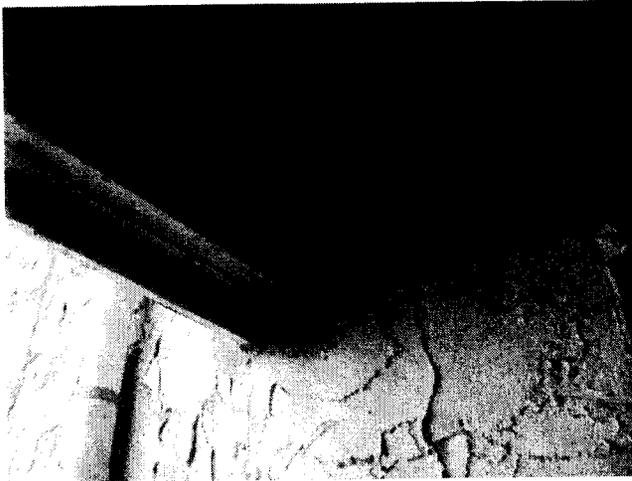
**Unit #17:**

- Bottom of sink cabinet is rotten thru
- Plug in bedroom is broken
- Questionable repairs to breezeway framing – need structural engineer's report

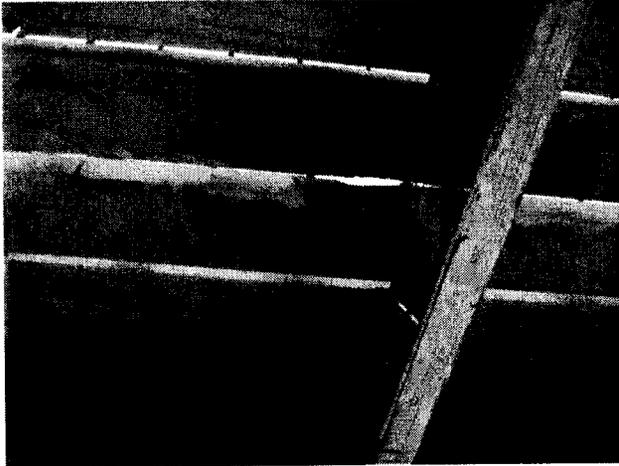
- Cover missing on HVAC unit
- No vent fan
- Missing parts of cabinets, sinks, etc.
- Fire damage at exterior balcony

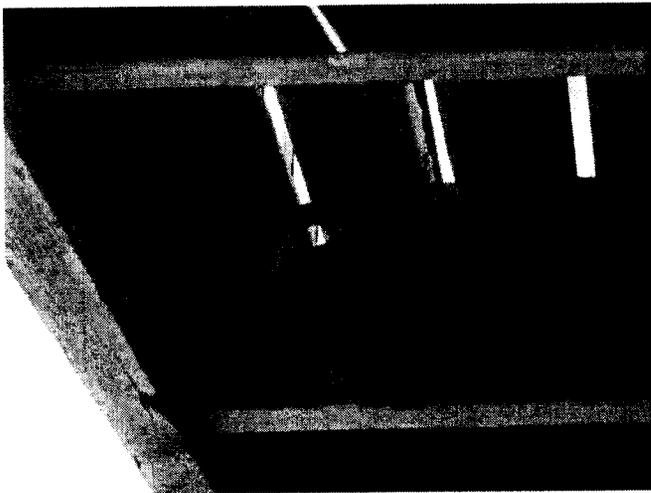
- Damaged joist at exterior balcony

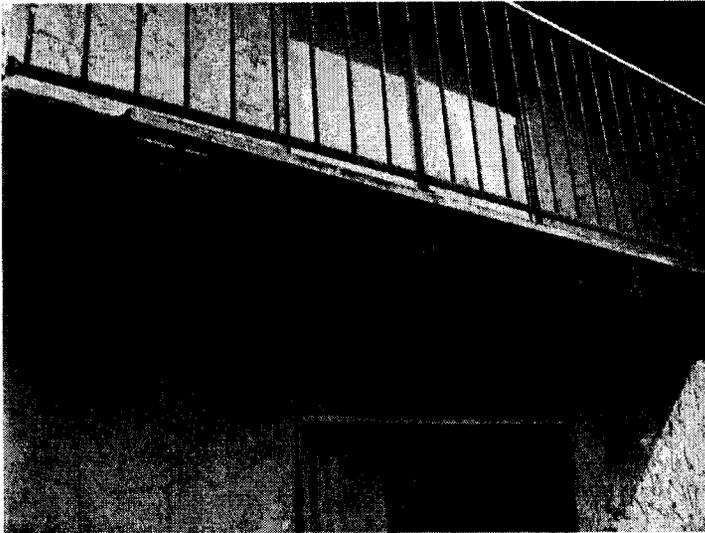
- Exterior balcony is missing out rim board – need structural engineer’s report

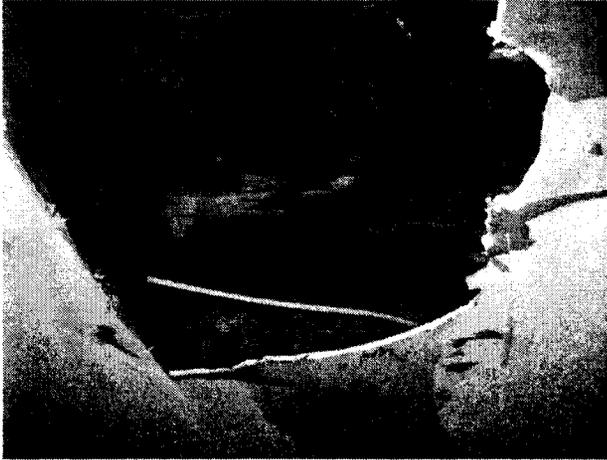
**Unit 30: vacant requires building permit and asbestos survey**

- No cover on plug under kitchen sink
- Mold damage under kitchen sink
- Broken plugs in bedroom
- Broken toilet
- Ceiling damage in bedroom

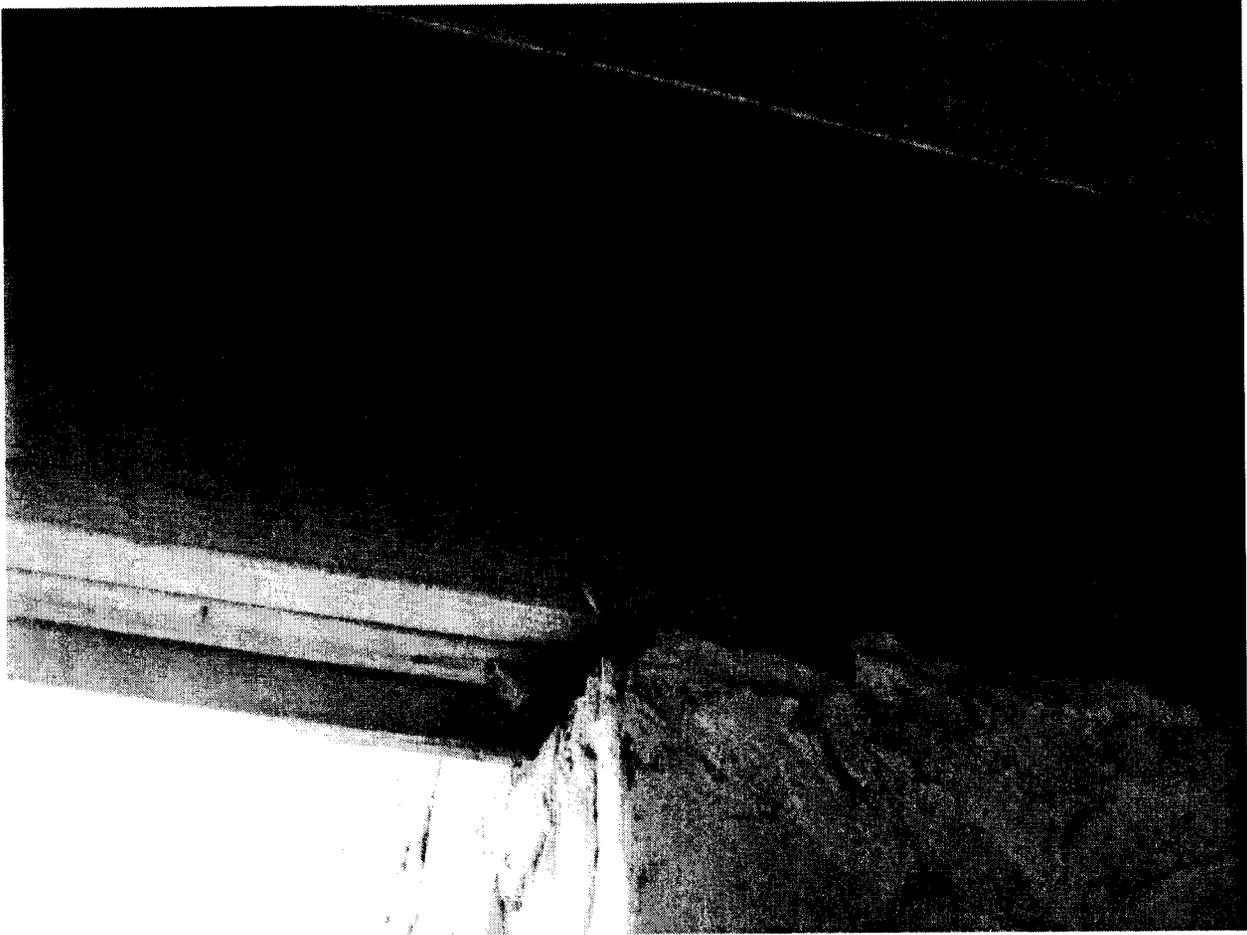
**Unit 33:**

- Questionable framing repairs at breezeway – need structural engineer's report

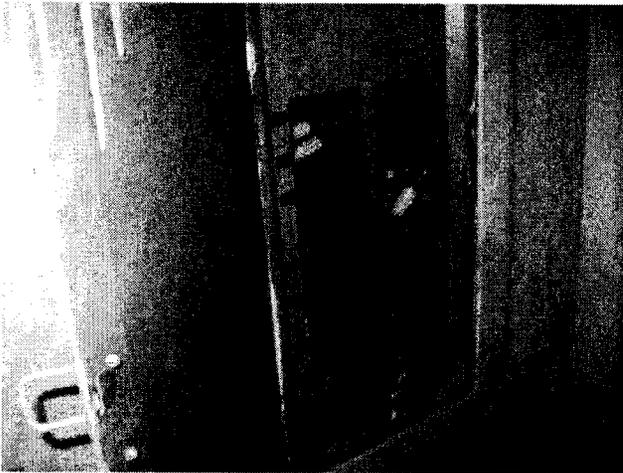
**Unit 40: vacant – requires building permit and asbestos survey**

- Holes in walls behind stove area
- No shower head
- Blanks and breakers missing in electrical panel – requires electrical permit and licensed electrician

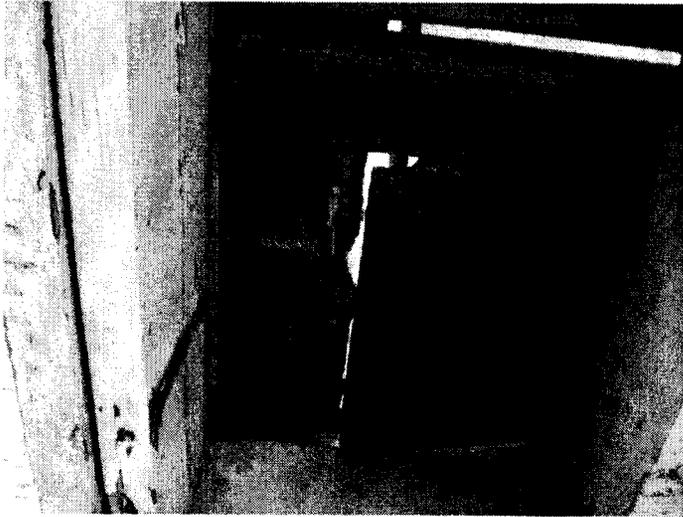
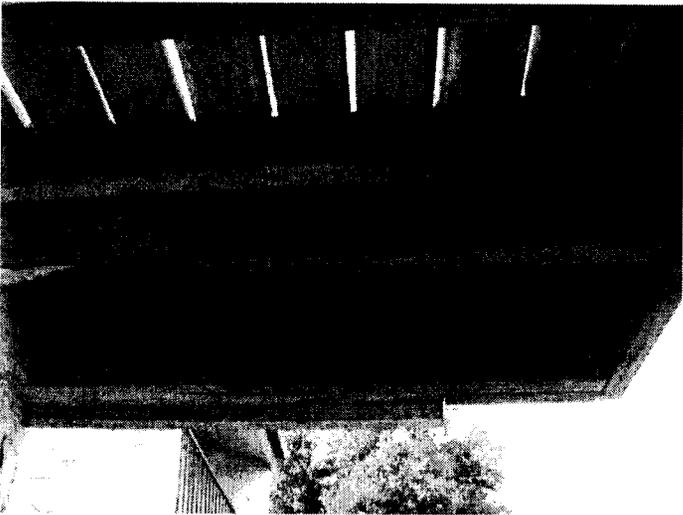
**Unit 45:**

- Water leak under kitchen sink
- Ceiling leaks in hallway, bedroom and bathroom areas
- Damage to joists at exterior balconies / rot
- Questionable repairs at exterior balconies – need structural engineer’s report
