**BUILDING AND STANDARDS COMMISSION
STAFF REPORT**

April 27, 2015

Case #1988 – 2000 Kazmeier Plaza

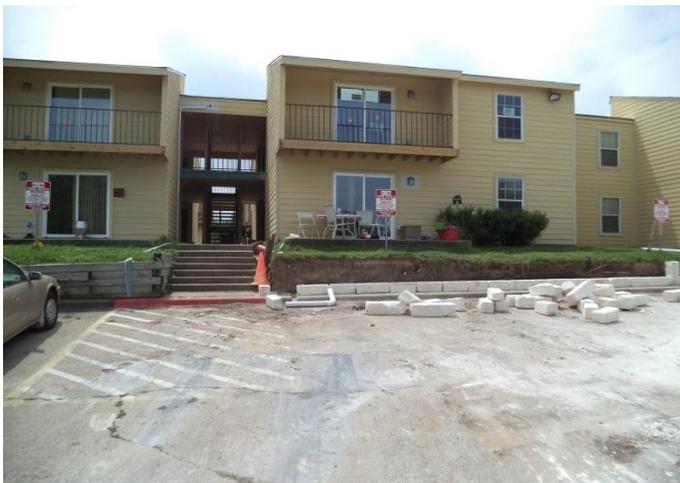
- Work on the retaining wall did not start until the later part of March 2015. See attached photos.
- Breezeway structural repairs were 90% completed on building #2 during first part of April 2015 (see attached engineer's report dated April 9, 2015).

Work has started on retaining walls.

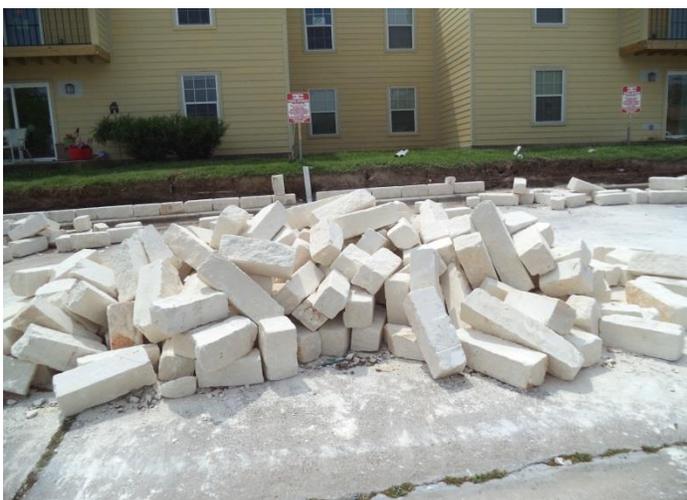
Stone delivered for retaining wall and landscaping

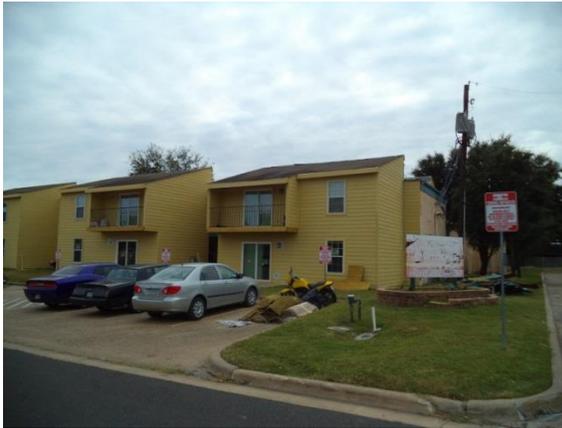
New siding and balconies at building #1

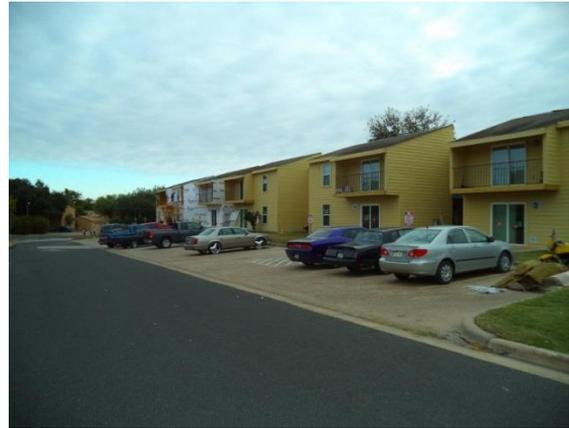
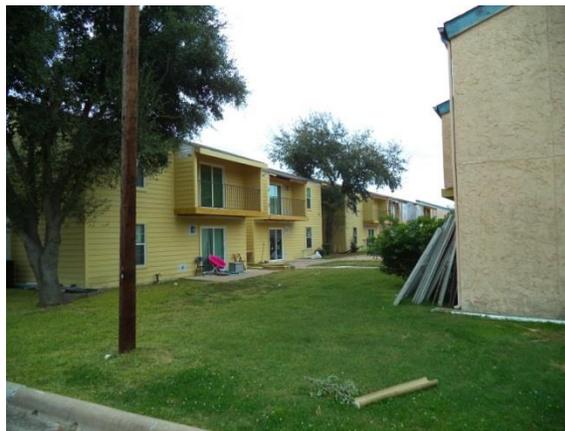
New siding and balconies at building #1
