Building name: Old Bryan Marketplace

202 South Bryan Avenue

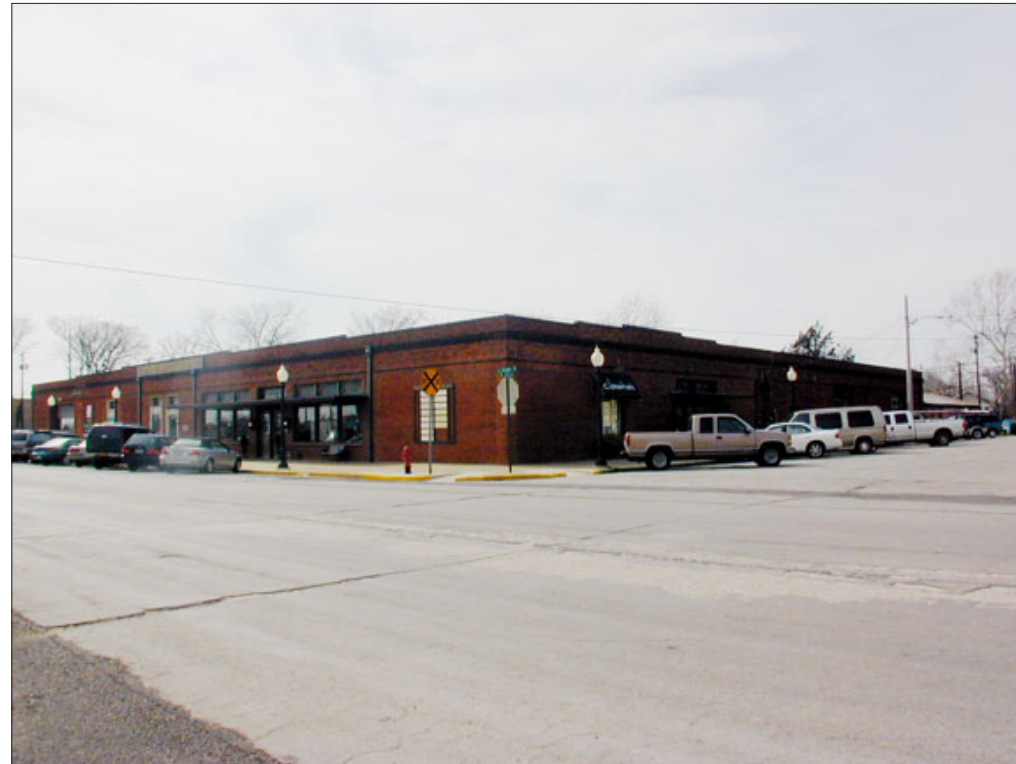
- Drain outlets need cleaning
- Southernmost downspout disconnected from underground drainage system
- Corrosion of metal lintels
- Poor service location on north facade
- Minor mortar deterioration
- Minor cracking along mortar joints
- Spalling of brick at parapet
- Unpainted adjoining metal on southwest facade causing staining on masonry

- Clean drain outlets.
- Tie southernmost downspout into underground drainage system.
- Update utilities while maintaining compliance. Remove as much conduit from the surface as possible.
- Replace corroded metal lintel.
- Determine and remedy cause of mortar deterioration and cracking along mortar joints; repoint as necessary with mortar matching the original in composition, color and profile.
- Install parapet cap after brick is repointed.
- Paint any metal in contact with the building.
- Ensure that entry is ADA compliant.

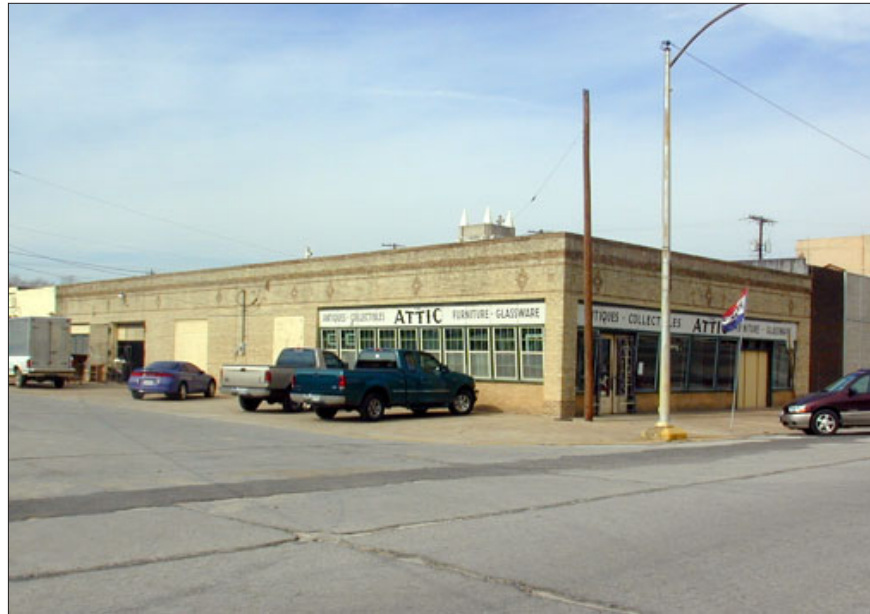
- No positive drainage away from the building
- Only one downspout on the south side drains this building
- Tar drippings on brick
- Biological staining
- Mortar deterioration, especially at parapet
- Cracking along mortar joints
- Brick at parapet are deteriorating
- Non-original storefront, doors, and windows
- Repointing with incompatible mortar high in portland cement
- Storefront has been infilled and enclosed in an incompatible manner

- Regrade site so that water flows away from the building.
- Evaluate drainage system to see if one downspout is adequately drains building. If not, additional downspouts and scuppers may be needed.
- Clean building in a manner that is not harmful to the mortar or masonry.
- Determine and remedy cause of mortar deterioration and cracking along mortar joints; repoint as necessary with mortar matching the original in composition, color and profile.
- Install parapet cap after brick is repointed.
- Remove incompatible mortar and repoint masonry with mortar matching the original in composition, color and profile.
- Reconstruct storefront in a style that is more compatible with the architecture.
- Ensure that entry is ADA compliant.

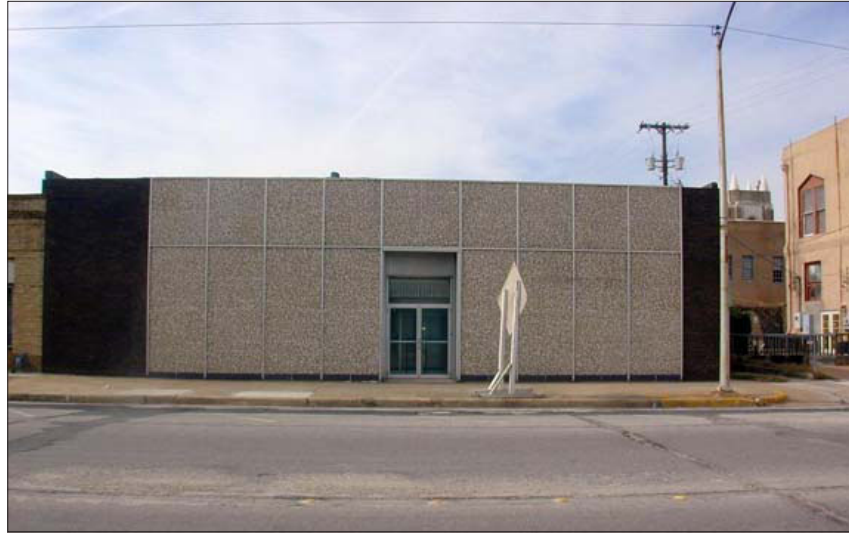
Existing Condition

- Pooling noted on north facade and poor drainage on west facade
- Steel casement windows in need of rehabilitation
- Minor biological staining
- Metal staining
- Paint deterioration along window sills
- Building in need of cleaning
- Areaway drain is clogged
- Non-original tile and aluminum slipcover on east facade

- Regrade site so that water drains away from the building.
- Update utilities while ensuring code compliance.
- Clean building in a manner that does not harm the masonry or mortar.
- If unpainted adjoining metal is staining the masonry, it should be primed and painted to prevent further damage.
- Ensure that entry is ADA compliant.
- Restore and repair windows.
- Remove non-original slipcover.
- Restore storefront and reconstruct canopy in a historically accurate manner.
