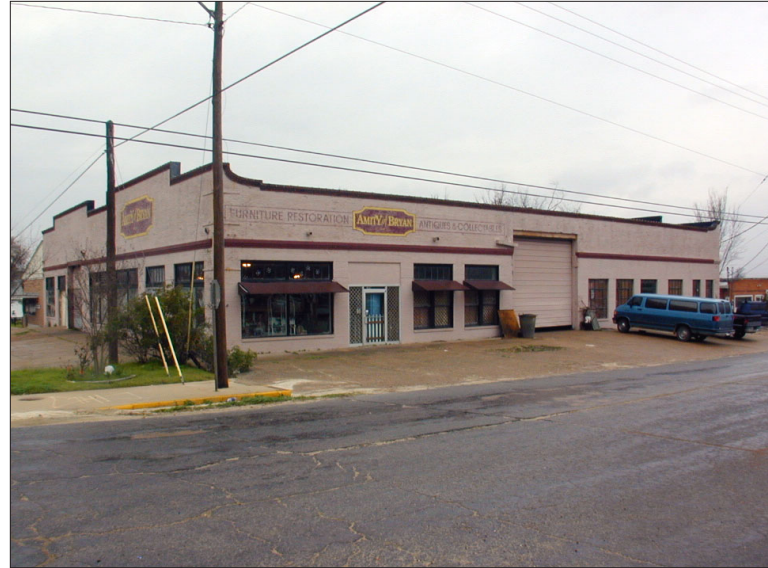
Existing Condition

- Lack of positive drainage, especially on the north and west sides
- Scupper allow water to drain down the side of the building
- Conduit attached to building
- Masonry and mortar deterioration, severe in some areas
- Corrosive spikes and pins in masonry
- Biological staining and growth
- Building in need of cleaning
- Plant growth located too close to the building
- Unsympathetic repointing and patching
- Holes in masonry
- Paint deterioration
- Door entry is not ADA compliant

- Regrade site so that water drains away from the building.
- Update utilities while ensuring code compliance.
- Determine cause of mortar and masonry deterioration and repoint as necessary with mortar matching the original in composition, color and profile. Areas that have been unsympathetically patched or pointed with Portland cement should be repointed with compatible mortar.

- Remove corrosive spikes and pins from masonry and patch with masonry patching compound.
- Clean building in a manner that does not harm the masonry or mortar.

- Determine cause of biological growth, remedy accordingly.
- Patch all holes in masonry with masonry patching compound.
- Ensure that entry is ADA compliant.

- If the paint on the brick is damaging the building in any way, the paint should be removed in the gentlest means possible.
- Remove plant growth located too close to the building.

- Restore original storefront with original door and window design and reconstruct original canopy.

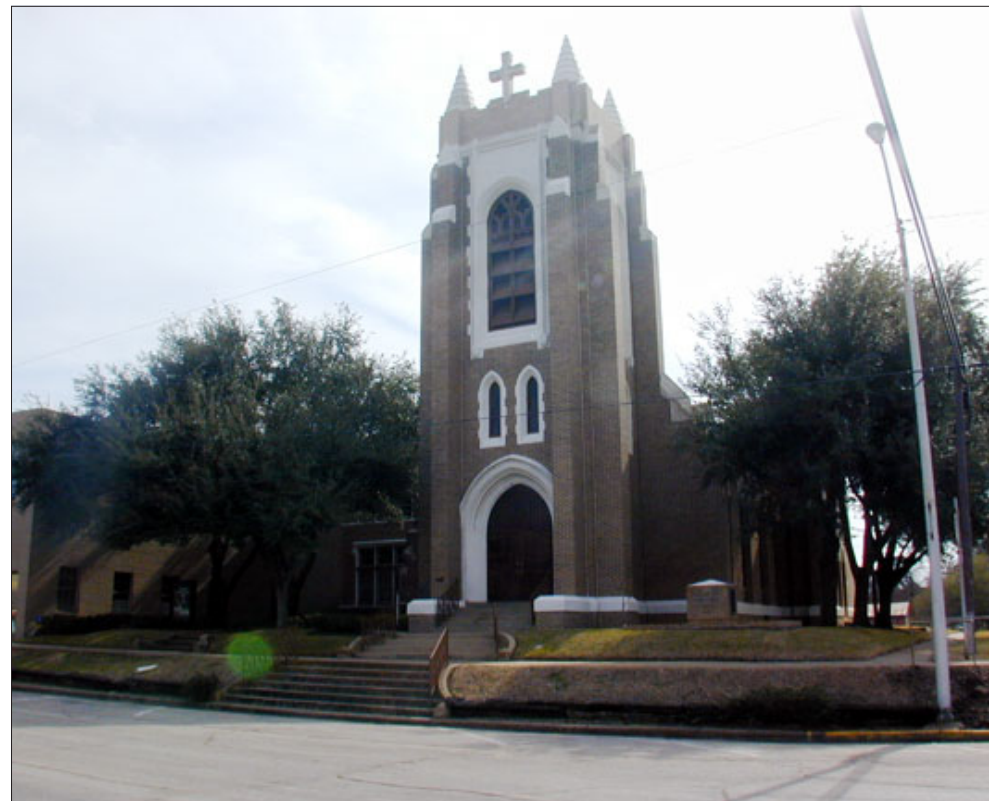
- Poor downspout termination
- Conduit attached to building
- Cracking through cast stone and brick
- Paint deterioration on cast stone and gutters
- Rust staining
- Biological staining
- Holes in masonry
- Building in need of cleaning
- Incompatible repointing

- Reconfigure downspout system so that water drains freely away from the building or into an underground drainage system. Unclog current drainage system and utilize all underground drains possible.
- Update utilities while ensuring code compliance.
- Repaint cast stone and brick.
- Clean building in a manner that does not harm the masonry or mortar.
- Ensure that entry is ADA compliant.
- When the time comes to replace the incompatible aluminum windows, they should be replaced with wood ones matching the originals.
- Patch holes in masonry with a masonry patching compound.
- Monitor stained glass windows for deterioration and ensure that the protective windows are not causing moisture to develop between the windows.
- Repoint areas that have been incompatibly repointed with a mortar matching the original in color, composition and profile.

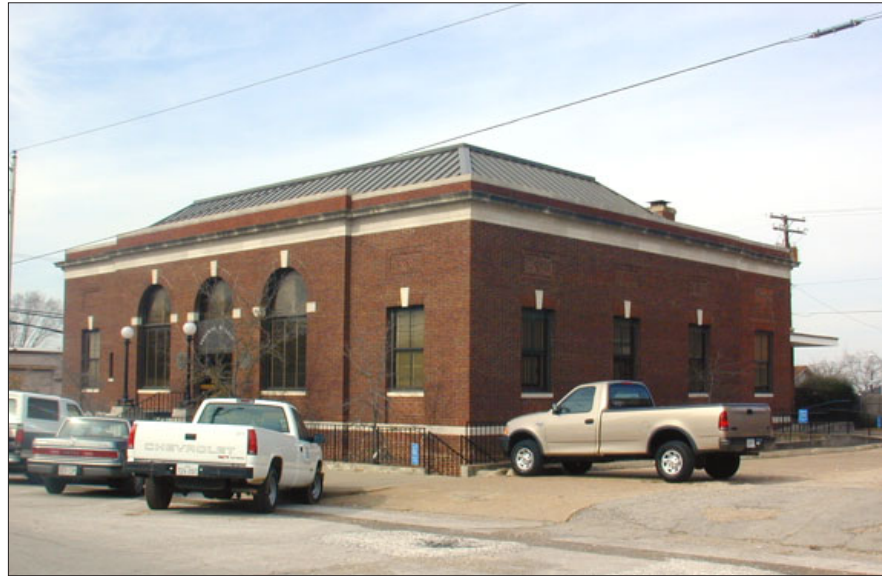
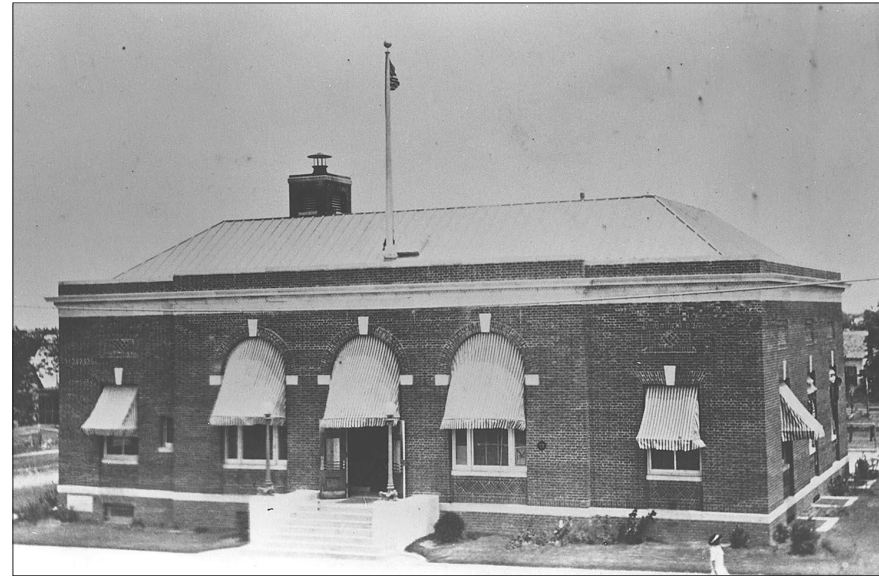
- Area around basement littered with plant debris
- Mortar and masonry deterioration
- Unsympathetic repointing, possibly with caulk
- Bitumen patching around portions of the building's base
- Minor cracking in masonry
- Spalling
- Biological staining
- Building in need of cleaning

- Clean area around basement so that water can flow through the drains freely.
- Determine cause of masonry and mortar deterioration and repair as necessary with mortar matching the original in composition, color and profile.
- Clean building in a manner that does not harm the masonry or mortar.
- Ensure that entry is ADA compliant.
- Replace windows and doors with ones that are more historically accurate.
- Reconstruct canopies over windows.

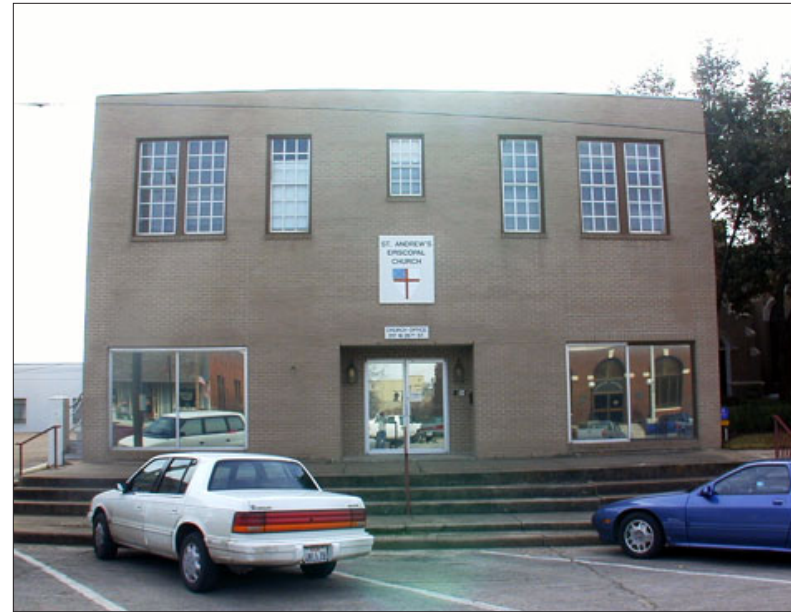
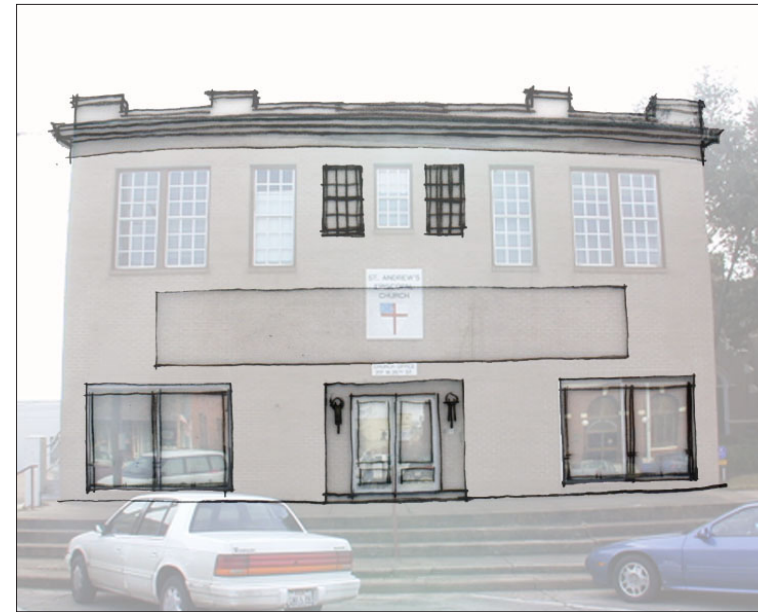
- Lack of positive drainage, especially on the south and west sides
- Poor downspout termination
- Large amounts of conduit attached to south facade
- Biological staining
- Metal staining
- Mortar deterioration
- Cracking along mortar joints
- Holes in masonry
- Paint over brick
- Paint deterioration
- Poor patching
- Metal jacking causing cracking through mortar joints
- Sprinkler heads too close to the west facade
- Inappropriate waterproof coating applied to base of west facade
- Building in need of cleaning

- Regrade site to ensure positive drainage away from the building.
- Reconfigure downspouts so that adequate drainage is provided and water is deposited into an underground drainage system or a proper distance away from the building.

- Reconfigure utilities while ensuring code compliance.
- Determine cause of masonry and mortar deterioration and repair as necessary with mortar matching the original in composition, color and profile.

- Clean building in a manner that does not harm the masonry or mortar.
- Remove inappropriate patching and patch holes in masonry with a masonry patching compound.

- Perform test area to determine if paint can be removed from the masonry without harming the brick or mortar. If it can be removed, do so in the most gentle means possible.

- Rehabilitate wood windows.
- Relocate or reposition sprinkler heads so that water does not spray on the building.
- Remove improper waterproof coating. If moisture problems are still evident after altering the sprinkler positions, waterproof the base of the building in a more sensitive and appropriate manner.

- Ensure that entry is ADA compliant.
- Replace aluminum windows and doors with ones that match the historic nature of the church.

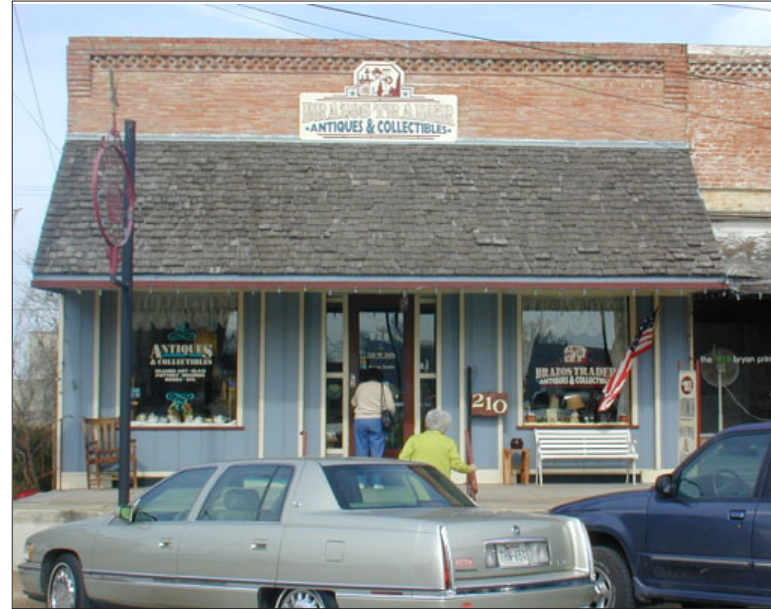
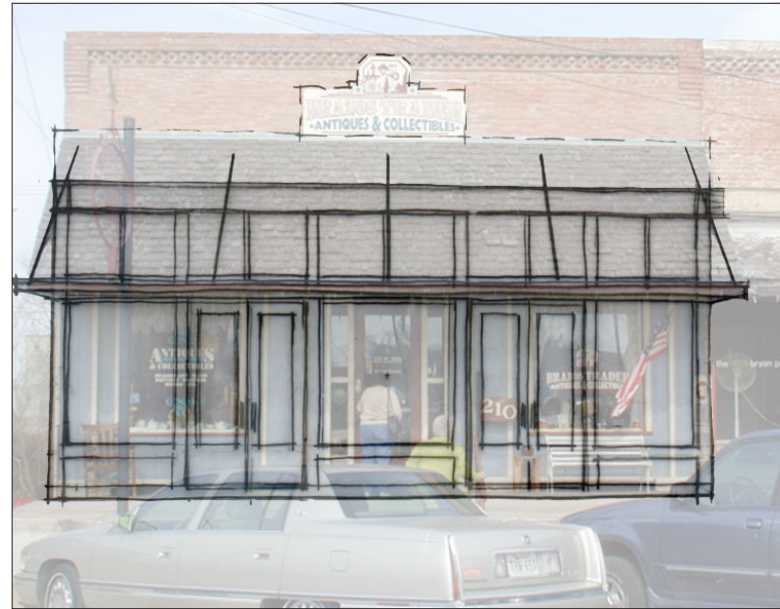
- One downspout leader is severely damaged
- Surface mounted utilities
- Mortar deterioration
- Cracking through brick and mortar joints
- Spalling
- Efflorescence
- Biological staining
- Metal staining
- Building in need of cleaning
- Tie rodding on west and north walls
- West wall deflecting
- Incompatible repointing
- Entry is not ADA compliant

- Restore downspouts so that they drain freely away from the building or into an underground drainage system.
- Update utilities while ensuring code compliance.
- West wall should be inspected by a structural engineer.
- Determine cause of mortar deterioration and repoint as necessary with mortar matching the original in composition, color and profile. Areas that have been unsympathetically patched or pointed with Portland cement should be repointed with compatible mortar.
- Clean building in a manner that does not harm the masonry or mortar.
- Determine cause of efflorescence and remedy accordingly.
- Ensure that entry is ADA compliant.
- Restore openings on north facade.
- Restore original storefront and canopy.

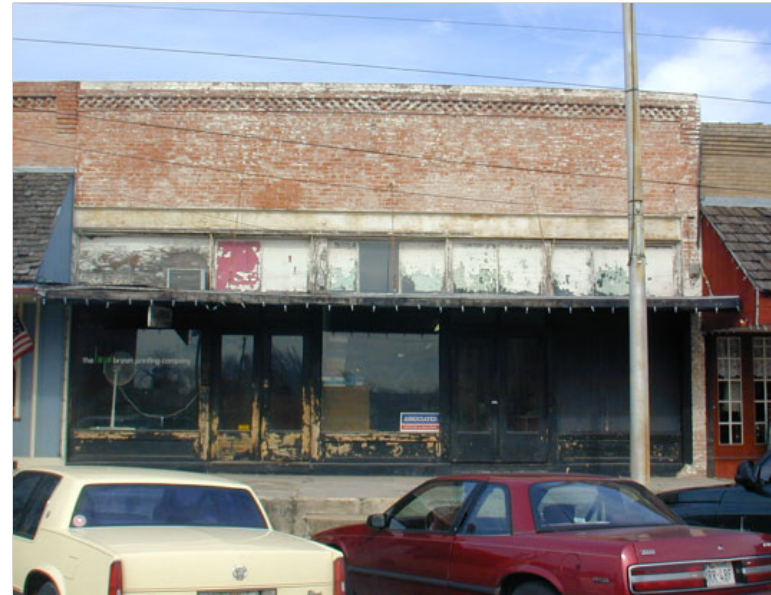
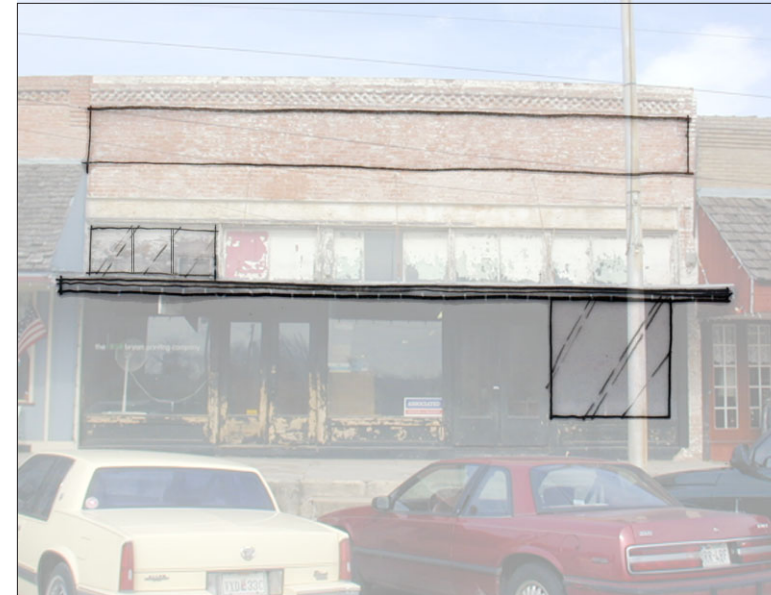
- Possible pooling at north facade
- Poor downspout termination
- Surface mounted utilities
- Vertical and horizontal deflections on south wall
- Mortar deterioration
- Biological staining
- Metal staining
- Building in need of cleaning
- Incompatible modification
- Metal jacking of lintels
- Paint deterioration
- Entry is not ADA compliant

- Reconfigure and restore downspouts so that they drain freely away from the building or into an underground drainage system.
- Update utilities while ensuring code compliance.
- South wall should be inspected by a structural engineer.
- Determine cause of mortar deterioration and repoint as necessary with mortar matching the original in composition, color and profile. Areas that have been unsympathetically patched or pointed with Portland cement should be repointed with compatible mortar.
- Clean building in a manner that does not harm the masonry or mortar.
- Ensure that entry is ADA compliant.
- Remove metal lintels and replace with a noncorrosive metal.
- Determine if paint is harming the brick and if so, remove it with the most gentle means possible.
- Restore openings on north facade.
- Restore original storefront and canopy.

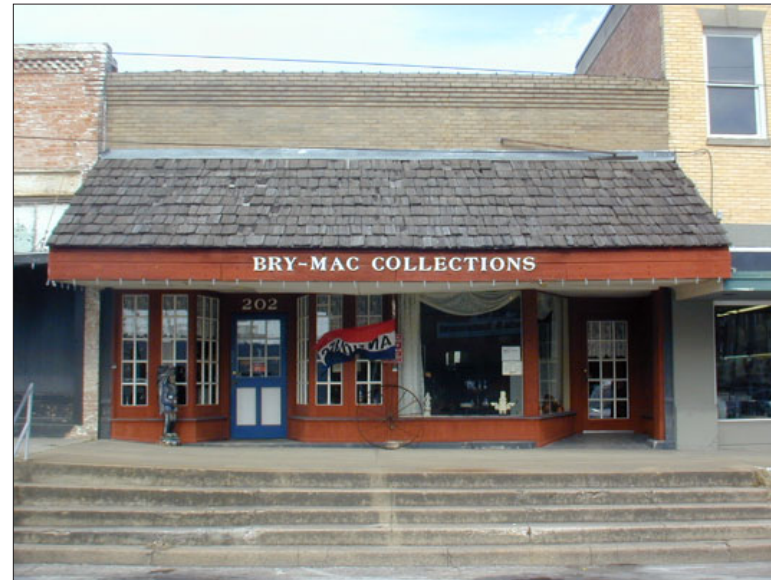
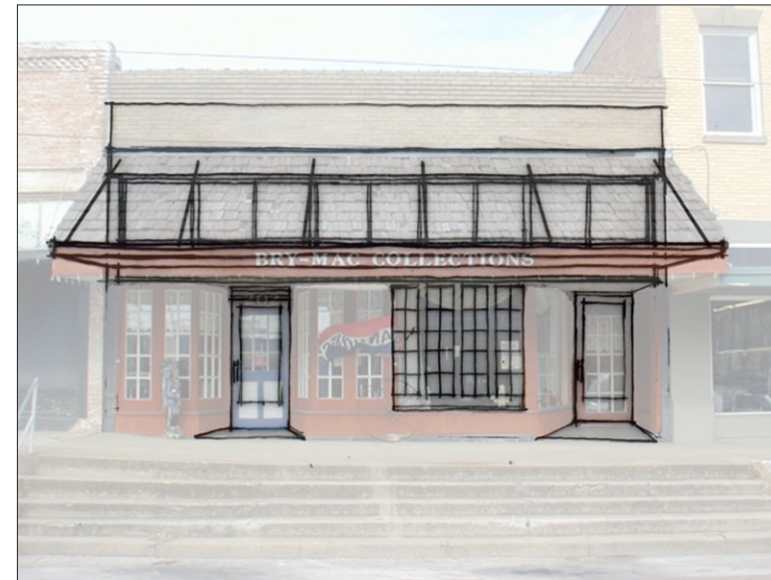
- Downspouts exhibits rust, clogs, and poor termination
- Downspouts are disjointed/disconnected
- Surface mounted utilities
- North wall is deflecting
- Tie rods noted on north wall
- Mortar deterioration, especially at the parapet where bricks are beginning to dislodge
- Biological staining
- Metal staining
- Efflorescence
- Building in need of cleaning
- Cracking along mortar joints
- Paint deterioration
- Entry is not ADA compliant

- Reconfigure and restore downspouts so that they drain freely away from the building or into an underground drainage system.
- Update utilities while ensuring code compliance.
- North wall should be inspected by a structural engineer.
- Determine cause of mortar deterioration and repoint as necessary with mortar matching the original in composition, color and profile. Areas that have been unsympathetically patched or pointed with Portland cement should be repointed with compatible mortar.
- Determine cause of efflorescence and remedy accordingly.
- Clean building in a manner that does not harm the masonry or mortar.
- Ensure that entry is ADA compliant.
- Replace existing windows and doors with ones that are more historically accurate.
- Remove unoriginal canopy. Restore storefront and reconstruct canopy to reflect original design.

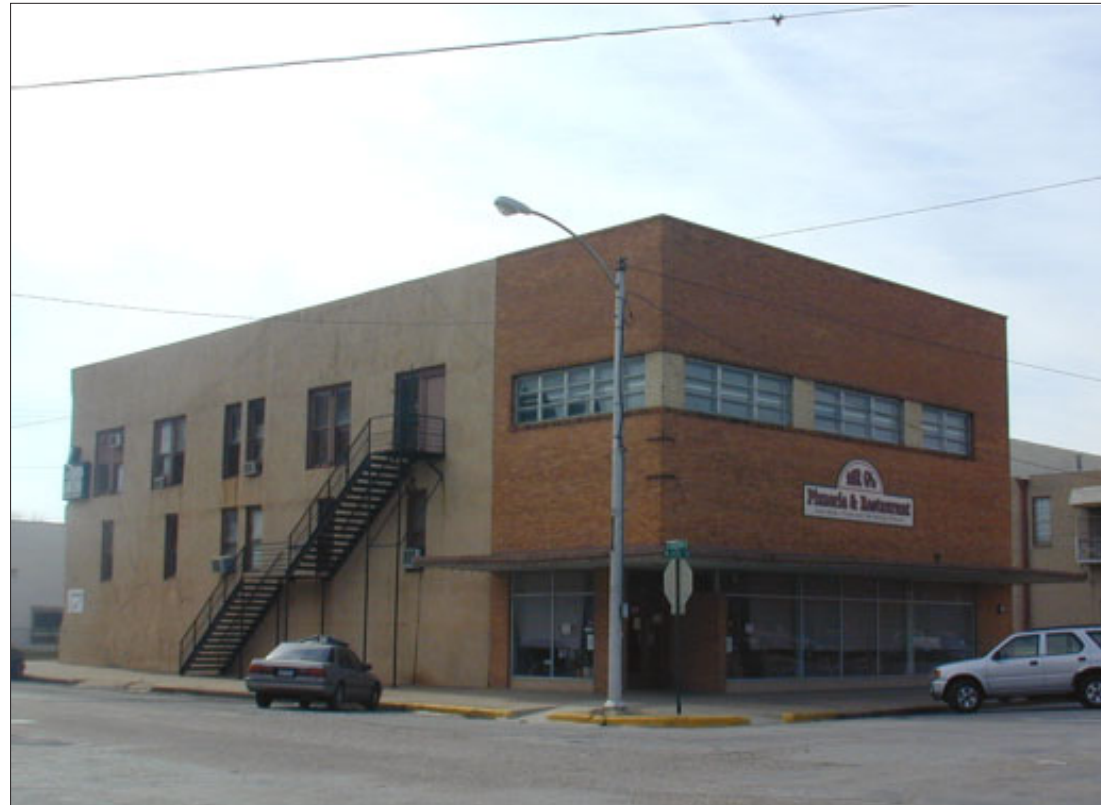
- Poor downspout termination
- Negative drainage
- Conduit attached to building
- Mortar deterioration
- Cracking through stucco
- Rust staining caused by exterior staircase
- Biological staining
- Building in need of cleaning
- Wood rot on windows
- Paint deterioration
- Cracking through brick and mortar joints
- Horizontal deflection
- Holes in masonry
- Incompatible patching and repointing
- Severe moisture problems (possibly faulty flashing or mortar deterioration) affecting parapet wall

- Reconfigure downspout system so that water drains freely away from the building or into an underground drainage system
- Regrade site so that water flows away from the building
- Update utilities while ensuring code compliance.
- Repair and repaint the stucco to match the original.
- Repoint areas where mortar has deteriorated or where brick has been unsympathetically repointed, with a mortar matching the original in composition, color and profile.
- Restore or replace wood windows, matching the 1950s appearance.
- Restore historic sign on west facade.
- Clean building in a manner that does not harm the masonry or mortar.
- Fill holes in masonry with patching compound.
- Ensure that entry is ADA compliant.
- Restore the storefront to match the building's 1950s appearance.
- Determine cause of moisture deterioration at parapet wall.

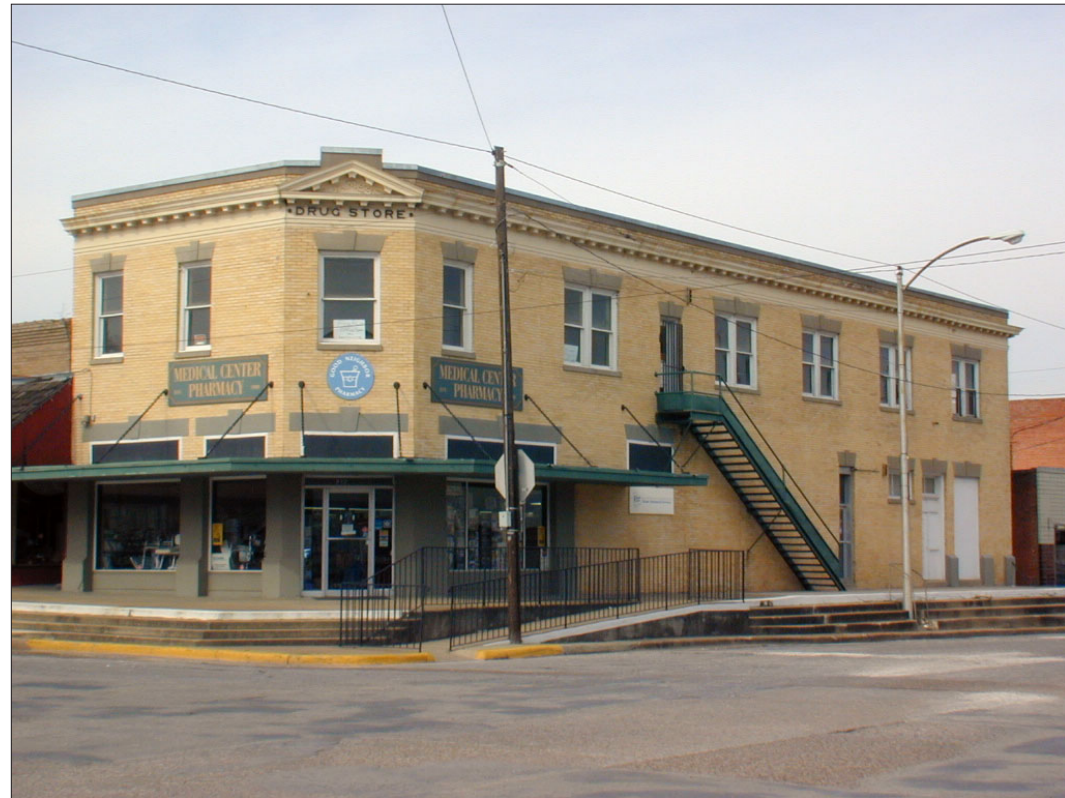
- Possible lack of positive drainage on east facade
- Downspout exhibits rust and poor termination
- Surface mounted conduit
- Sheet metal cornice exhibits solder joint failure, rust, paint failure and possible deterioration of underlying mortar
- Biological staining
- Building in need of cleaning
- Cracking along mortar joints
- Chipping of stucco at base of building
- Rust stains on brick from staircase
- Holes in masonry
- Paint deterioration on windows and cornice
- Door handle is not ADA compliant

- Regrade site so that water flows away from the building.
- Reconfigure downspouts so that they drain freely away from the building or into an underground drainage system.
- Update utilities while ensuring code compliance.
- Restore metal cornice. This includes resoldering failing joints, removing rust and failing paint and repointing any deteriorated underlying mortar.
- Determine cause of mortar deterioration and repoint as necessary with mortar matching the original in composition, color and profile. Areas that have been unsympathetically patched or pointed with Portland cement should be repointed with compatible mortar.
- Clean building in a manner that does not harm the masonry or mortar.
- Patch holes in masonry with a masonry patching compound.
- Ensure that entry is ADA compliant.
- Restore original windows.
- Restore original storefront and canopy.
