Building name: Unknown

Building use: Storage

217 West 27th Street

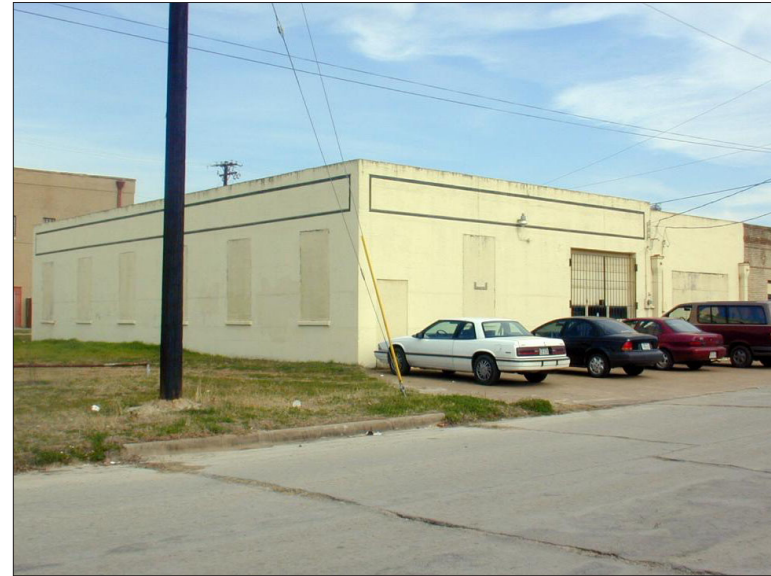
Existing Condition

- Lack of positive drainage on west and south sides
- Drainage clog
- Scupper deposit water onto building
- Conduit attached to building
- Minor cracking through stucco
- Biological staining
- Building in need of cleaning
- Paint deterioration
- Holes in masonry

- Regrade site so that water flows away from the building.
- Construct downspout system so that water drains freely away from the building or into an underground drainage system and repair clogged drain.
- Update utilities while ensuring code compliance.
- Clean building in a manner that does not harm the masonry or mortar.
- Ensure that entry is ADA compliant.
- Patch holes and cracks in masonry with compatible masonry patching compound.
- Repaint stucco on building.
- Uncover windows and doors, and restore or replace with ones that are historically compatible.
- Restore storefront in a historically compatible manner.

Front Facade and Side: Repair stucco and repaint; remove coverings from windows on side of building; restore original storefront, transoms, and entry system per detail; install new wood canopy.
\$ 35,000.00
