## Existing Condition

**Building name:** Ice House

**100 West MLK Jr. Street**

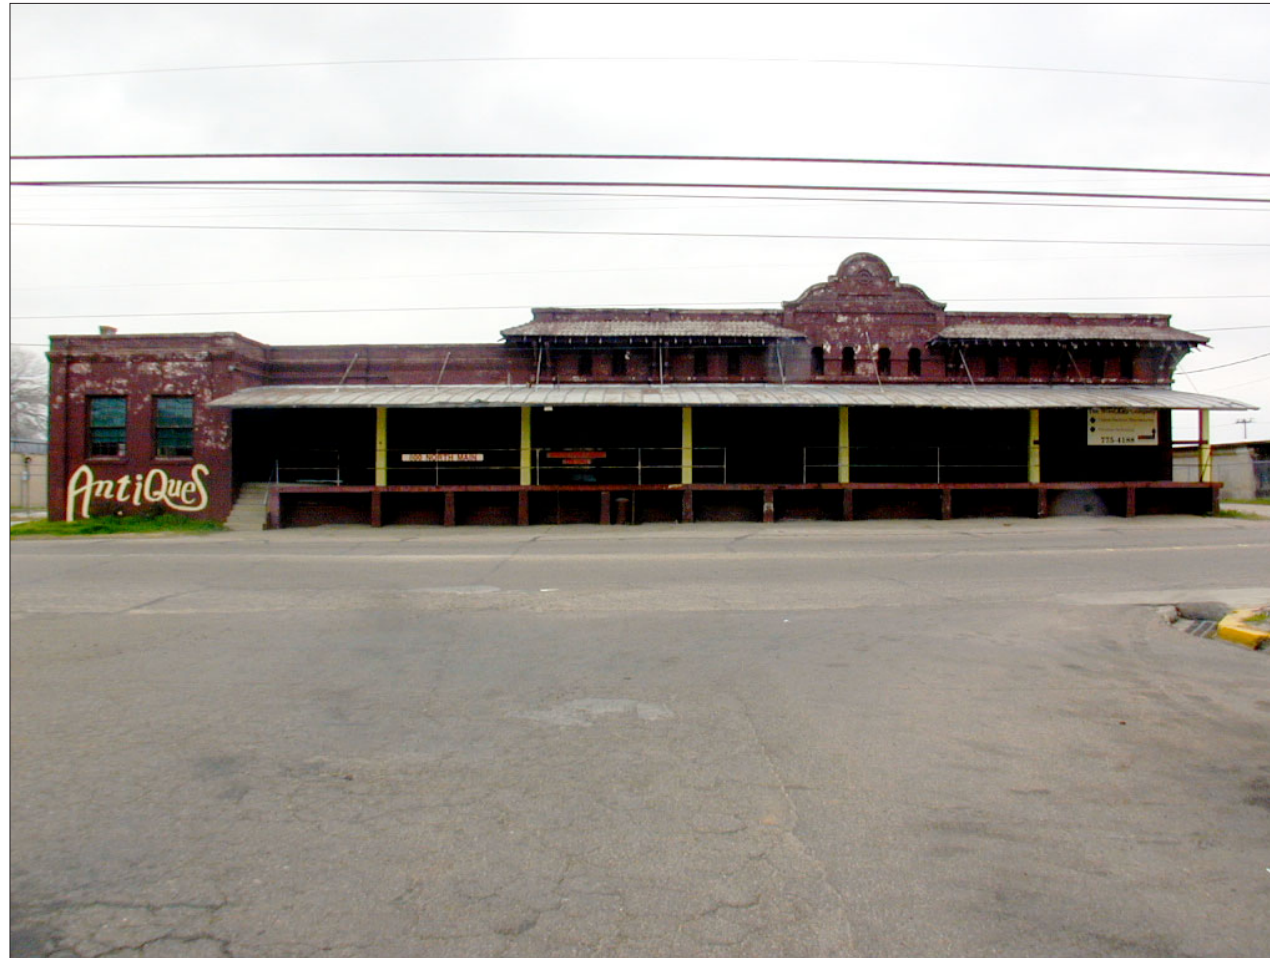
- Negative drainage conditions toward the east facade
- Poor downspout termination
- N/E downspout can not drain freely due to the extreme overgrowth of plants and brush
- Conduit attached to the building
- Wood rot noted on overhang and building openings
- Mortar and masonry deterioration, especially on east facade
- Cracking through masonry and mortar joints
- Tie rodding evident
- Severe parge coat deterioration on parapet cap and at base of pilasters
- Efflorescence
- Poorly configured utility service
- Biological staining
- Building in need of cleaning
- Some windows have been painted over
- Deterioration of a lintel over crawlspace vent causing failure of masonry
- Holes in masonry
- Exposed brick has been painted on south facade
- Severe paint deterioration
- Building is not compliant with ADA regulations

- Regrade site and reconfigure downspouts so that they drain freely away from the building. Ensure that the downspouts are free of debris.
- Update utilities while ensuring code compliance.
- Reconfigure electrical services and remove conduit from building's exterior.
- Repair or replace rotted wood on building.
- Determine cause of mortar and masonry deterioration and repoint as necessary with mortar matching the original in composition, color and profile.
- Determine cause of efflorescence, remedy accordingly.
- Clean building in a manner that does not harm the masonry or mortar. Determine if paint is causing accelerated deterioration and if so, remove paint.
- Fill holes in brick with masonry patching compound. Patch large holes in masonry with matching brick and mortar.
- Ensure that entry is ADA compliant.
- Restore original building openings.
- Replicate original canopy.

Front Facade and Sides: Chemical paint stripping and repointing of masonry façade (scaffolding not included); repair/replace wood elements on building; restore tile roof on canopies; restore original building openings and replicate original canopy.  
\$ 202,500.00
