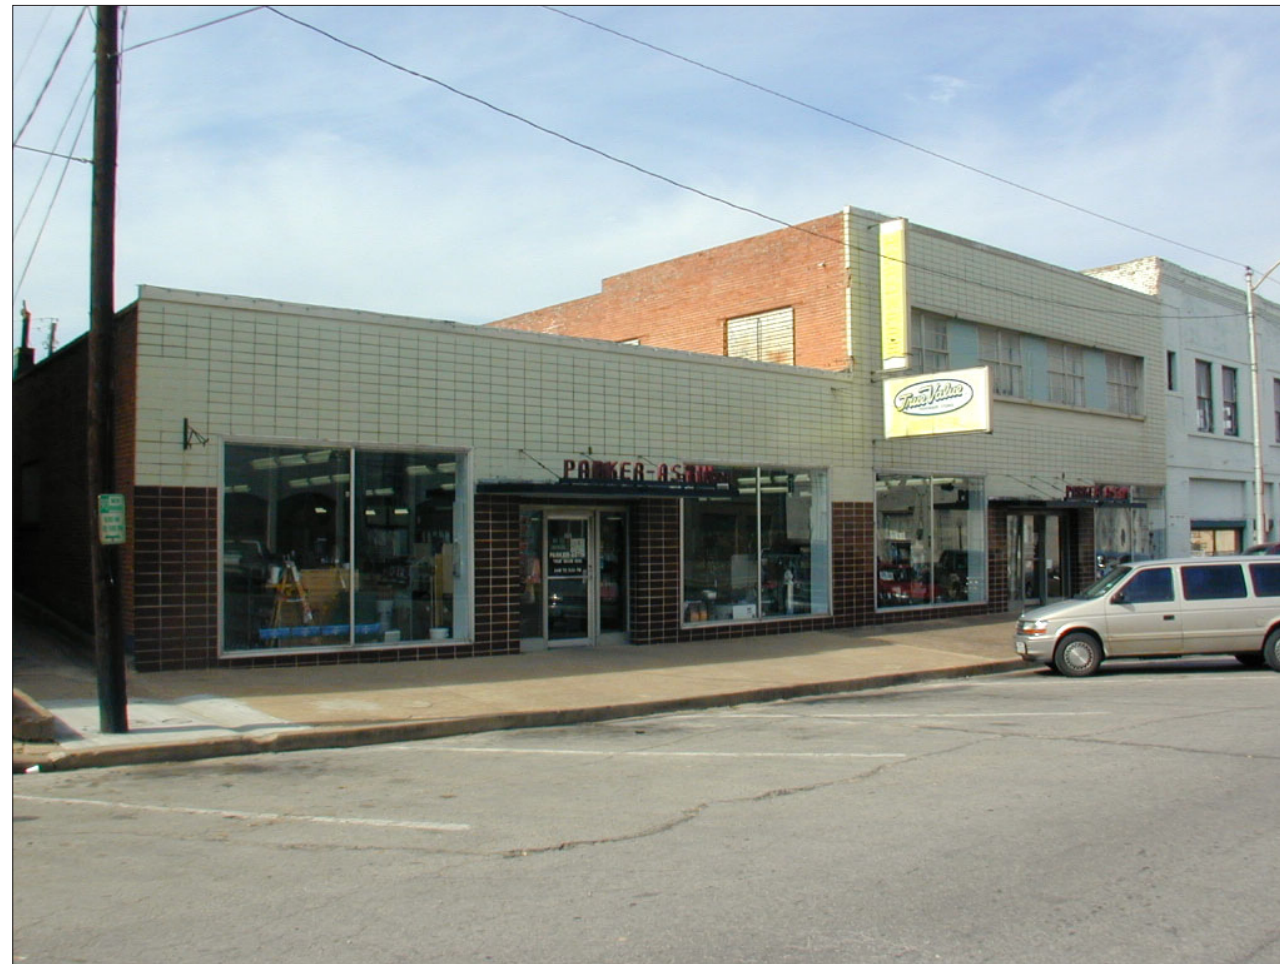
Existing Condition

- Marginal positive drainage along west facade
- Scuppers allow water to drain down side of building
- Poorly configured utilities
- Metal jacking of all lintels on west facade, especially on second floor
- Aluminum window surrounds in need of repair and maintenance
- Bitumen patching along base of southern wall
- Mortar deterioration
- Cracking through brick and mortar joints caused by metal jacking
- Spalling
- Biological staining
- Metal staining
- Efflorescence
- Corrosive spikes and pins embedded in the masonry
- Unpainted adjoining metal
- Inadequate waterproofing of parapet on west facade
- Building in need of cleaning
- Incompatible repointing
- Door handles are not ADA compliant

- Regrade site so that water flows away from the building.
- Connect scuppers to a drainage system so that water drains freely away from the building or into an underground drainage system.

- Update utilities while ensuring code compliance.
- Deteriorating metal lintels should be replaced with new lintels.
- Determine cause of mortar deterioration and repoint as necessary with mortar matching the original in composition, color and profile. Areas that have been unsympathetically patched or pointed with Portland cement should be repointed with compatible mortar.

- Remove bitumen patching in a manner that does not harm the masonry or mortar
- Clean building in a manner that does not harm the masonry or mortar.
- Determine cause of efflorescence and remedy accordingly

- Remove corrosive spikes and pins from masonry
- Patch any holes in the masonry with a masonry patching compound.
- Paint any adjoining metal.
- Ensure that entry is ADA compliant.

- Restore and repair windows.
- Properly waterproof parapet wall with assistance from an experienced professional.

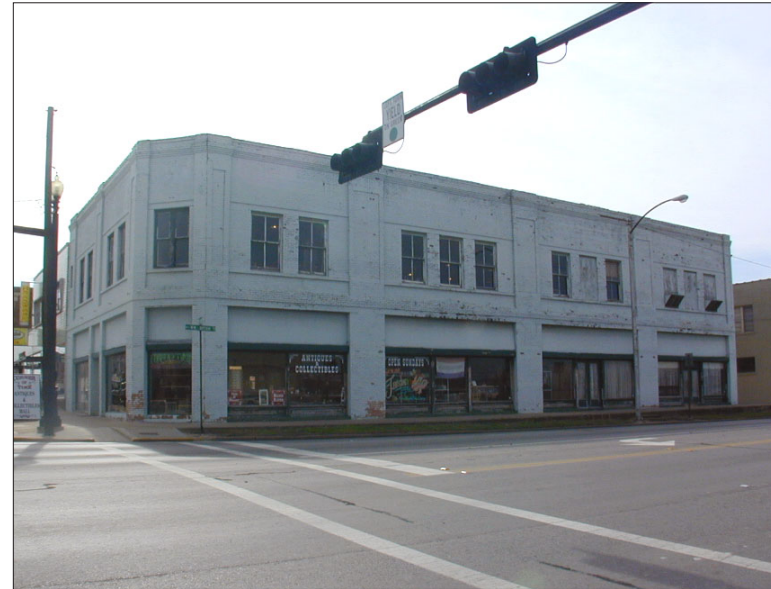
- Marginal positive drainage along west facade
- Gutter leaks and fair downspout termination
- Minor lintel corrosion
- Mortar deterioration, especially around base of west service door and parapet
- Cracking through masonry and mortar joints caused by metal jacking
- Spalling
- Biological staining
- Metal staining
- Unpainted adjoining metal
- Inadequate waterproofing of parapet on west facade
- Building in need of cleaning
- Incompatible repointing
- Holes in masonry
- Paint deterioration
- Paint coating trapping moisture
- Door handles are not ADA compliant

- Regrade site so that water flows away from the building.
- Repair drainage system so that water drains freely away from the building or into an underground drainage system.

- Update utilities while ensuring code compliance.
- Metal lintels should be replaced with new metal lintels.
- Determine cause of mortar deterioration and repoint as necessary with mortar matching the original in composition, color and profile. Areas that have been unsympathetically patched or pointed with Portland cement should be repointed with compatible mortar.

- Clean building in a manner that does not harm the masonry or mortar.
- Patch any holes in the masonry with a masonry patching compound.
- Paint any adjoining metal.

- Ensure that entry is ADA compliant.
- Remove paint from masonry in the most gentle means possible. If paint removal harms the brick, repaint the brick on a regular schedule to prevent paint deterioration.

- Restore and repair windows.
- Properly waterproof parapet wall with the aid of an experienced professional.
- Restore storefront and reconstruct canopy.

- Reconstruct parapet.

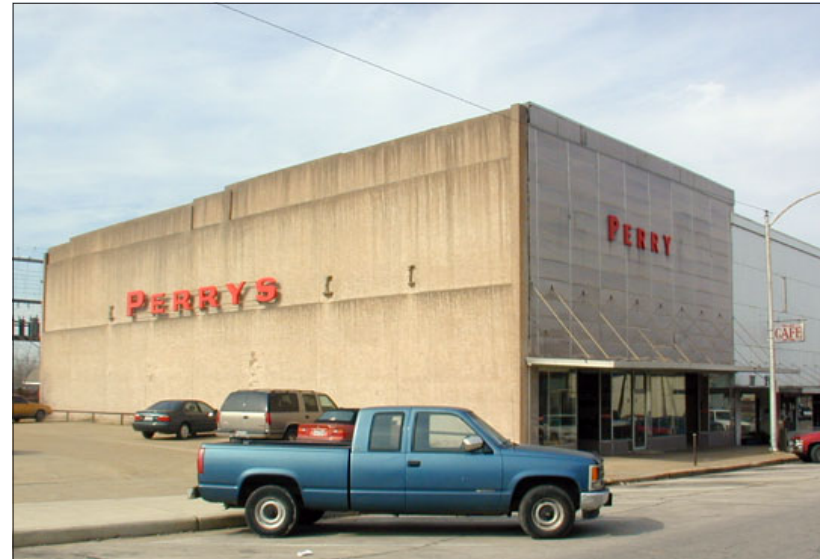
- Poor downspout termination
- Conduit attached to the building
- Cracking through masonry and mortar joints
- Spalling
- Biological staining and growth
- Metal staining
- Building in need of cleaning
- Holes in masonry
- Painted brick
- Paint deterioration
- Door handles are not ADA compliant

- Reconfigure downspout system so that water flows freely away from the building or into an underground drainage system.
- Update utilities while ensuring code compliance.
- Metal lintels should be replaced with new metal lintels.
- Repoint building as necessary with mortar matching the original in composition, color and profile.
- Clean building in a manner that does not harm the masonry or mortar.
- Patch any holes in the masonry with a masonry patching compound.
- Paint any adjoining metal.
- Ensure that entry is ADA compliant.
- Remove paint from masonry in the most gentle means possible as long as the removal process does not harm the brick.
- Restore and repair windows.
- Remove slipcover and restore front facade.
- Restore storefront, including transom windows, and reconstruct canopy in a historic manner.

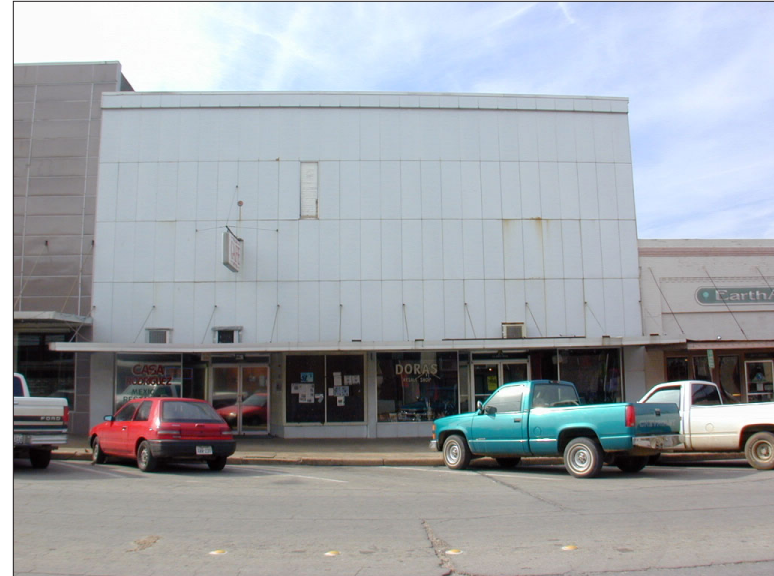
- Poor downspout termination
- Rusting downspout causing staining on wall
- Conduit attached to building
- Mortar deterioration
- Cracking through stucco
- Rust staining on slipcover
- Biological staining
- Building in need of cleaning

- Reconfigure downspout system so that water drains freely away from the building or into an underground drainage system.
- Update utilities while ensuring code compliance.
- If possible, remove stucco from west facade without harming the building. If not, determine cause of masonry deterioration and repair as necessary with stucco matching the original in composition and color.
- Repoint areas where mortar has deteriorated with a mortar matching the original in composition, color and profile.
- Clean building in a manner that does not harm the masonry or mortar.
- Ensure that entry is ADA compliant.
- Restore and repair windows.
- Remove slipcover and restore the front facade, including the storefront.
- Reconstruct canopy to reflect building's original historic design.

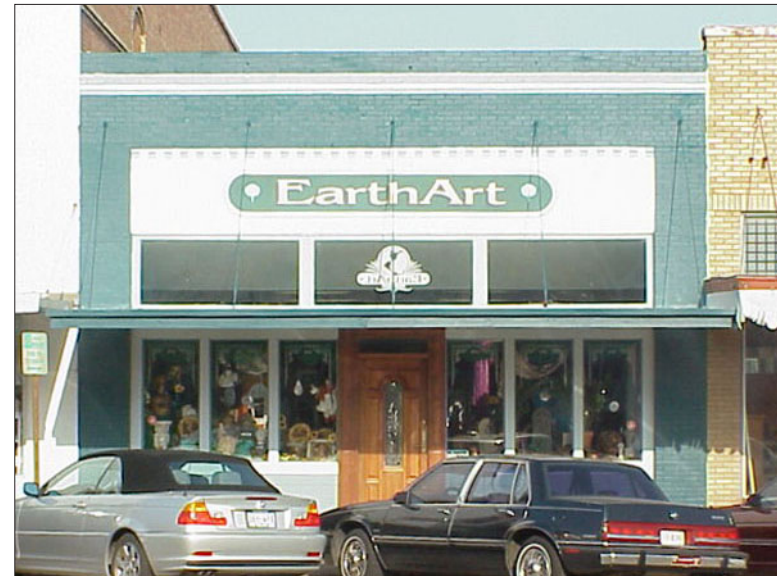
- Poor downspout termination
- Corrosion of west service door lintel, possible minor corrosion of storefront lintel
- Mortar deterioration, especially around base of west service door and parapet
- Minor cracking through masonry and mortar joints
- Spalling
- Biological staining
- Efflorescence under paint
- Building in need of cleaning
- Paint deterioration
- Paint coating trapping moisture
- Wooden canopy deteriorating

- Reconfigure downspout system so that water drains freely away from the building or into an underground drainage system.
- Update utilities while ensuring code compliance.

- Metal lintels should be replaced with new metal lintels, depending on the level of corrosion.
- Determine cause of mortar deterioration and repoint as necessary with mortar matching the original in composition, color and profile. Areas that have been unsympathetically patched or pointed with Portland cement should be repointed with compatible mortar.

- Clean building in a manner that does not harm the masonry or mortar.
- Determine cause of efflorescence and remedy accordingly.
- Ensure that entry is ADA compliant.

- Remove paint from masonry in the most gentle means possible.
- Restore and repair windows, including transom windows.
- Restore storefront along with period style door, and reconstruct canopy to reflect the original historic design.

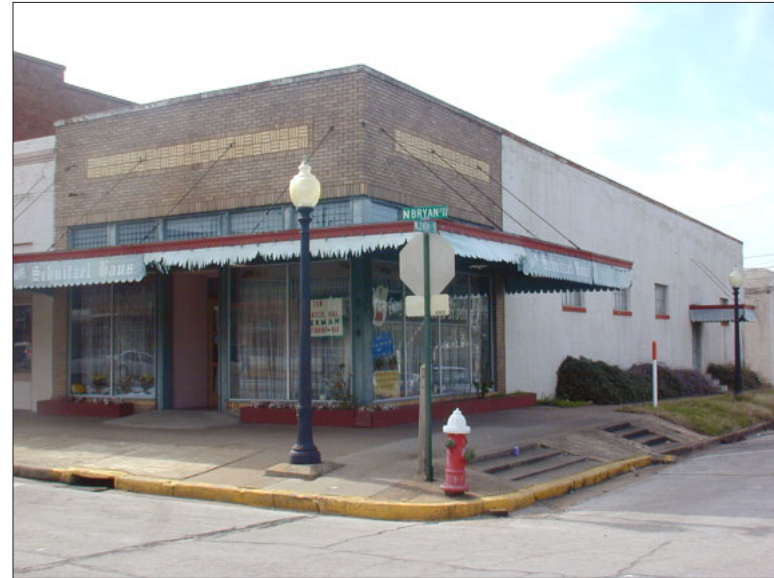
- Poor downspout termination
- Minor corrosion of storefront lintel
- Masonry deterioration
- Cracking through stucco
- Severe cracking and crazing of parapet stucco
- Metal staining
- Spalling
- Biological staining
- Building in need of cleaning
- Landscaping against building on north and west facades
- Paint deterioration

- Reconfigure downspout system so that water drains freely away from the building or into an underground drainage system.
- Update utilities while ensuring code compliance.
- Metal lintels should be replaced with new metal lintels, depending on the level of corrosion.
- Determine cause of masonry deterioration and repair as necessary with stucco matching the original in composition and color.
- Clean building in a manner that does not harm the masonry or mortar.
- Ensure that entry is ADA compliant.
- Restore and repair windows.
- Restore storefront and reconstruct canopy to reflect the original design.

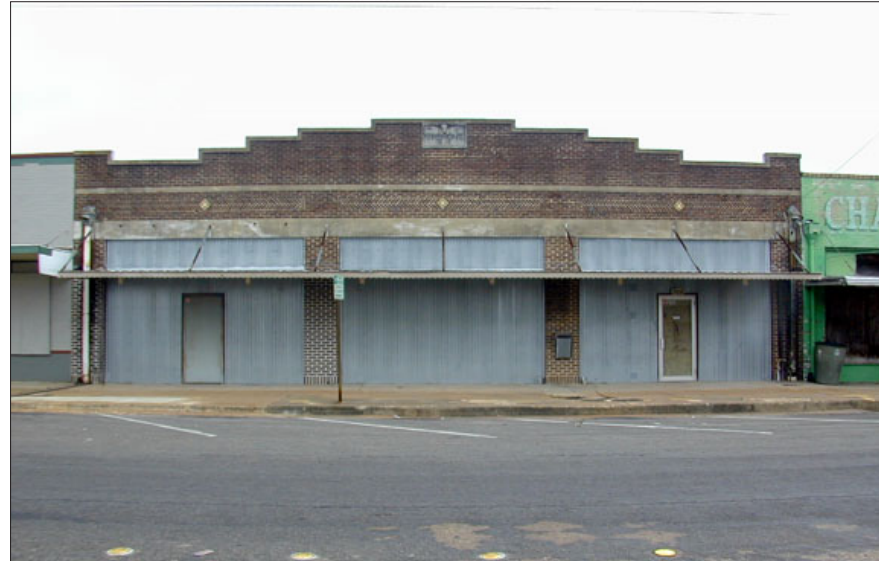
- Lack of positive drainage on west side and some areas are conducive to pooling
- Poor downspout termination causing bricks to erode at the base of the building
- Conduit attached to building
- Masonry and mortar deterioration
- Portions of wall covered in roofing mastic
- Corrosive spikes and pins in masonry
- Biological staining
- Spalling of brick
- Some brick have been painted
- Building in need of cleaning
- Unsympathetic repointing and patching; some holes in brick have been filled in with expanding insulation foam
- Door handles are not ADA compliant

- Regrade site so that water drains away from the building.
- Update utilities while ensuring code compliance.
- Determine cause of mortar and masonry deterioration and repoint as necessary with mortar matching the original in composition, color and profile. Areas that have been unsympathetically pointed with Portland cement should be repointed with compatible mortar.
- Remove corrosive spikes and pins from masonry and patch with masonry patching compound.
- Clean building in a manner that does not harm the masonry or mortar.
- Remove expanding insulation foam and patch brick with a masonry patching compound.
- If it is determined that paint or roofing mastic is harming the brick, remove the material in a manner that does not harm the brick.
- Ensure that entry is ADA compliant.
- Restore original storefront and transom design and reconstruct original canopy.

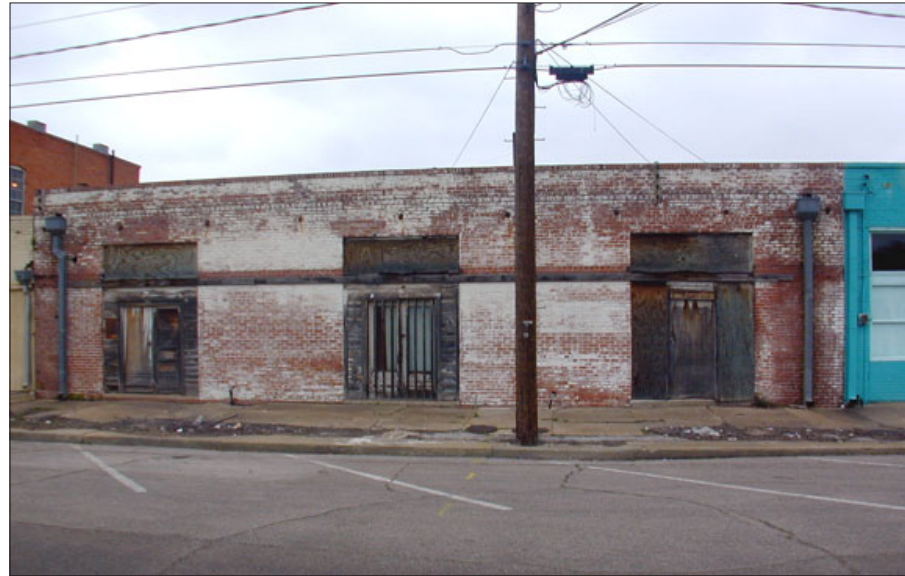
- Ponding and poor drainage conditions at west side
- Poor downspout termination
- Mortar deterioration
- Cracking along mortar joints
- Poorly configured utility service
- Biological staining
- Building in need of cleaning
- Transoms have been infilled
- Holes in masonry
- Exposed brick has been painted
- Door handles and approach do not comply with ADA regulations
- Corrosive spikes and/or pins embedded in masonry

- Regrade site and reconfigure downspouts so that they drain underground, either into the sewer system or at street level. Ensure that the downspouts are free of debris and drain freely away from the building.
- Determine and remedy cause of mortar deterioration and cracking along mortar joints; repoint as necessary with mortar matching the original in composition, color and profile.
- Update utilities while ensuring code compliance.
- Clean building in a manner that does not harm the masonry or mortar. Determine if paint is causing accelerated deterioration and if so, remove paint in the most gentle means possible.
- Remove corrosive spikes and pins and fill all holes in brick with masonry patching compound.
- Ensure that entry is ADA compliant.
- Restore original openings, including doors and transoms.
- Reconstruct canopy to reflect the historic nature of the building.

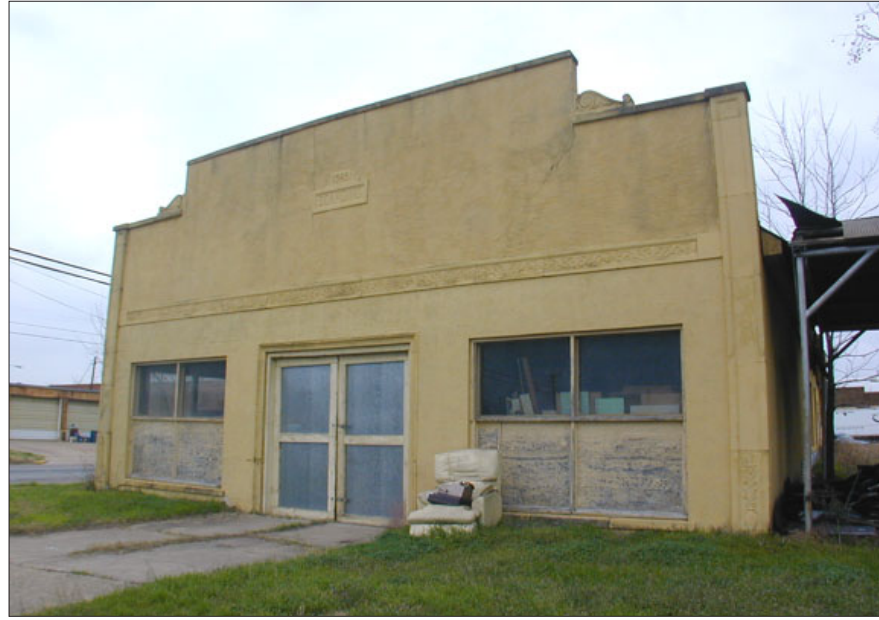
- Very poor drainage conditions causing deterioration and biological growth
- Building does not have any drainage system
- Old gutter located on south facade is falling off of building
- Trees and plants growing too close to the base of the building
- Facia board missing in several areas
- Masonry deterioration
- Cracking through masonry
- Biological staining and growth
- Building in need of cleaning
- Wood rot
- Metal jacking of lintels on east side, causing cracking through mortar.
- Unoriginal windows.
- Several windows and a door have been boarded over or infilled
- Holes in stucco

- Regrade site so that water drains freely away from the building.
- Provide drainage system so that water is not deposited at the base of the building.
- Update utilities while ensuring code compliance.
- Reconfigure electrical services and remove conduit from building's exterior.
- Repair or replaced rotted wood.
- Determine cause of stucco deterioration and repair as necessary with stucco matching the original in composition.
- Clean building in a manner that does not harm the stucco.
- Fill holes in stucco with patching compound.
- Ensure that entry is ADA compliant.
- Restore original window and door openings and transoms.
- Remove trees and brush near the base of the building.
- Replace corroded metal lintels and repoint mortar joints with mortar matching the original in composition, color and profile.
