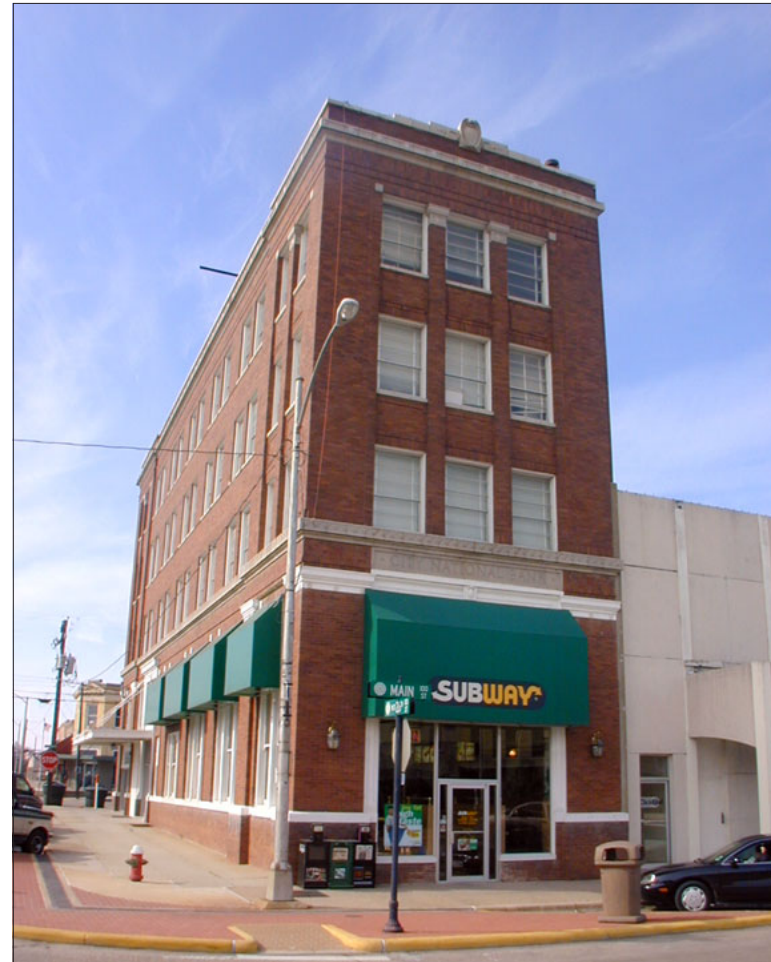
- Questionable drainage along south facade
- Evidence of metal corrosion within terra cotta
- Conduit attached to building
- Some spalling of terra cotta and cast stone decorative elements
- Cracking of stucco
- Biological staining
- Metal staining
- White paint on first floor staining adjoining brick
- Holes in masonry
- Corrosive spikes, pins and fasteners
- Building in need of cleaning
- Unpainted adjoining metal of fire escape

- If negative drainage exists on south facade, regrade site so that water drains away from the building.
- Restore terra cotta and cast stone decorative elements, replace corroded fasteners as needed.
- Update utilities while ensuring code compliance.
- Clean building in a manner that does not harm the masonry or mortar.
- Remove white paint from decorative elements in the most gentle means possible.
- Patch holes in masonry with a masonry patching compound.
- Remove corrosive spikes and pins from masonry and patch holes with masonry patching compound.
- Ensure that entries are ADA compliant.
- Restore and repair existing historic windows.
- Replace aluminum windows and doors with ones that are more historically compatible.
- Paint metal fire escape in order to prevent further metal staining of the brick.

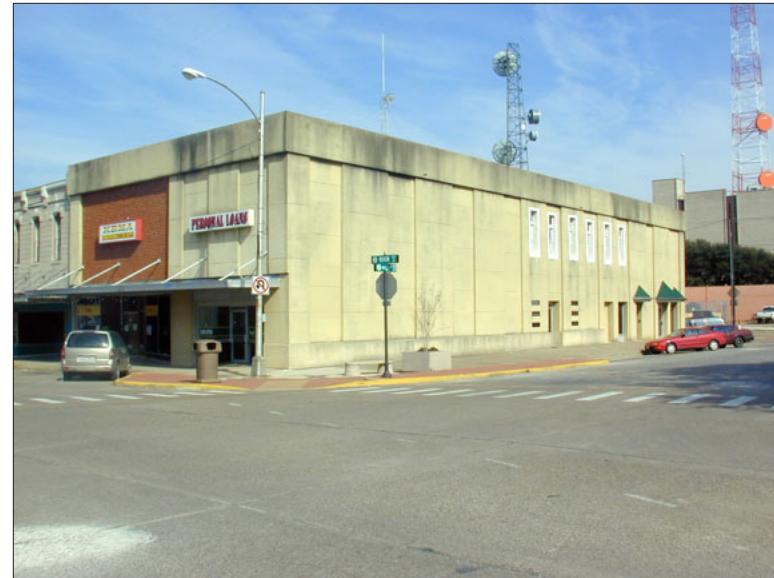
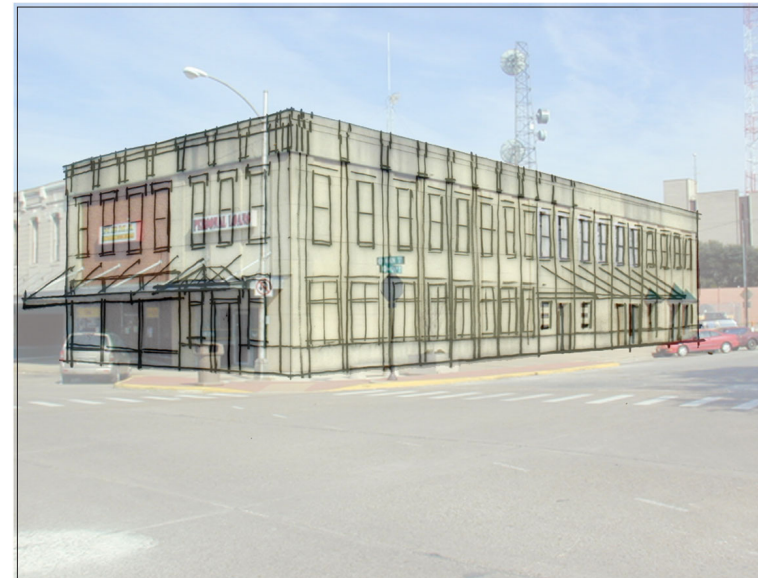
# 100 North Main Street

- Questionable drainage along east facade
- Poor downspout termination
- Downspouts no longer drain into underground drainage system
- Scuppers have been added on the south facade, allowing water to drain down the side of the building
- Conduit attached to building
- Biological staining
- Mortar deterioration
- Paint over brick
- Holes in masonry

- Regrade site so that water flows freely away from the building.
- Reconfigure downspouts so that they drain into existing underground drainage system
- Update utilities while ensuring code compliance.

- Clean building in a manner that does not harm the masonry or mortar.
- Repoint areas that exhibit mortar deterioration using a mortar that matches the original in color, composition and tooling.

- Ensure that entries are ADA compliant.
- Remove a test area of paint from the brick to determine if the removal process will damage the brick. If it is determined that the paint can be removed, do so in the most gentle means possible. If the paint should not be removed, repaint the test area and inspect the painted brick on a regular schedule of maintenance.

- Replace incompatible windows and doors with ones that are more historically accurate.
- Remove brick and stucco slipcover.
- Restore storefront to reflect its historic appearance.

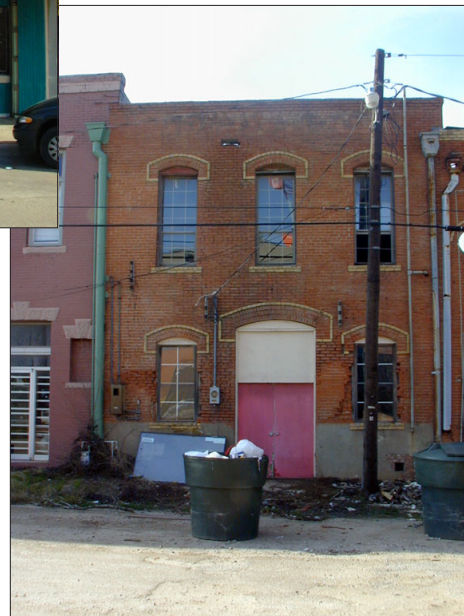
## 101, 103 North Main Street

- Questionable drainage along east facade
- Poor downspout termination
- Scupper allowing water to drain down the side of the building
- Conduit attached to building
- Very poor service configuration
- Sever mortar and masonry deterioration on east facade
- Cracking through mortar joints
- Minor parge coat deterioration
- Biological staining
- Holes in masonry
- Cracking and patching of stucco surface
- Building in need of cleaning
- Displaced and missing brick

- Regrade site so that water drains away from the building.
- Reconstruct downspouts so that they are tied into an underground drainage system.
- Insure that two downspouts provide adequate drainage and if so, remove scupper and infill with brick matching the original.

- Update utilities while ensuring code compliance.
- Stop moisture infiltration that is causing mortar and masonry deterioration.
- Once moisture problem is controlled, reset displaced brick and replace missing brick with brick that matches the original.

- Repoint building using a mortar that matches the original in color, composition and tooling.
- Remove parge coat and replace damaged brick with new matching the original.

- Patch stucco facade in a compatible manor.
- Restore and repair existing historic window and door openings.
- Reconstruct storefront and canopy to match the original design.

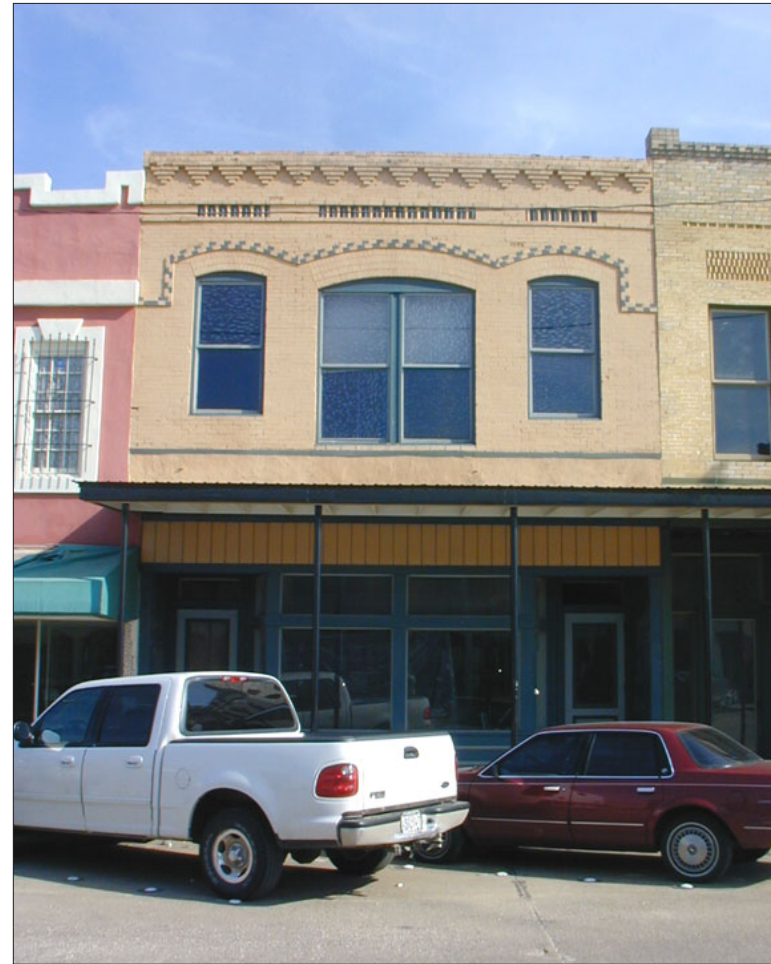
# 107 North Main Street

- Pooling water around base of building
- Lack of positive drainage
- Disjointed/disconnected downspouts
- Poor downspout termination
- Underground drainage needed
- Masonry deterioration
- Spalling
- Mortar deterioration
- Biological staining
- Building in need of cleaning
- Tar dripping on brick
- Paint deterioration

- Regrade site to ensure positive drainage away from the building.
- Ensure downspouts drain away from the building or tie them into underground drainage system.
- Restore downspouts.
- Update utilities while ensuring compliance.
- Repoint areas where mortar has deteriorated with mortar matching the original in composition, color and profile.
- Clean building in a manner that is not harmful to the brick or mortar.
- Restore window and door openings in a historically accurate manner.
- Restore storefront, canopy and parapet in a historically accurate manner.
- Ensure entry is ADA compliant.

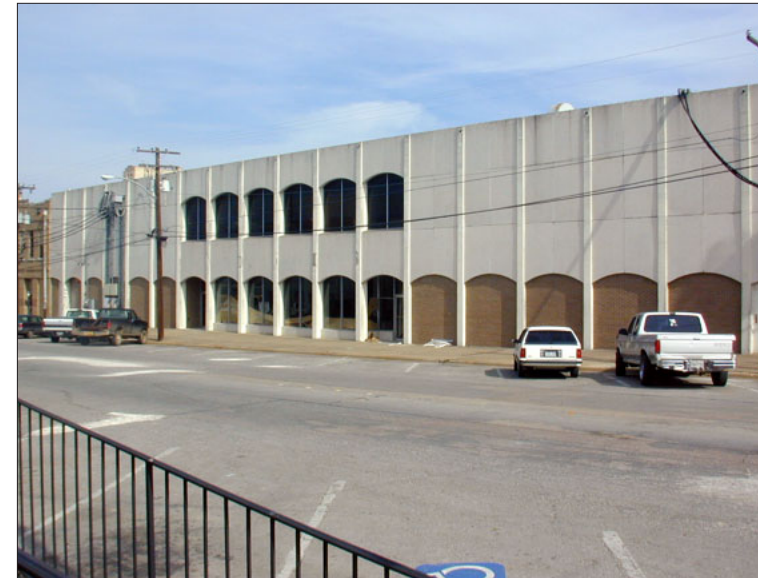
*Bryan Street facade (rear)*

- The building is drained by only scuppers which has allowed water to run down the building resulting in staining of the exterior
- Conduit attached to building
- Cracking of stucco
- Biological staining
- Mortar deterioration between terrazzo panels
- Some paint deterioration on stucco
- Chipped stucco
- Building is in need of cleaning

- Rebuild drainage system so that water drains into an underground drainage system via downspouts.
- Update utilities while ensuring code compliance.
- Clean building in a manner that does not harm the masonry or mortar.
- Patch holes in stucco with stucco matching the original in composition.
- Repoint between terrazzo panels with mortar matching the original in color, composition and profile.
- Repaint areas of stucco that are deteriorating.
- Ensure that entries are ADA compliant.

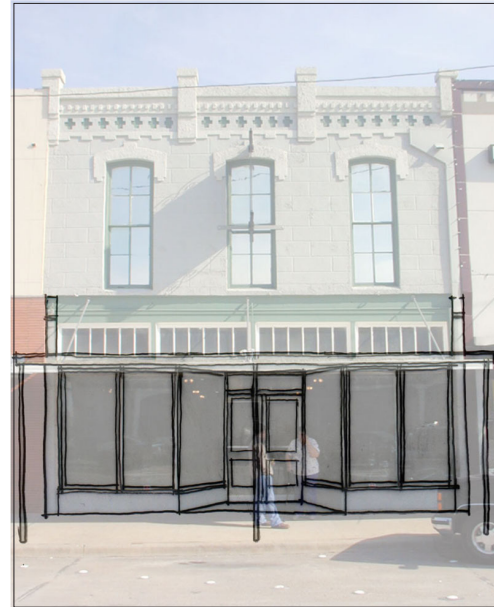
# 117 North Main Street

- Poor downspout termination on east facade allowing water to damage the brick
- Poor drainage conditions on east side
- Conduit attached to building
- Poor service configuration
- Biological staining
- Mortar deterioration
- Dislodged brick on east facade
- Deteriorated stucco parge coat
- Areas of the stucco have been painted

- Reconfigure downspout so that it is connected to an underground drainage system.
- Update utilities while ensuring code compliance.
- Clean building in a manner that does not harm the masonry or mortar.
- Repoint areas where mortar has deteriorated with a mortar matching the original in color, composition and tooling.
- Reset any dislodged brick using mortar as described above.
- Remove stucco parge coat only if the removal process does not harm the masonry.
- Remove paint from stucco in the most gentle means possible if the masonry is not harmed in the process.
- Restore original wood windows and door.
- Restore painted sign on the east facade.
- Reconstruct storefront, including entry doors, to match the original.
- Reconstruct canopy to match the original.

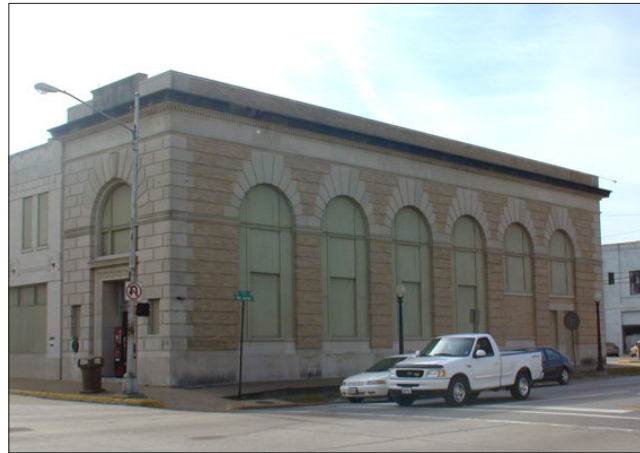
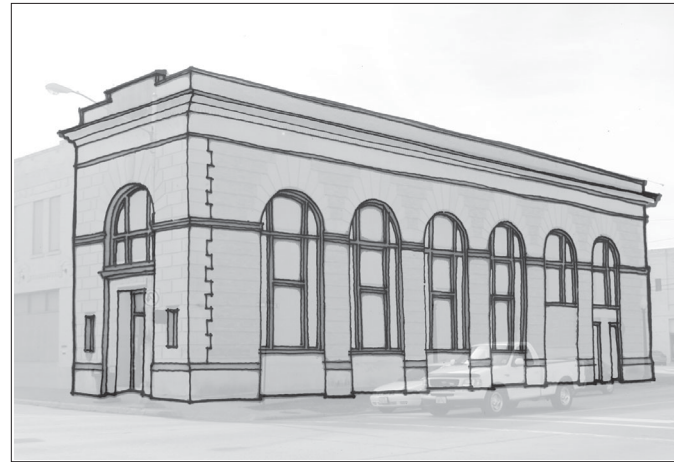
# 119 North Main Street

- Disjointed/Disconnected downspout allowing water to deposit on the building
- Mortar deterioration around scupper
- Biological staining
- Metal staining
- Building in need of cleaning
- Holes in masonry
- Wood rot in some windows
- Paint deterioration located on windows, water table, and brick
- Paint over brick
- Spalling
- Metal jacking has caused mortar deterioration and movement
- Cracking along mortar joints and through masonry

- Reconstruct downspout and reconnect it to the underground drainage system.
- Examine leader heads and scuppers to determine if they are draining properly and contributing to mortar deterioration.

- Remove any corrosive spikes and pins from masonry.
- Paint any corroding metal that is in contact with the building.
- Clean building in a manner that does not harm the masonry or mortar.

- Repoint areas that exhibit mortar deterioration using a mortar that matches the original in color, composition and tooling.
- Restore historic windows.

- Remove a test area of paint from the brick to determine if the removal process will damage the brick. If it is determined that the paint can be removed, do so in the most gentle means possible. If the paint should not be removed, repaint the test area and inspect the painted brick on a regular schedule of maintenance.

- Replace incompatible doors with ones that are more historically accurate.
- Arrest further damage caused by the corrosion of metal lintels by replacing them with new metal lintels.

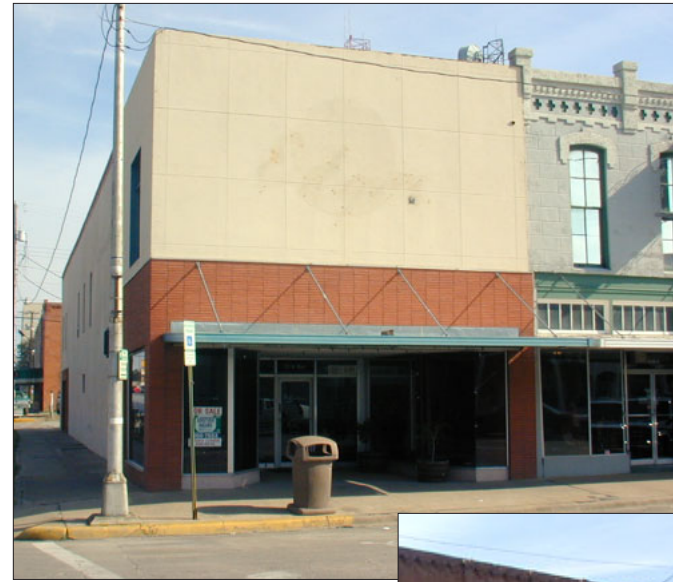
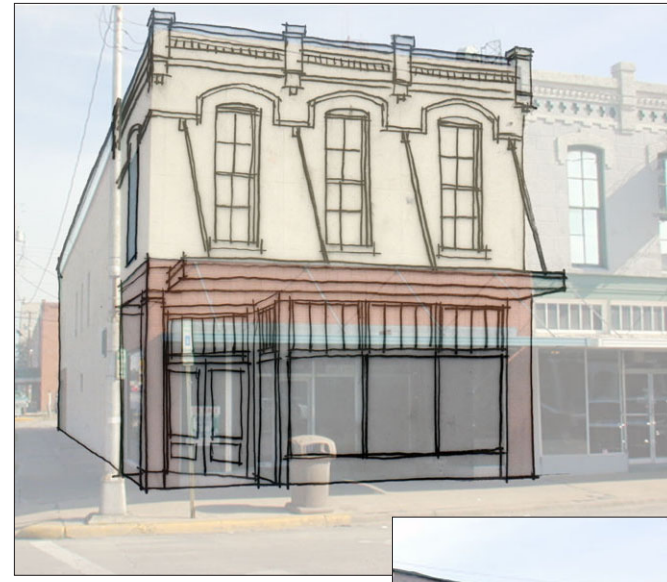
# 120 North Main Street

- Differential Settling
- Severe mortar deterioration
- Cracking through mortar joints
- Cracking through stones
- Masonry deterioration
- Spalling
- Cracking through stucco
- Biological staining
- Cracking along mortar joints
- Cracking through masonry
- Building in need of cleaning
- Holes in masonry
- Wood rot
- Paint deterioration
- Unsympathetic patching

- Examine downspout to ensure that it is not leaking or overflowing and causing mortar deterioration.
- If differential settling appears to be serious, have structure evaluated by a structural engineer.
- Update utilities while ensuring compliance.
- Repoint areas where mortar has deteriorated with mortar matching the original in composition, color and profile.
- Clean building in a manner that is not harmful to the brick or mortar.
- Remove unsympathetic patching and patch all holes in masonry with a masonry patching compound.
- Restore window and door openings in a historically accurate manner.
- Remove stucco and unoriginal brick veneer from building and restore storefront, canopy and windows in a historically accurate manner.
- Ensure entry is ADA compliant.

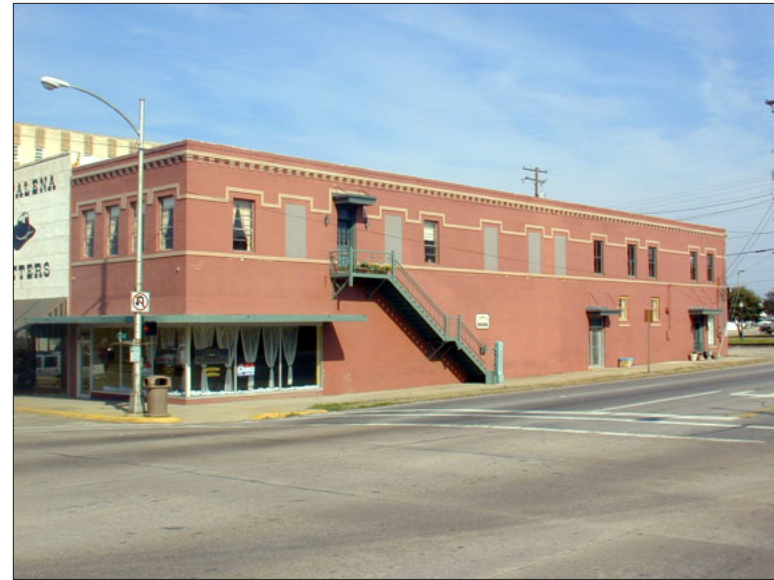
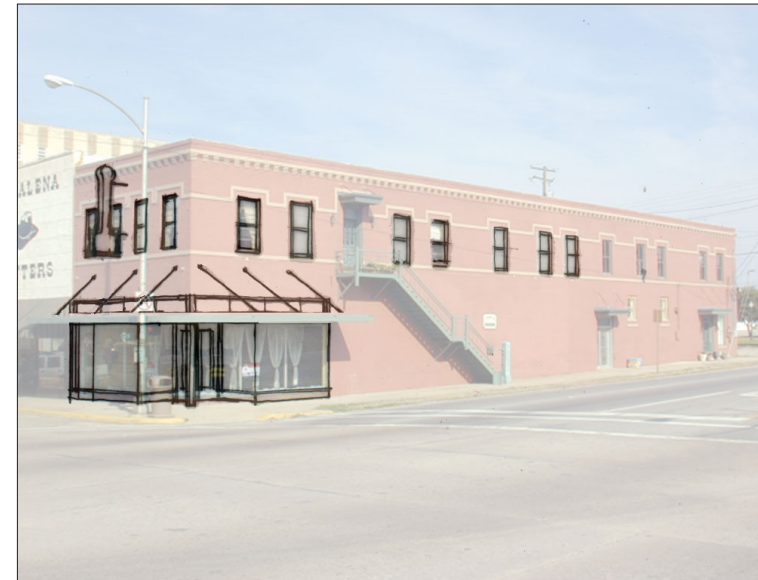
# 121 North Main Street

- Mortar deterioration
- Efflorescence
- Metal deterioration
- Cracking along mortar joints
- Cracking through the masonry
- Masonry deterioration
- Paint deterioration

- Repoint areas where mortar has deteriorated with mortar matching the original in composition, color and profile.
- Test masonry to determine if the removal of paint from the brick will harm the building. If not, remove the paint in the most gentle means possible. If removing the paint harms the brick, paint the exterior on a regular schedule to avoid deterioration.
- Restore window and door openings in a historically accurate manner.
- Restore storefront and canopy in a historically accurate manner (restore canopy if allowed by TxDOT. If TxDOT will not allow a new canopy, modify existing to resemble a historic canopy).
- Restore metal staircase.
- Ensure entry is ADA compliant.
- Remove masonry infill at original window openings and provide replica windows where possible.

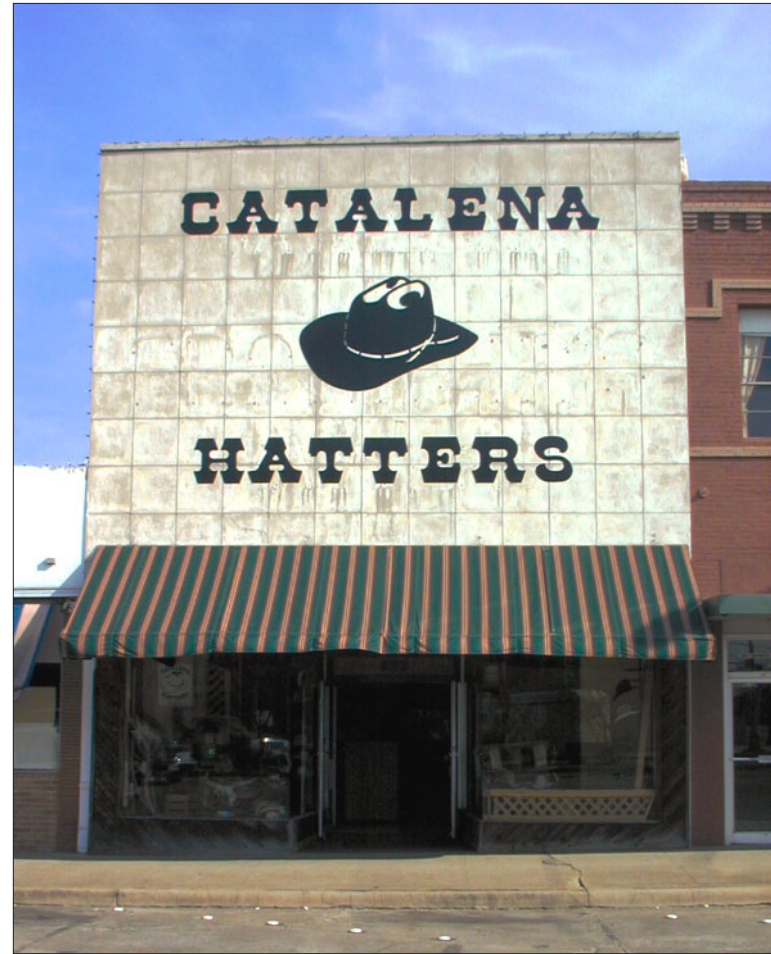
## 201 North Main Street

- Pooling and lack of positive drainage on alley side
- Improper gutter slope and poor downspout termination
- Mortar deterioration visible on east and north facades
- Original windows covered
- Biological staining
- Building in need of cleaning
- Stucco lintel deterioration
- Holes in masonry
- Paint on brick

- Regrade site to ensure proper drainage away from the building.
- Reconfigure drainage system so that downspouts drain at a proper slope and distance away from the building or into an underground drainage system.

- Repoint areas where mortar has deteriorated with mortar matching the original in composition, color and profile.
- Patch holes in masonry with a masonry patching compound.

- Repair stucco lintels.
- Test masonry to determine if the removal of paint from the brick will harm the building. If not, remove the paint in the most gentle means possible.

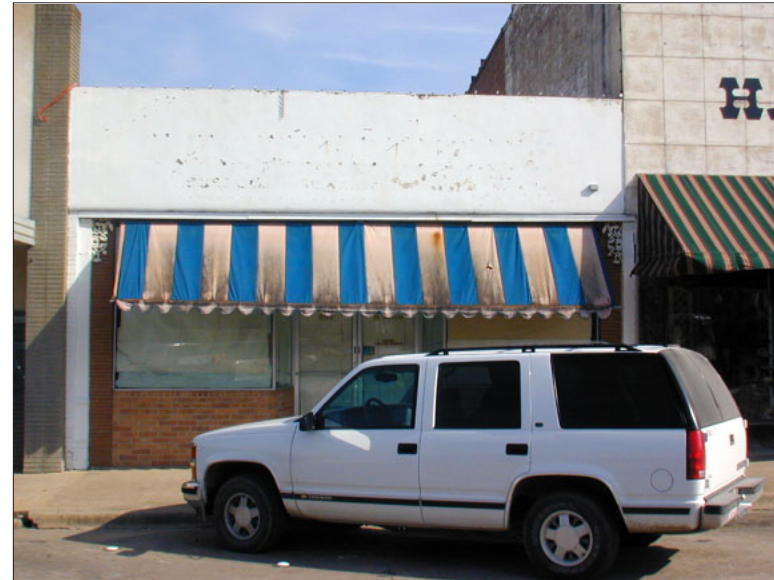
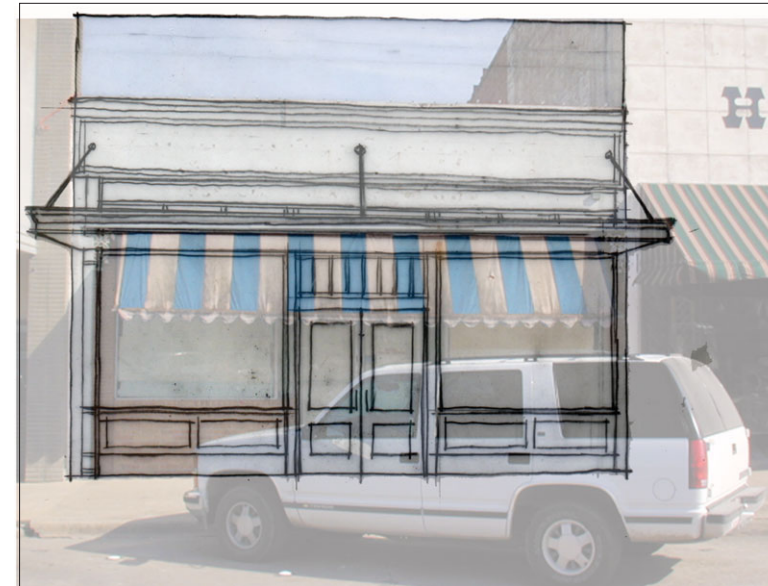
**203 North Main Street**

- Pooling at back door
- Lack of positive drainage
- Downspout clogs
- Poor downspout termination
- Masonry deterioration
- Spalling
- Mortar deterioration, some severe
- Building in need of cleaning
- Rust staining
- Stucco spalling
- Paint deterioration on stucco
- Bitumen based patching on brick
- Biological staining/growth
- Cracking along mortar joints
- Unsympathetic repointing
- Corrosive spikes and pins embedded in the masonry

- Update utilities while ensuring compliance.
- Clean building in a manner that is not harmful to the brick or mortar.
- Remove corrosive spikes and pins from masonry and patch holes in masonry with a masonry patching compound.

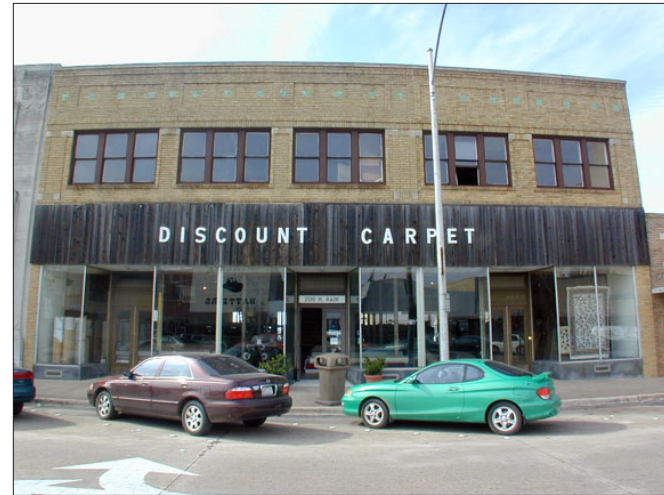
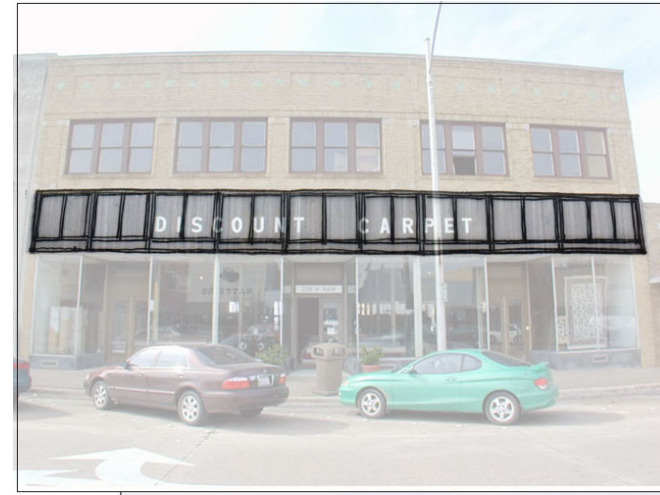
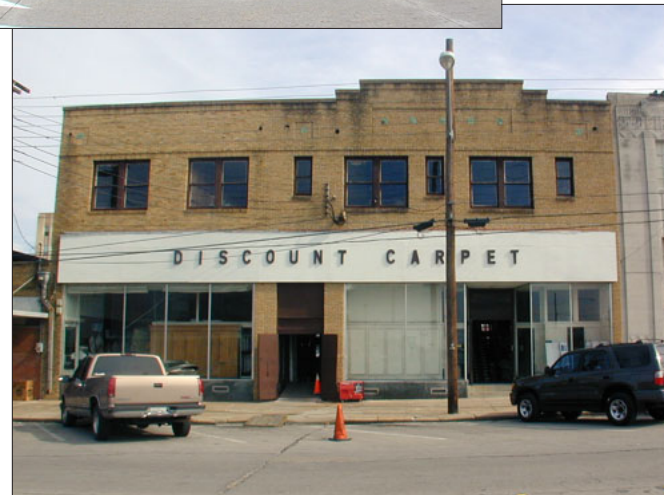
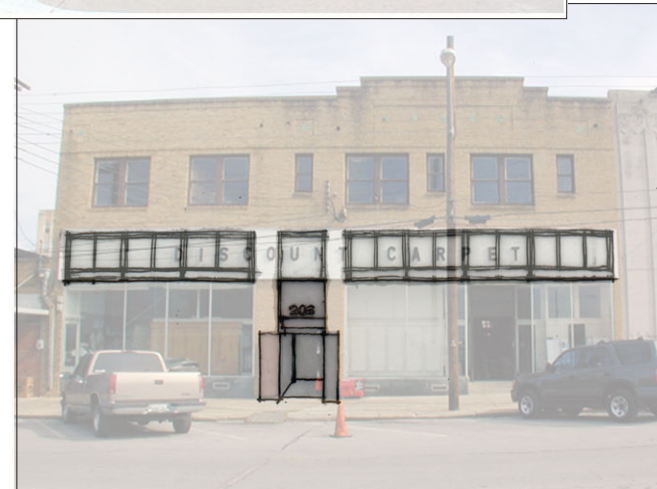
## 205 North Main Street

- Lack of downspouts causing staining and deterioration on west facade
- Poor utility configuration
- Minor mortar deterioration
- Holes in masonry
- Biological staining
- Building in need of cleaning
- Entry soffit deterioration
- Original one-over-one windows in fair to good condition

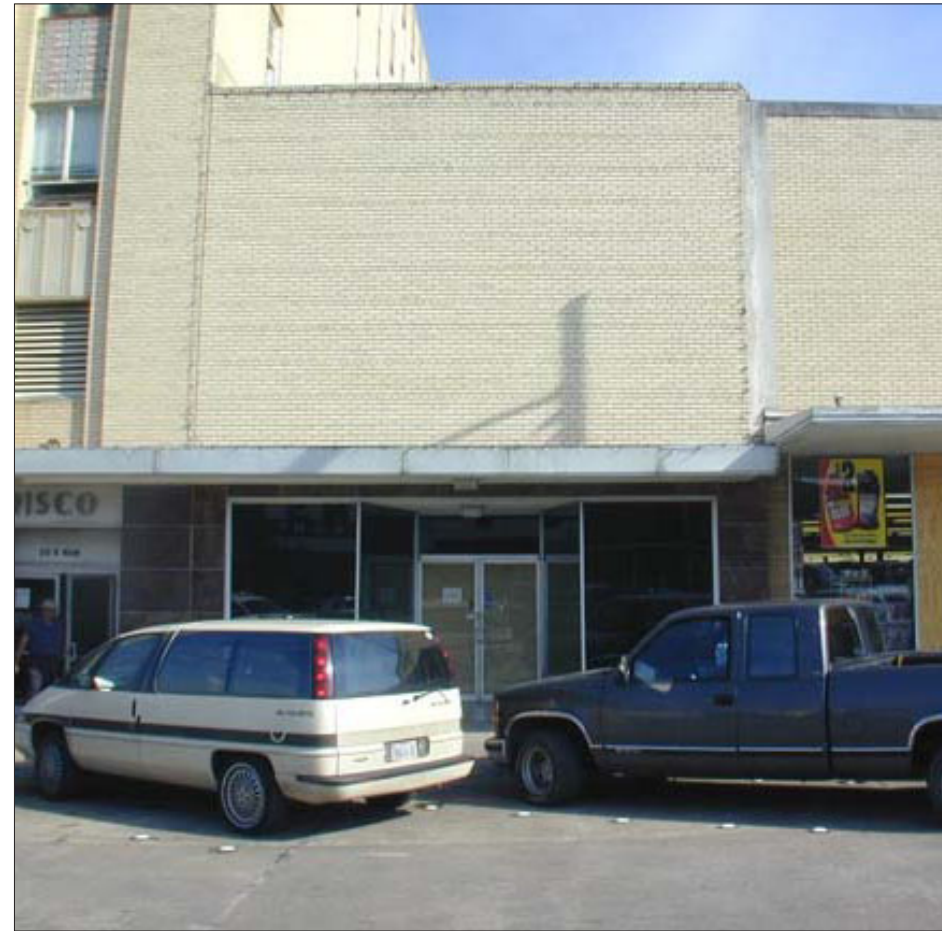
## 215 North Main Street

- Lack of positive drainage
- Flashing deterioration on south parapet wall
- Gutter is rusting and shows signs of water overflowing
- Possible clogging of gutter
- Poor patching and insulation where pipes enter building
- Poor configuration of utilities
- Biological staining
- Mortar deterioration,
- Cracking along mortar joints
- Horizontal deflections of chimney
- Graffiti on south wall
- Bird droppings on canopy

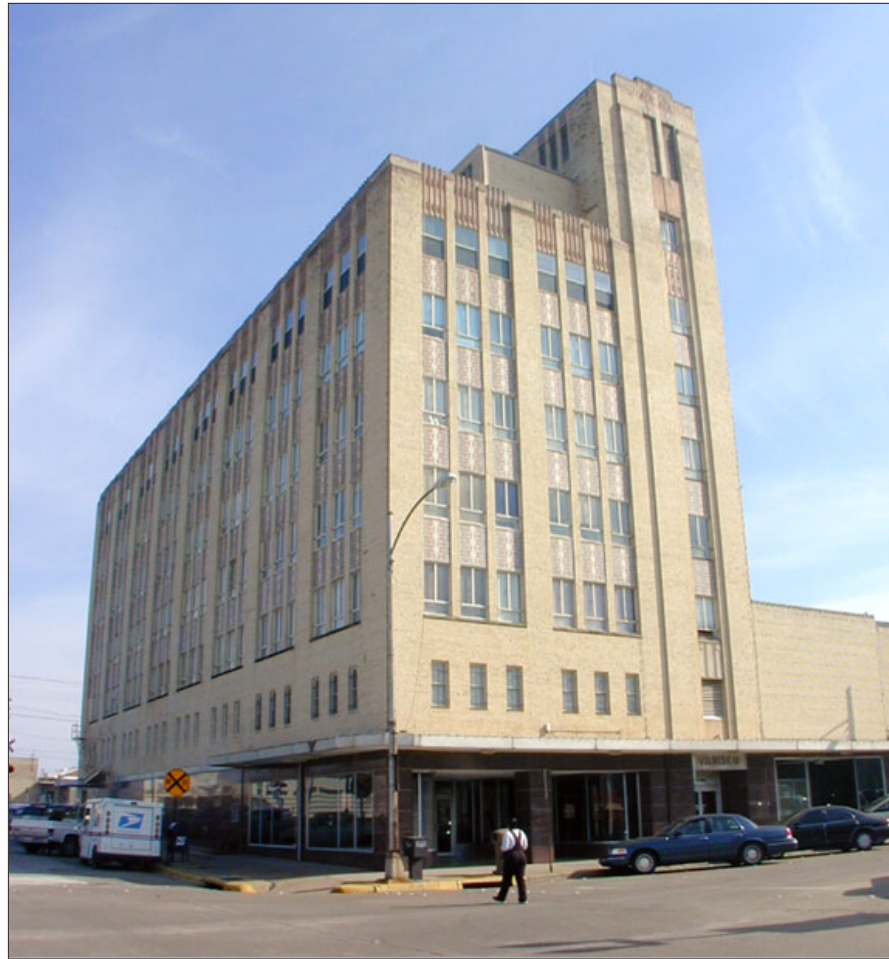
**218 North Main Street**

- Site behind the building is in poor condition
- Canopy downspouts and underground drains are in need of rehabilitation
- Mortar deterioration and brick damage is largely limited to the upper facade along the parapet and to the penthouse
- Limited conduit attached to building
- Tile spandrels are dull and crazed
- Canopies clad in aluminum need rehabilitation
- Biological staining
- Iron and rust staining
- Mortar deterioration
- Spalling
- Holes in masonry
- Corrosive spikes, pins and fasteners
- Building in need of cleaning

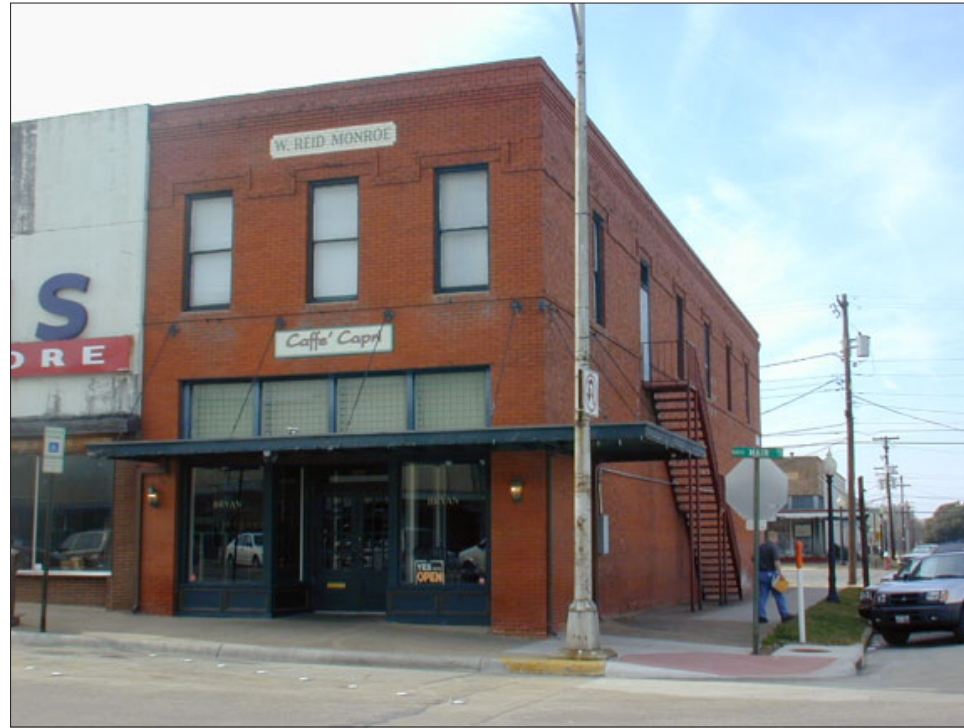
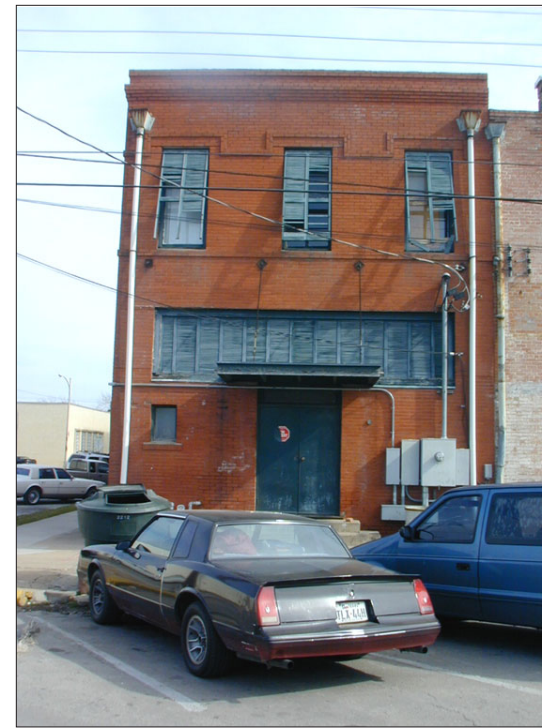
**220 North Main Street**

- Poor drainage conditions
- Poor downspout termination
- Biological staining and growth
- Iron staining, especially from exterior staircase
- Mortar deterioration
- Cracking along mortar joints
- Cracking through masonry
- Poorly configured utility service
- Building in need of cleaning
- Transoms have been infilled
- Vertical deflection
- Holes in masonry
- Paint deterioration on windows and stairs
- Unsympathetic patching
- Door handles and approach do not comply with ADA
- Corrosive metal lintels

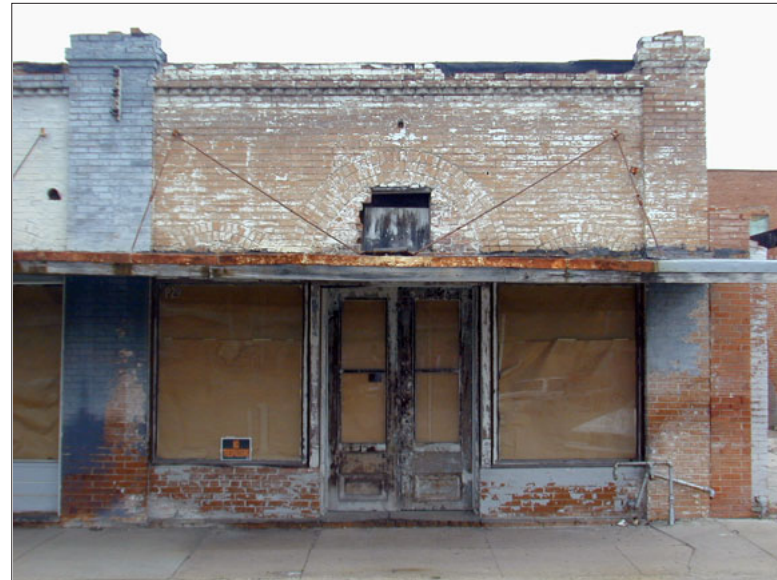
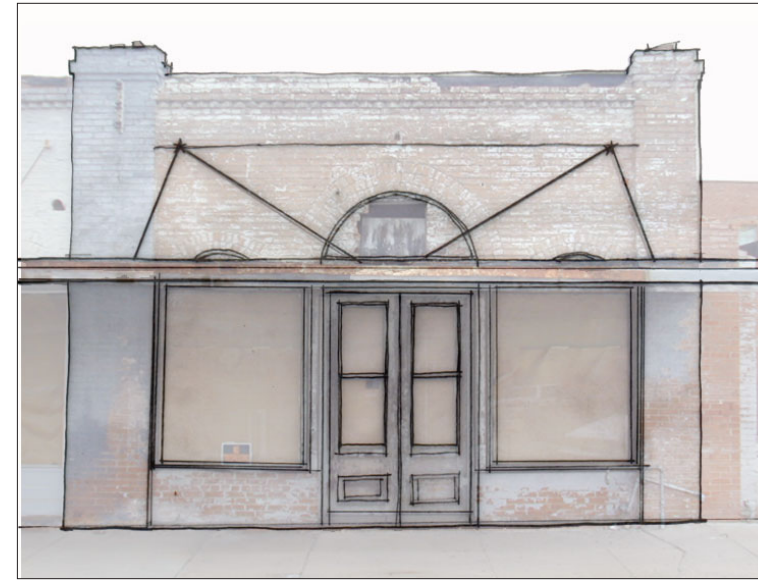
**415 North Main Street**

- Found no downspouts or scuppers
- Mortar deterioration and cracking through masonry
- Could not determine if building has current utility service
- Biological staining
- Building in need of cleaning
- Transoms have been infilled
- Holes in masonry
- Parapet cap has been covered with roofing paper
- Exposed brick has been painted
- Door handles and approach do not comply with ADA

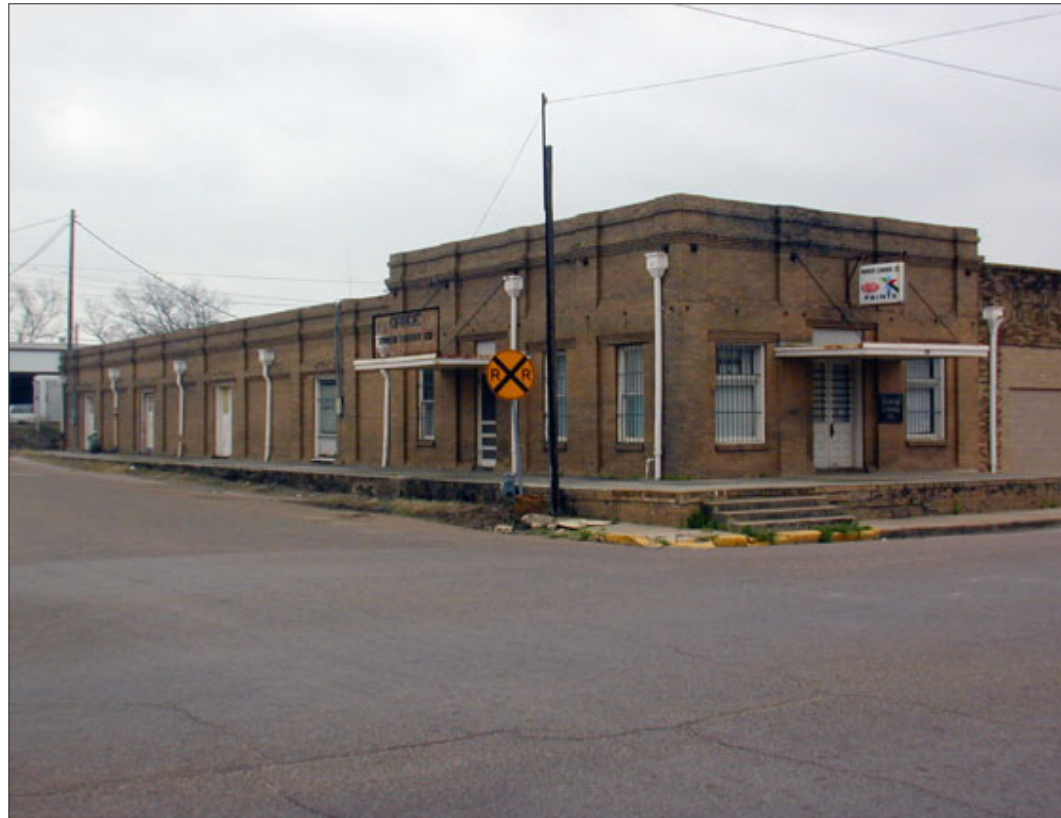
**416 North Main Street**

- Lack of positive drainage on east side
- Disjointed/disconnected downspouts
- Conduit attached to building
- Masonry and mortar deterioration, especially on the parapet wall
- Corrosive spikes and pins in masonry
- Biological staining and growth
- Building in need of cleaning
- Cracking through masonry and along mortar joints
- Wood rot and paint deterioration
- Plant growth too close to and growing from the base of the building
- Large bow in watercourse above windows on east facade where brick is detaching from the building
- Metal jacking of lintels causing cracking through mortar joints
- Portion of parapet wall covered with black roof coating
- Door handles, threshold and sidewalks do not comply with ADA standards

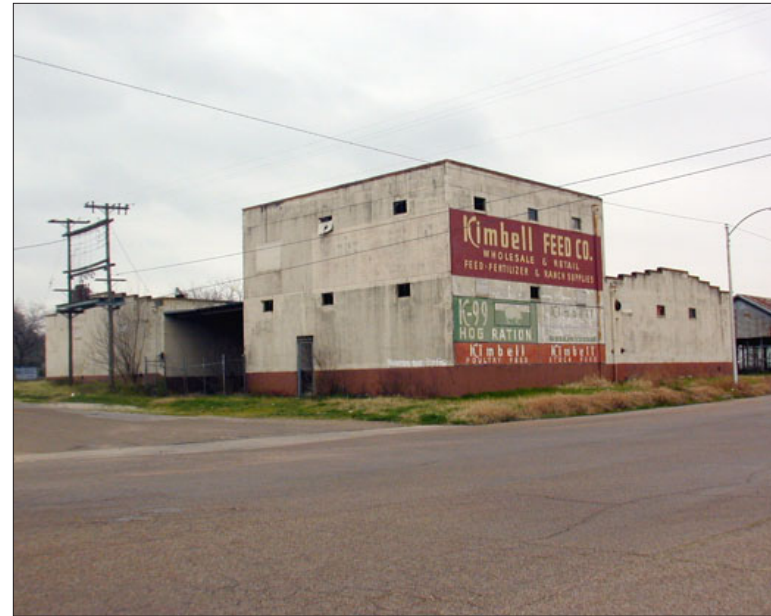
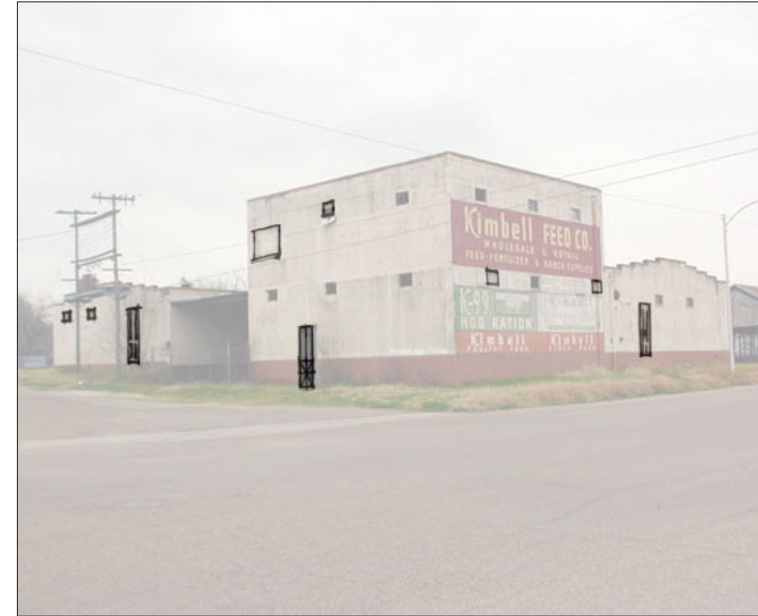
**512 North Main Street**

- Poor drainage conditions
- Poor downspout termination
- Disjointed/Disconnected downspouts at the southern facade allow water to flow from the scuppers to the canopy
- Some conduit attached to the building
- Cracking, spalling and deterioration of parapet cap
- Stucco deterioration
- Cracking through stucco
- Poorly configured utility service
- Biological staining
- Metal staining
- Plant growth next to building
- Building in need of cleaning
- Corrosive spikes and pins in stucco
- Deterioration of paint on stucco
- Entry does not comply with ADA
