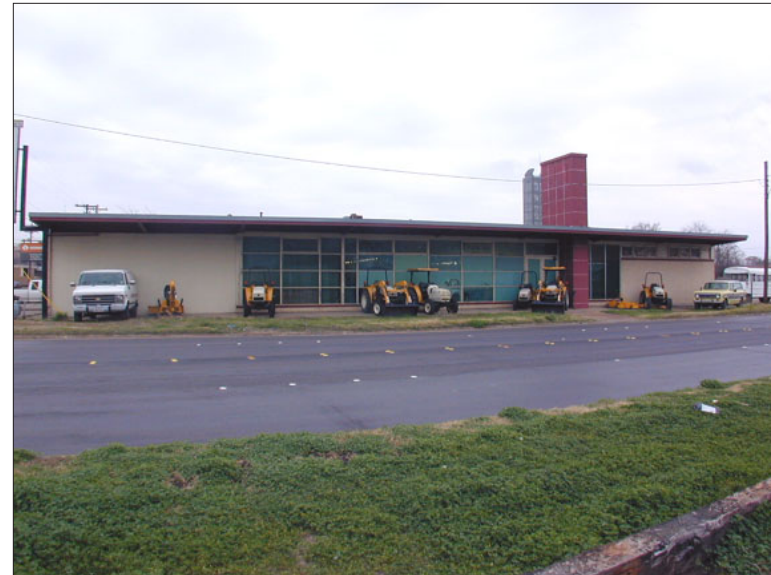
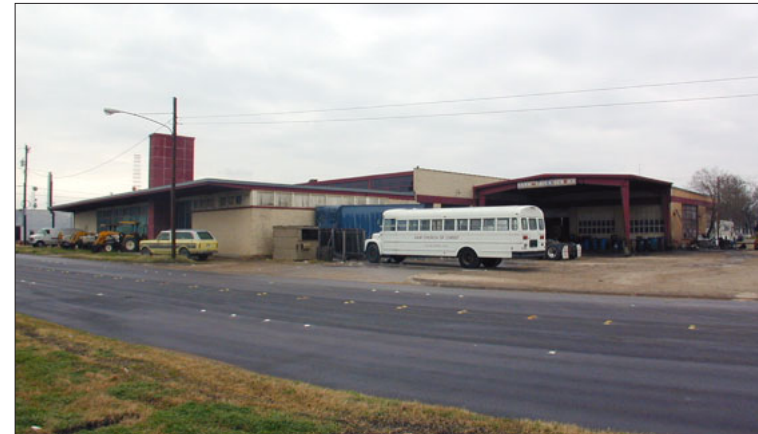
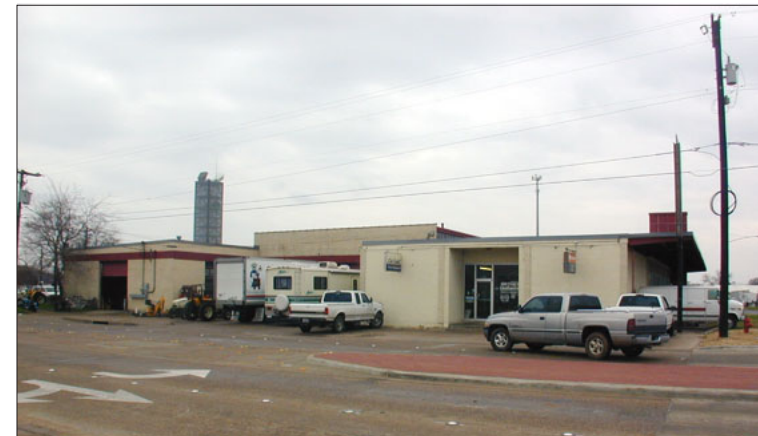
- Lack of positive drainage and some areas are conducive to pooling
- Conduit attached to building
- Masonry and mortar deterioration
- Corrosive spikes and pins in masonry
- Biological staining
- Building in need of cleaning
- Plant growth located too close to the building
- Site very clutter, making assessment difficult
- Paint deterioration
- Wood rot
- Holes in masonry
- Door entry is not ADA compliant

- Regrade site so that water drains away from the building.
- Update utilities while ensuring code compliance.
- Determine cause of mortar and masonry deterioration and repoint as necessary with mortar matching the original in composition, color and profile. Areas that have been unsympathetically pointed with Portland cement should be repointed with compatible mortar.
- Remove corrosive spikes and pins from masonry and patch with masonry patching compound.
- Clean building in a manner that does not harm the masonry or mortar.
- Patch holes in masonry with masonry patching compound.
- Ensure that entry is ADA compliant.
- Remove plant growth located too close to the building.
- Clean site to ensure accessibility to all parts of the building.
- Restore original windows and doors.

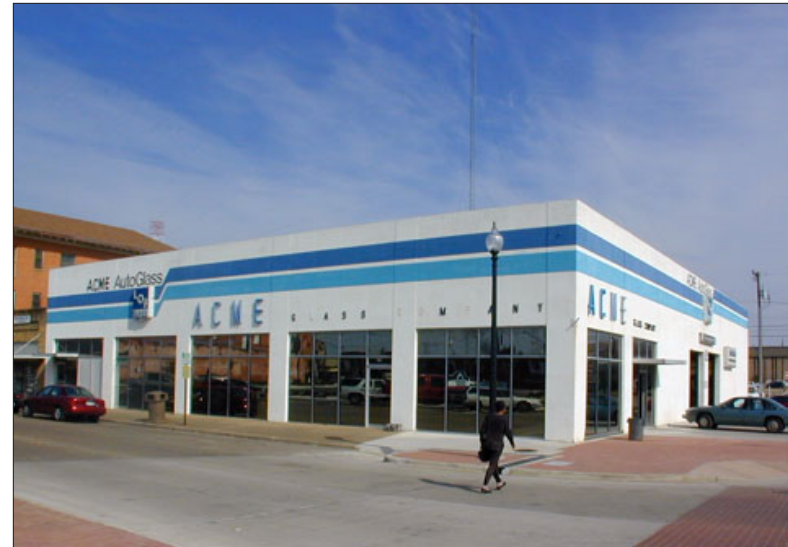
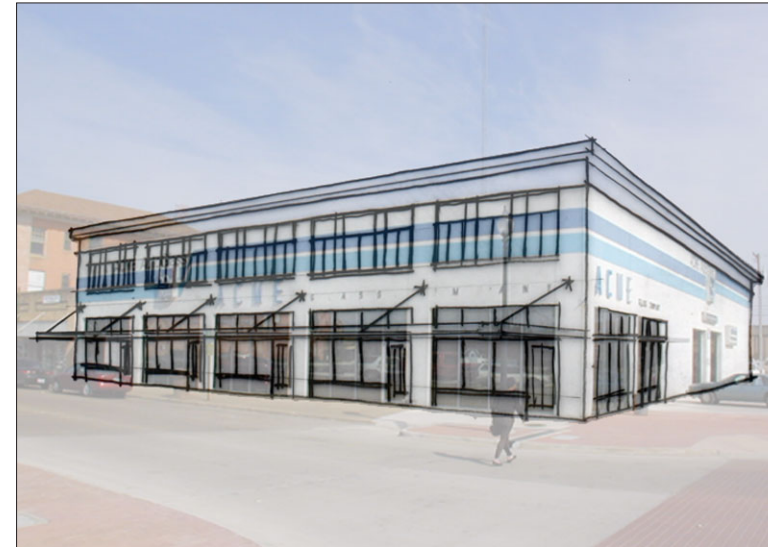
## 401 South Main Street

- Poor drainage characteristics on east side of building
- Poor downspout termination
- Cracking through stucco, especially on south side
- Biological staining
- Iron and rust staining
- Building in need of cleaning
- Minor paint deterioration
- Door entry is not ADA compliant

- Regrade site so that water flows away from the building.
- Reconfigure downspout system so that it drains effectively away from the building or into an underground drainage system.
- Determine cause of masonry deterioration and patch with stucco matching the original in composition, color and profile.
- Clean building in a manner that does not harm the masonry or mortar.
- Patch holes in stucco with stucco patching compound.
- Clean and paint all metal that is in contact with the building.
- Paint stucco.
- Ensure that entry is ADA compliant.
- Restore original window and door openings.
- Reconstruct storefront to match original.

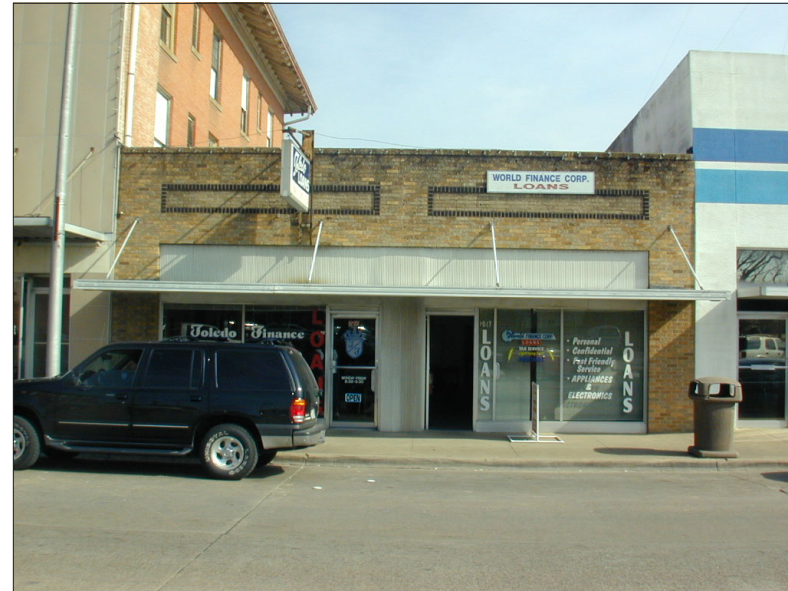
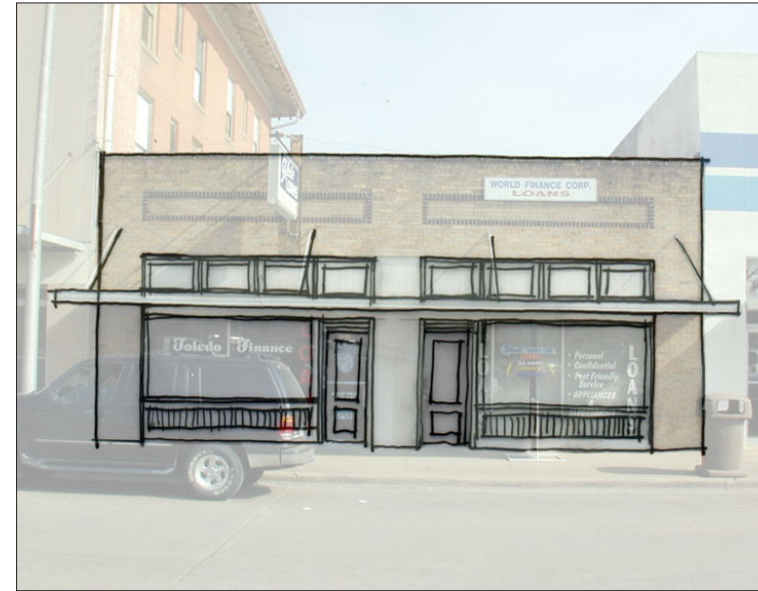
**221, 223  
South Main Street**

- Poor drainage conditions on east side
- Poor downspout termination
- Deteriorating downspouts
- Severe metal jacking on east side due to metal lintel corrosion
- Biological staining
- Iron and rust staining
- Building in need of cleaning
- Minor cracking through masonry
- Cracking along mortar joints
- Horizontal deflections
- Wood rot
- Holes in masonry
- Door entry is not ADA compliant

- Regrade site so that water flows freely away from the building.
- Replace downspouts and reconfigure system so that they drain into an underground drainage system or effectively away from the building.
- Prevent further deterioration by replacing the corroded metal lintels with a new metal lintel.
- Determine cause of mortar and masonry deterioration and repoint as necessary with mortar matching the original in composition, color and profile.
- Clean building in a manner that does not harm the masonry or mortar.
- Patch holes in masonry with masonry patching compound.
- Clean and paint metal that is in contact with the building.
- Restore original wood windows.
- Ensure that entry is ADA compliant.
- Reconstruct storefront and canopy in a historically accurate manner.
- Restore transom windows.

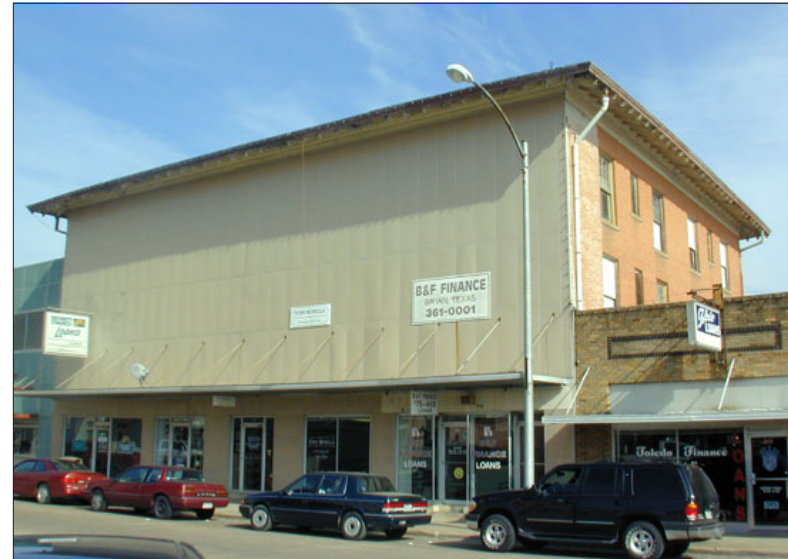
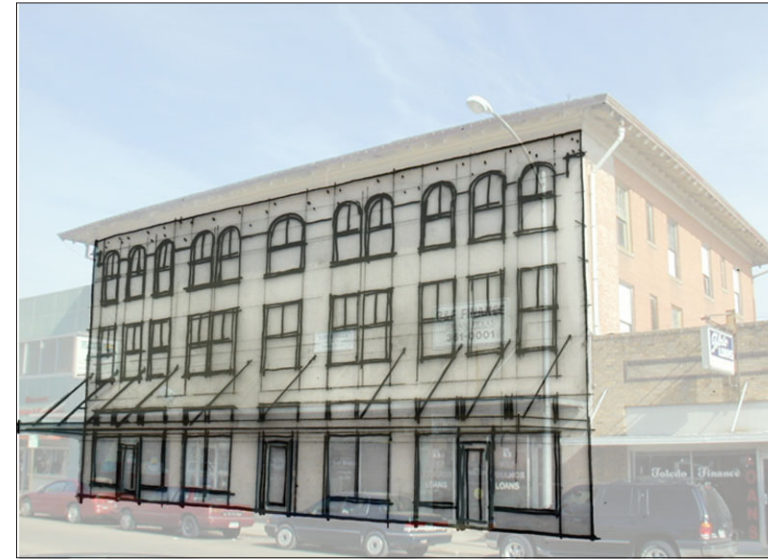
**217, 219  
South Main Street**

- Lack of positive drainage
- Gutter and downspout leaks
- Disjointed/disconnected downspouts
- Poor downspout termination
- Solder joint failure
- Rust on cornice
- Paint failure on cornice
- Wood rot and water damage on soffit, overhang and cornice
- Holes in masonry
- Poor patching
- Lintels rusting
- Biological staining
- Building in need of cleaning
- Mortar deterioration
- Cracking through masonry

- Regrade site to ensure positive drainage away from the building.
- Repair downspouts and tie them into underground drainage system.
- Update utilities while ensuring compliance.

- Resolder any areas of joint failure.
- Clean, repaint and restore metal cornice.
- Repair and restore wood overhang and brackets.
- Remove improper patching and patch holes in masonry with masonry patching compound.

- Paint rusting lintels.
- Repoint areas where mortar has deteriorated with mortar matching the original in composition, color and profile.
- Remove stucco from brick as long as it does not harm the brick. If the removal process harms the masonry, patch all holes with stucco matching the original compound. Paint stucco to match.

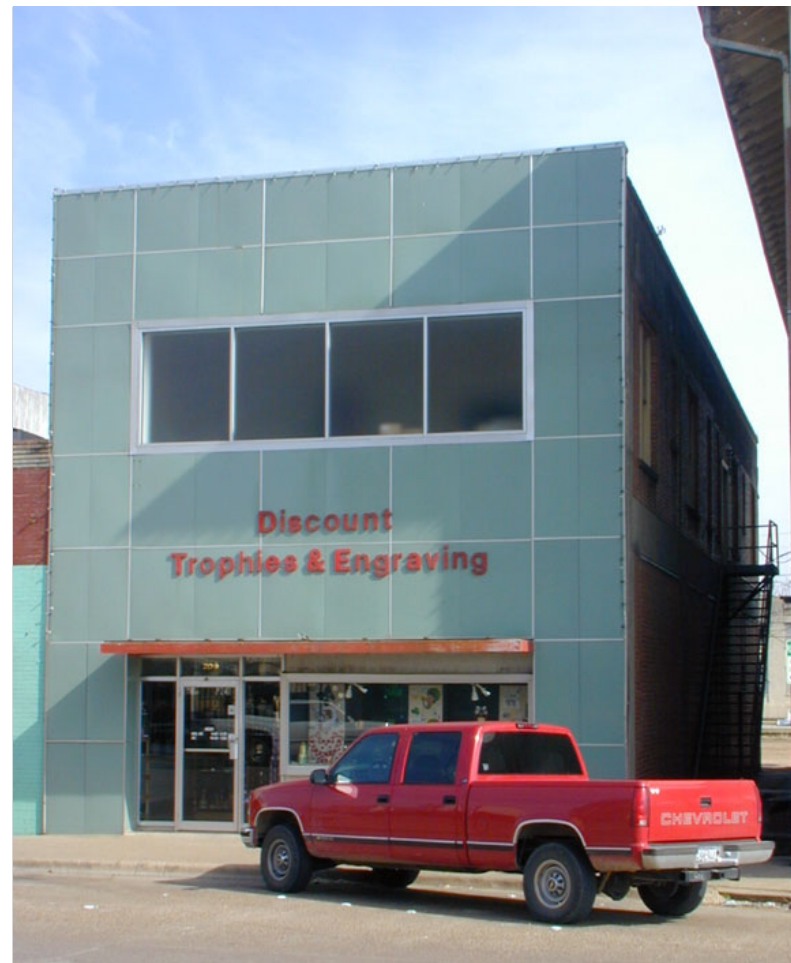
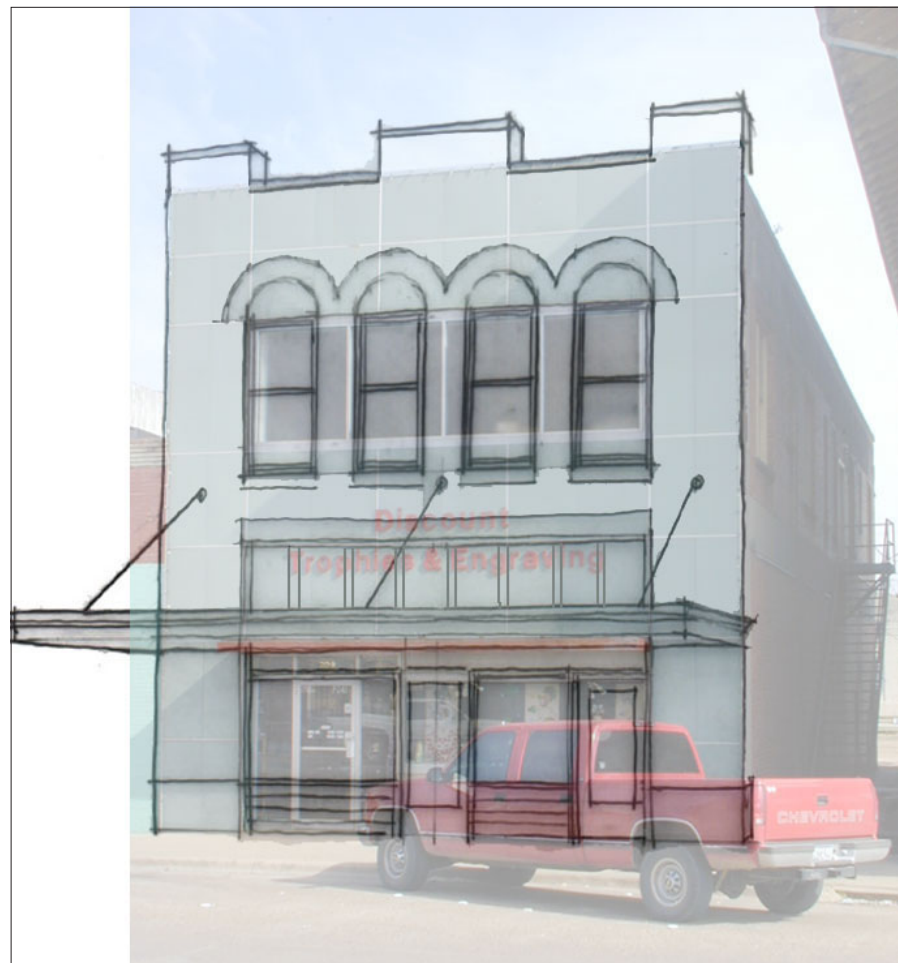
**213A, 213B, 215  
South Main Street**

- Lack of positive drainage in the back
- Plant growth at back of building prevents water from draining properly
- Downspout modified to drain over elevator tower
- Downspouts very rusty
- Biological staining
- Metal staining
- Spalling of stucco
- Mortar deterioration
- Cracking through stucco
- Building in need of cleaning
- Wood rot and paint deterioration at windows
- Holes in metal facade

- Regrade and clean site so that water drains properly away from the building.
- Repair and restore downspouts.
- Reconfigure downspouts to ensure that water is not being deposited at the base of the building. If possible, tie drainage downspouts into an underground drainage system.

- Replace new windows with ones that match the historic ones.
- Remove unsympathetic aluminum and glass door and replace with one that is historically accurate.

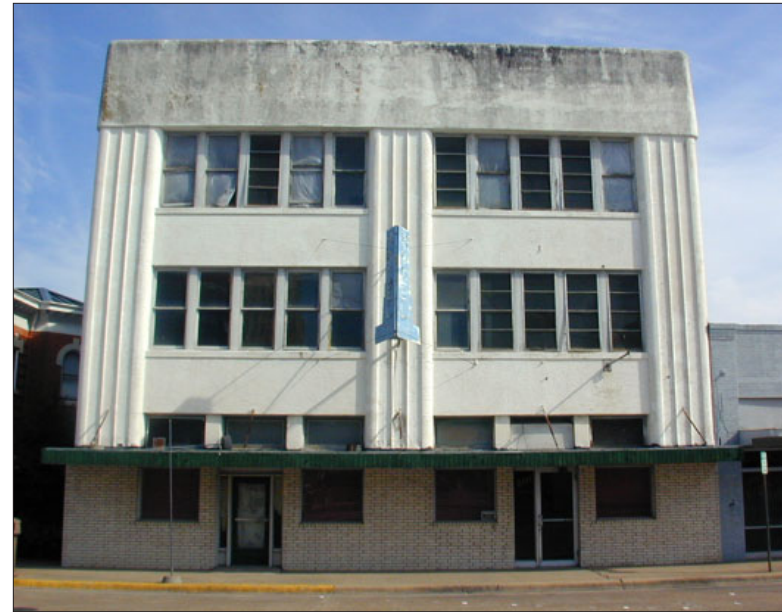
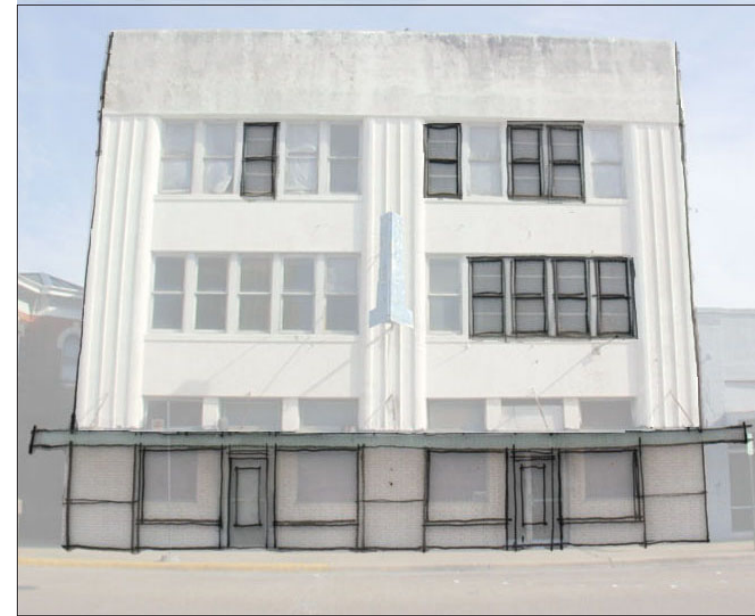
**203, 205  
South Main Street**

- Poor downspout termination
- Possible inadequate drainage with only one large downspout located at back of building
- Poor service configuration
- Conduit attached to building
- Cracking through mortar joints
- Cracking through masonry
- Parge coat deterioration
- Metal corrosion
- Biological staining
- Spalling
- Metal staining
- Holes in masonry
- Painted brick
- Possible incompatible repointing with a Portland cement mortar
- Corrosive spikes and pins
- Crazeing of stucco
- Door entry is not ADA compliant

- Monitor drainage to determine if one downspout is adequate drainage. If not, reconfigure drainage system to include additional downspout(s).
- Configure current and any additional downspouts so that they drain properly away from the building or into an underground drainage system.

- Update utilities while ensuring code compliance.
- Determine cause of cracking through masonry and mortar. Repoint with mortar matching the original in composition, color and profile.

- Remove parge coat and waterproof the parapet in a more compatible manner.
- Arrest cracking due to corroding metal lintel by replacing the lintel with a new metal lintel.

- Prime and paint fire escape in order to prevent further metal staining on the building.
- Perform test to determine if paint removal from the brick will damage the masonry. If not, remove the paint in the most gentle means possible.

- Restore original door and window openings.
- Reconstruct storefront to match original.
- Test possible removal of unoriginal stucco slipcover to ensure the original brick is not damaged in the process. If not, remove stucco.

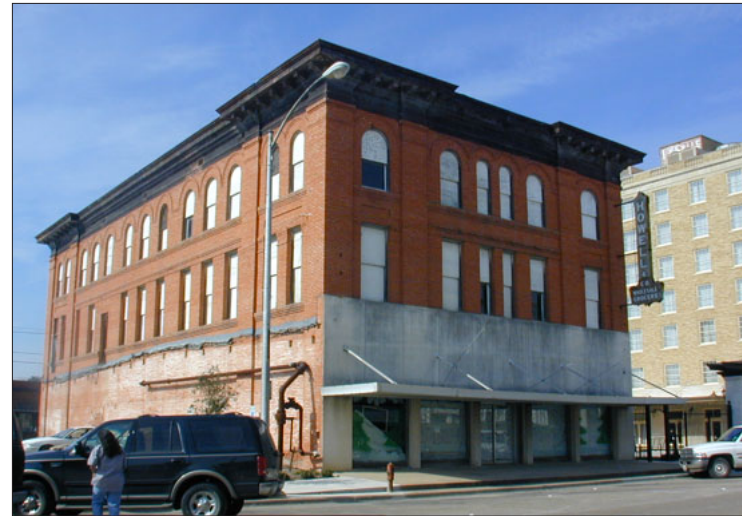
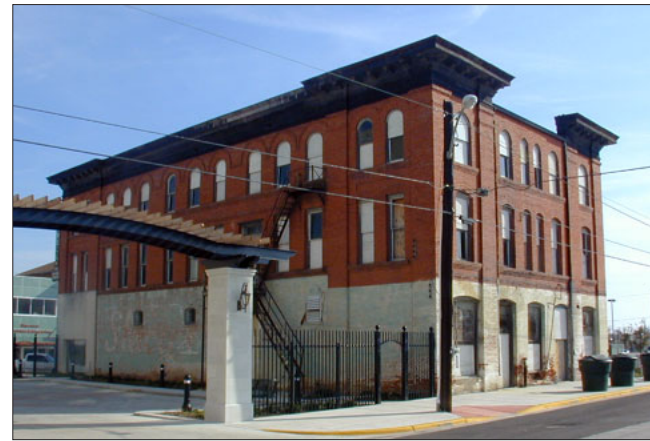
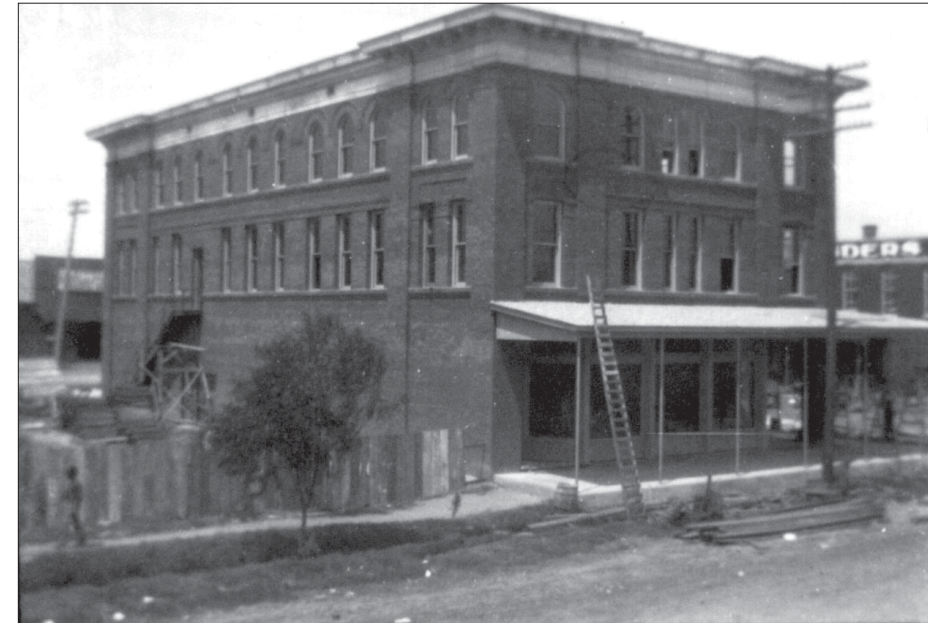
## 201 South Main Street

- Poor drainage characteristics from new landscaping on north and south facades
- Gutter/downspout leaks
- Disjointed/disconnected downspouts
- Poor downspout termination
- Poorly configured and inadequate utilities
- Deflection in metal cornice indicating deterioration of underlying wood structure
- Masonry and mortar deterioration, especially along the base of the south and west facades
- Corrosive spikes and pins in masonry
- Biological, iron, rust and bitumen staining
- Efflorescence
- Cracking through masonry
- Plant growth located too close to the building
- Paint deterioration
- Wood rot
- Holes in masonry
- Spalling
- Door entry is not ADA compliant

- Regrade site so that water drains away from the building.
- Move landscaping away from building to prevent trapping moisture in masonry.
- Repair gutter and downspout system. Either tie the downspouts into an underground drainage system or ensure the all water flows freely away from the building.

- Update utilities while ensuring code compliance.
- Restore and repair metal cornice, including replacement of any deteriorated underlying structure.
- Determine cause of mortar and masonry deterioration and repoint as necessary with mortar matching the original in composition, color and profile.

- Remove corrosive spikes and pins from masonry and patch with masonry patching compound.
- Clean building in a manner that does not harm the masonry or mortar.

- Prime and paint any metal adjoining brick to prevent rusting and staining.
- Determine cause of efflorescence and remedy accordingly.
- Determine cause of cracking through masonry and repair accordingly.

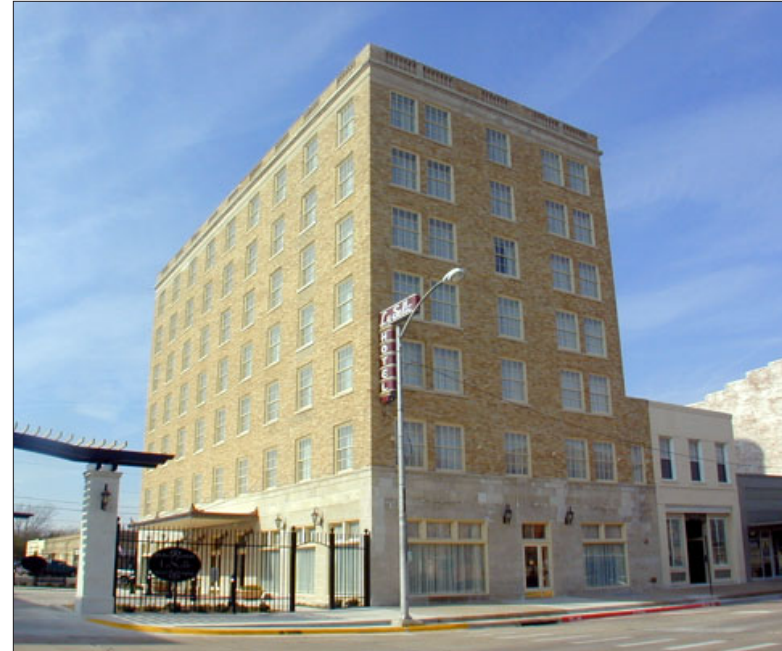
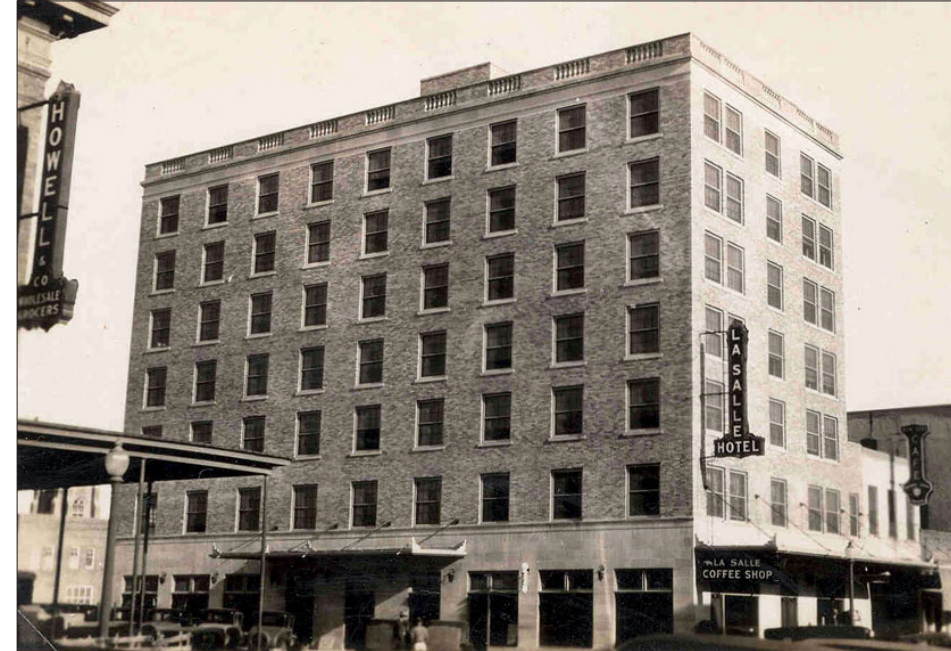
## 200 South Main Street

- Large crack in the chimney
- Biological staining
- Mortar deterioration
- Building needs cleaning
- Paint deterioration
- Spalling of limestone
- Original canopy missing
- Possible metal jacking of lintel located on north facade

- Restore brick chimneys.
- Clean building in manner that will not harm the masonry or mortar.
- Repoint areas where mortar has deteriorated with mortar matching the original in composition, color and profile.
- Test masonry to determine if the removal of paint from the brick will harm the building. If not, remove the paint in the most gentle means possible.
- Reconstruct canopy for the east entrance.
- Remove corroding metal lintel and replace with a noncorrosive metal lintel.

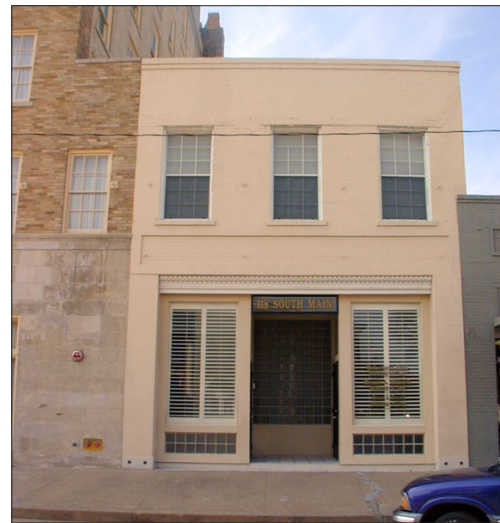
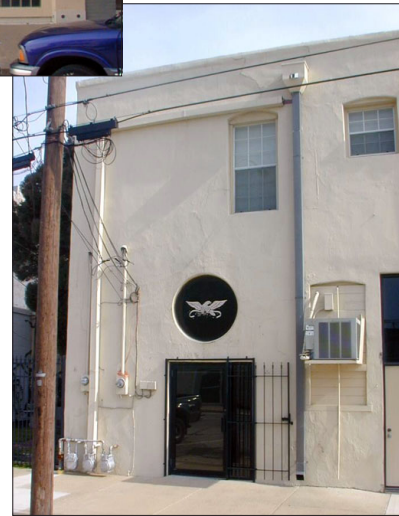
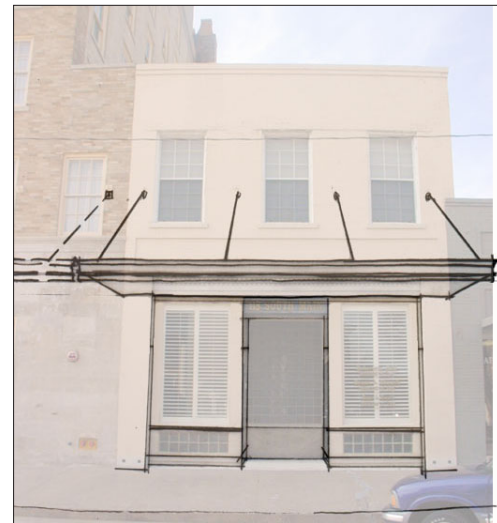
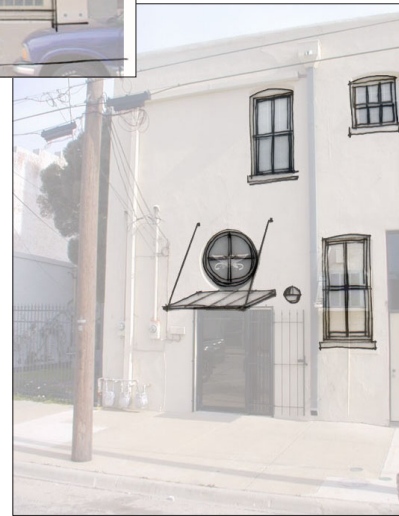
**120 South Main Street**

- Poor downspout termination, underground drainage needed
- Tie rodding
- Poor service entry
- Masonry deterioration
- Mortar deterioration
- Cracking through stucco
- Cracking along mortar joints
- Cracking through the masonry
- Building needs cleaning
- Horizontal deflections
- Paint on brick
- Paint deterioration
- Crack above circular window in back door
- Holes in stucco
- Entrance not ADA compliant

- Tie downspout into underground drainage system.
- If tie rodding is due to structural cracking, have building analyzed by a structural engineer.
- Update utilities while ensuring compliance.

- Repoint areas where mortar has deteriorated with mortar matching the original in composition, color and profile.
- Remove stucco from brick as long as it does not harm the brick. If the removal process harms the masonry, patch all holes with stucco matching the original compound. Paint stucco to match.

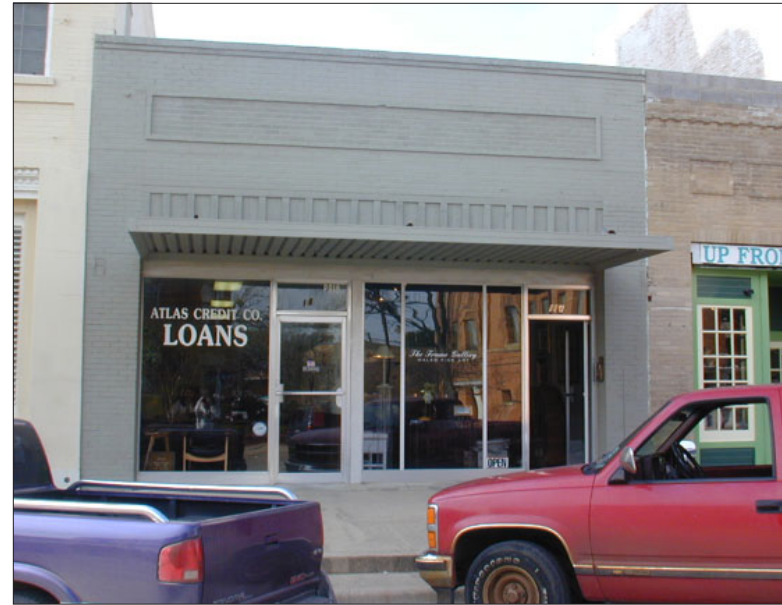
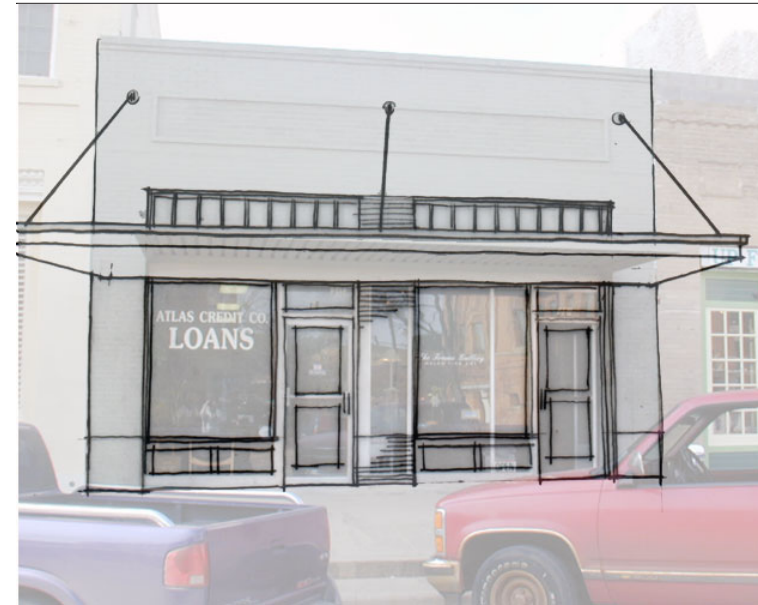
# 118 South Main Street

- Lack of positive drainage
- Courtyard has a potential for pooling
- One downspout in the courtyard deposits water at the end of the courtyard which is eroding the soil under the concrete of a park bench
- Masonry deterioration
- Mortar deterioration
- Not original storefront, canopy or doors
- Poor patching and repointing
- Biological staining
- Spalling
- Cracking along mortar joints
- Building in need of cleaning
- Paint deterioration
- Entry is not ADA compliant

- Regrade site to ensure proper drainage away from the building.
- Reconfigure drainage system so that all downspouts drain at a proper slope and distance away from the building or into an underground drainage system.
- Repoint areas where mortar has deteriorated with mortar matching the original in composition, color and profile.
- Patch holes in masonry with a masonry patching compound. Areas that have been improperly patched should be repatched in the above manner.
- Clean building in a manner that is not harmful to the brick or mortar.
- Test masonry to determine if the removal of paint from the brick will harm the building. If not, remove the paint in the most gentle means possible.
- Restore transom windows and reconstruct storefront and canopy in a historically accurate manner.
- Restore all window and door openings in a historically accurate manner.
- Ensure entry is compliant.

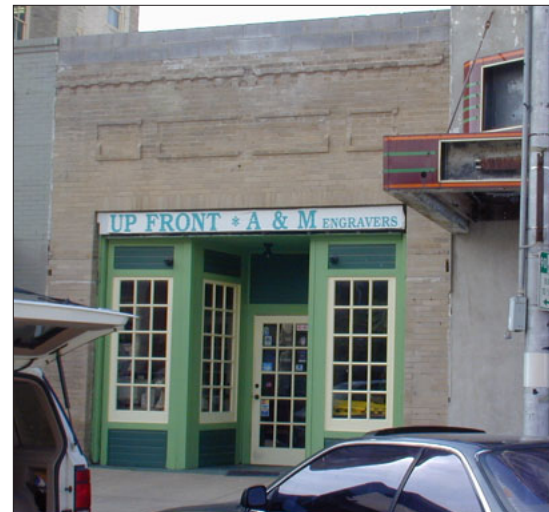
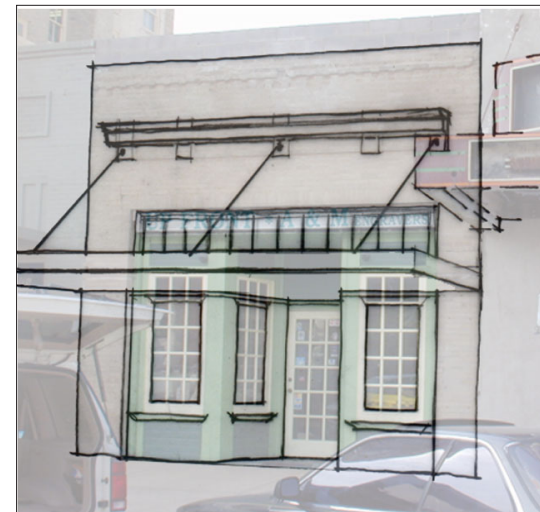
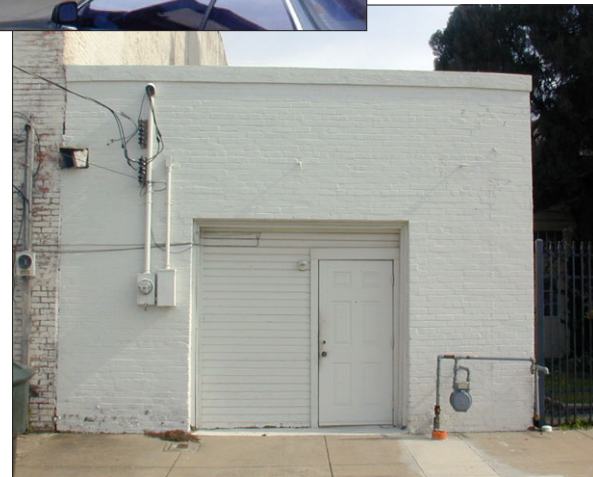
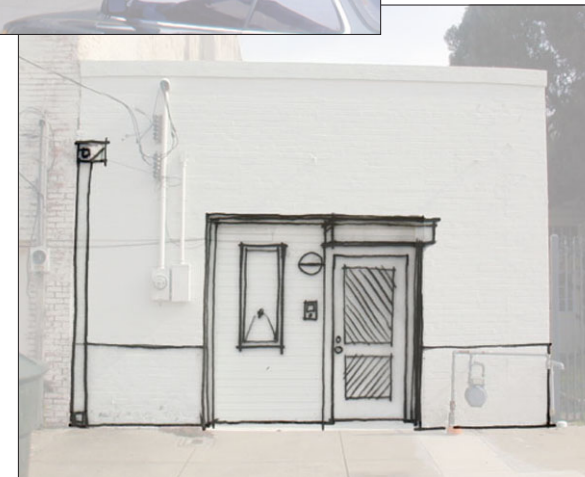
**114, 116  
South Main Street**

- One through-wall scupper allows water to drain down the side of the building
- Minor cracking on west side from corroding metal lintel
- Poor service configuration
- Holes in masonry
- Painted brick
- Plant growth located on the south side of the building
- Door entry is not ADA compliant

- Tie scupper into an underground drainage system.
- Arrest cracking due to corroding metal lintel by replacing it with a new metal lintel.
- Perform test to determine if paint removal from the brick will not damage the masonry. If not, remove the paint in the most gentle means possible.
- Patch all holes in masonry with masonry patching compound
- Ensure that entry is ADA compliant.
- Monitor plans located on the south side to ensure that they do not rub against the building or allow brick to retain moisture.
- Restore original door openings.
- Reconstruct storefront to match original.
- Remove concrete masonry units and restore the original east parapet configuration.
- Reconstruct canopy in a historically accurate manner.
- Remove masonry infill and provide appropriate door and window infill.

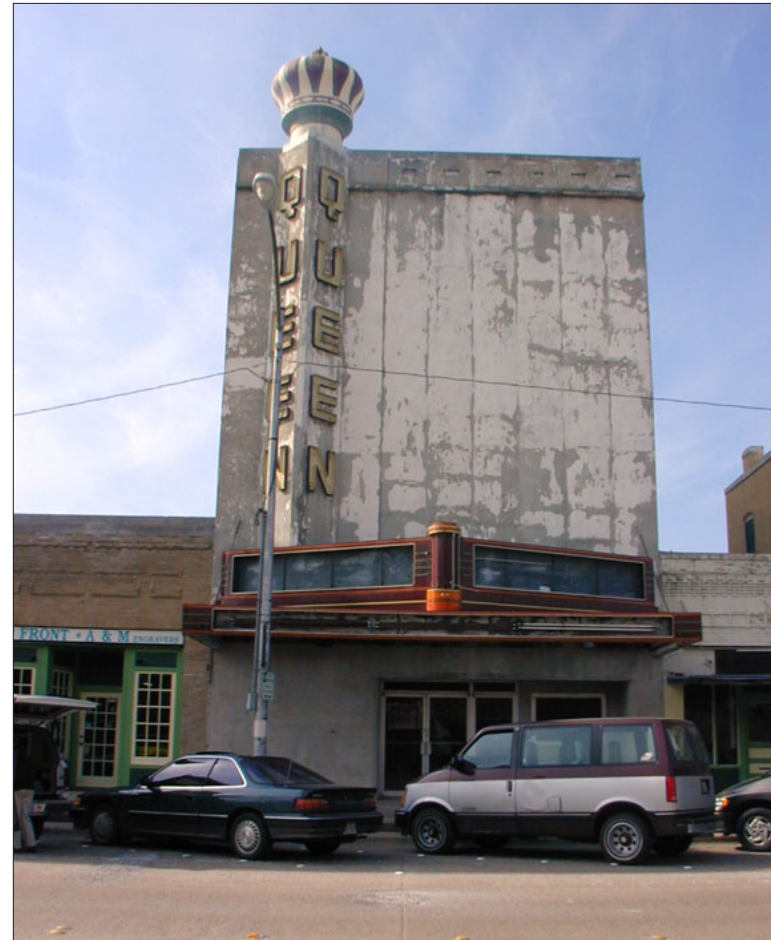
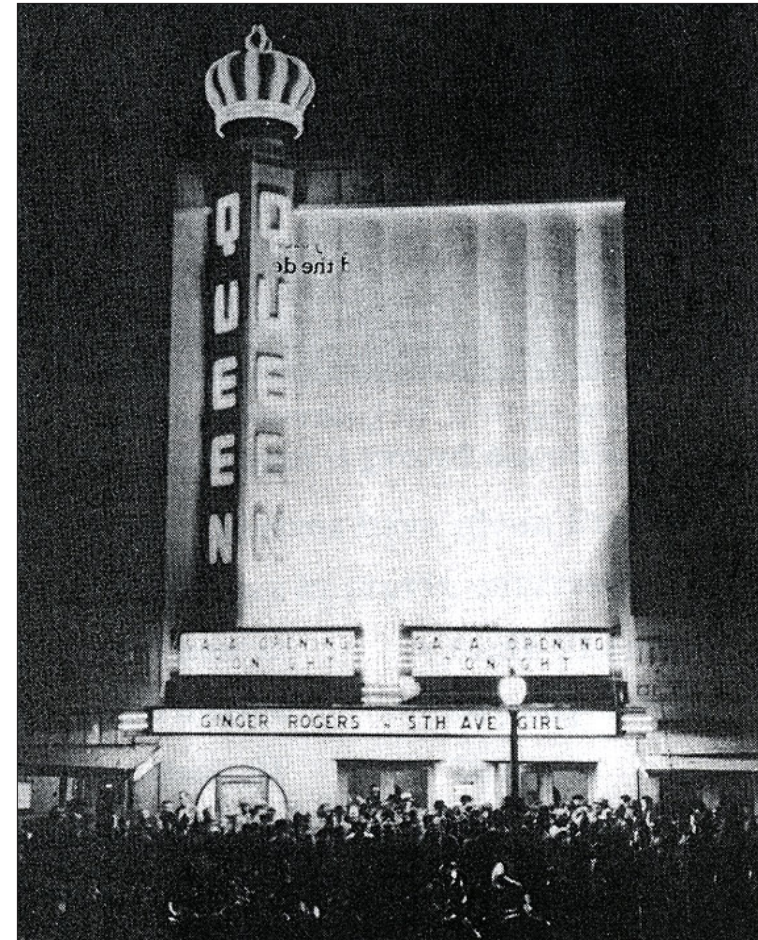
**111 South Main Street**

- Downspouts terminate above ground, damaging masonry
- Poor utility configuration
- Windows exhibit large amounts of rust and several panes are broken
- Painted brick
- Mortar deterioration
- Biological staining
- Iron and rust staining
- Building in need of cleaning
- Minor cracking/crazing of stucco
- Minor cracking through masonry
- Holes in masonry
- Paint deterioration
- Door entry is not ADA compliant

- Reconnect downspouts to the underground drainage system.
- Update utilities, ensuring that they are code compliant.
- Determine cause of mortar and masonry deterioration and repoint as necessary with mortar matching the original in composition, color and profile.

- Determine if brick was originally painted. If so, repaint brick in a color that matches the original. If not, perform test to determine if paint removal from the brick will damage the masonry. If the paint can be removed, do so in the most gentle means possible.

- Patch all cracks and holes in the stucco with a stucco that matches the original in color and composition.
- Restore original door openings.
- Rehabilitate original windows.

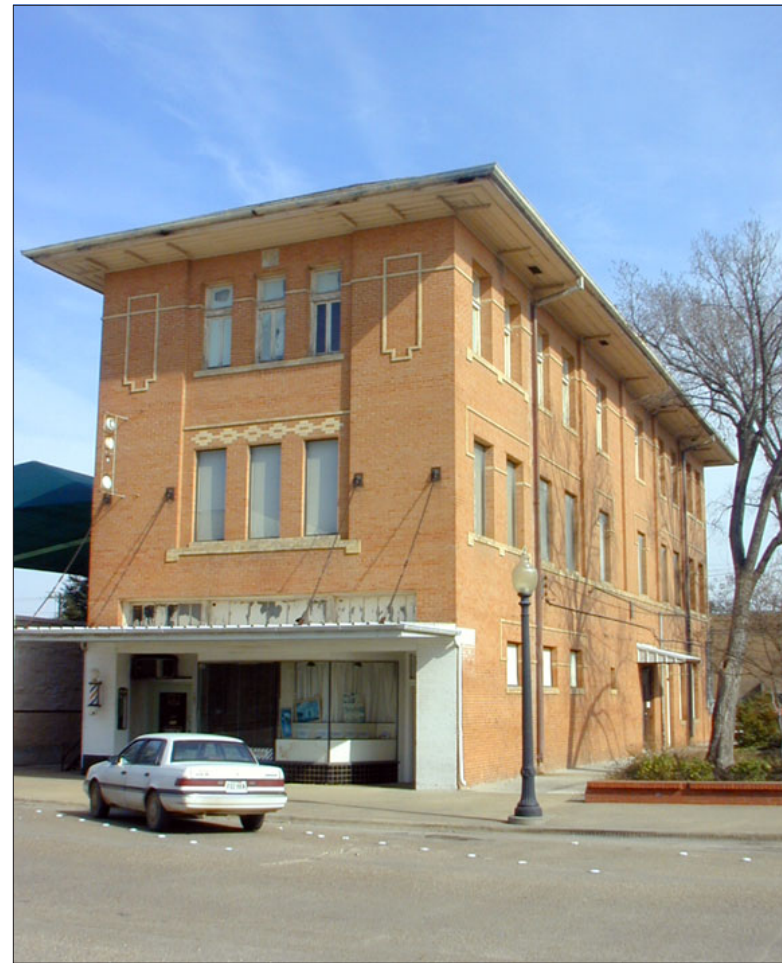
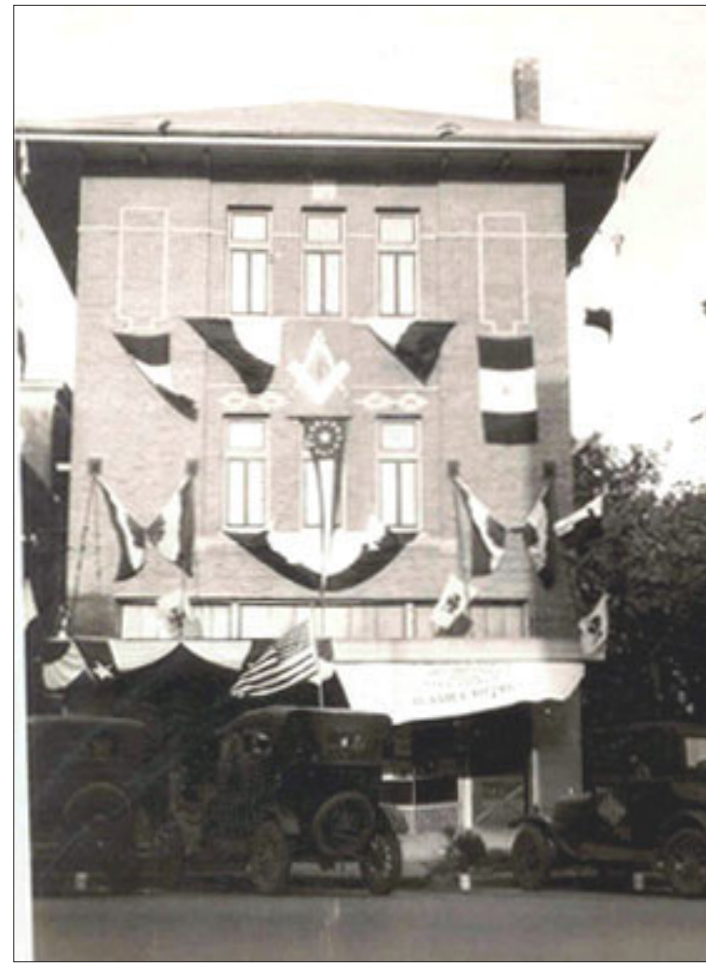
**110 South Main Street**

- Lack of positive drainage
- Gutter/downspout leaks
- Poor downspout termination leading to mortar deterioration
- Poor utility configuration
- Mortar deterioration
- Cracking through stone
- Solder joint failure
- Rust paint failure
- Wood rot
- Biological staining
- Iron staining
- Cracking along mortar joints
- Building in need of cleaning
- Holes in masonry
- Paint deterioration
- Metal deterioration of staircase and metal lintels
- Unsympathetic patching

- Regrade site so that water drains away from the building properly.
- Repair and restore gutters and downspouts.
- Reconfigure downspouts to ensure that water is not being deposited at the base of the building. If possible, tie drainage downspouts into an underground drainage system.

- Restore and rehabilitate historic wood windows.
- Replace corroding metal lintels.
- Repair and paint metal staircase.
- Replace new windows with ones that match the historic ones.

- Remove unsympathetic aluminum and glass door and replace with one that is historically accurate.
- Restore storefront in a historically accurate manner.

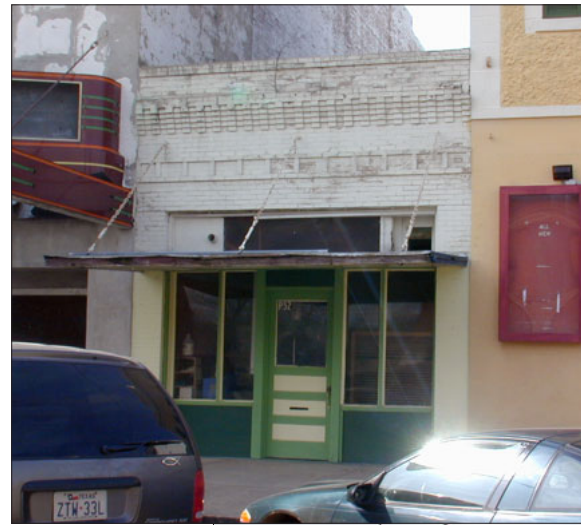
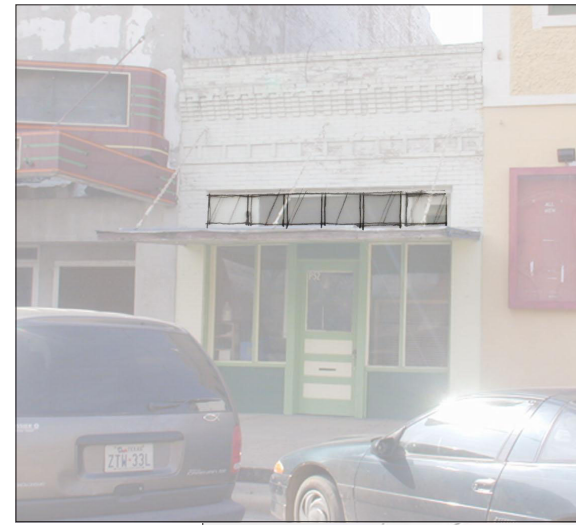
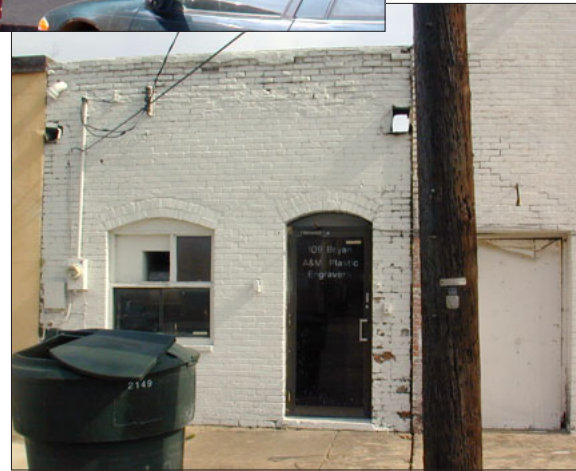
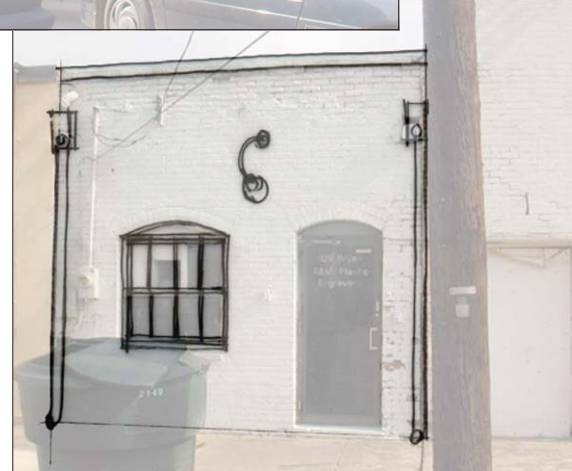
**109 South Main Street**

- Lack of downspouts is causing major water deterioration on walls
- Mortar Deterioration in cornice
- Biological staining and growth
- Mortar deterioration
- Cracking through masonry
- Building in need of cleaning
- Holes in masonry
- Wood rot on canopy
- Paint deterioration
- Spalling

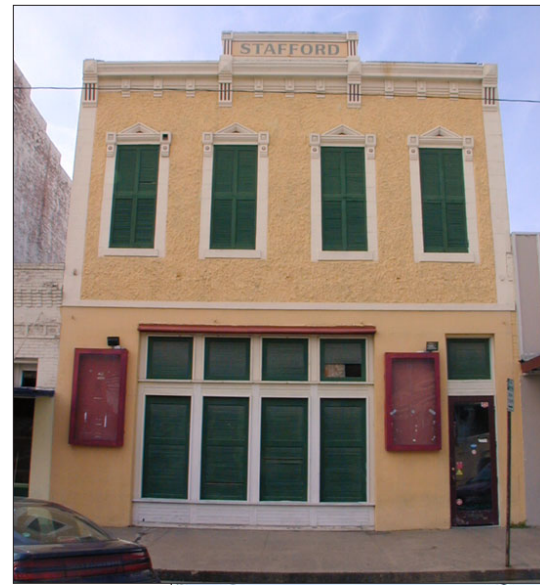
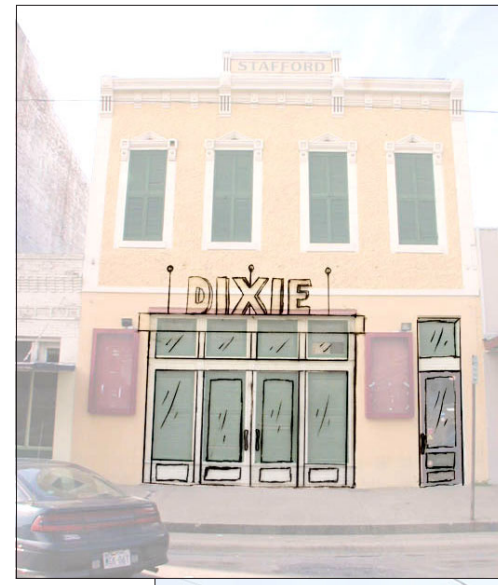
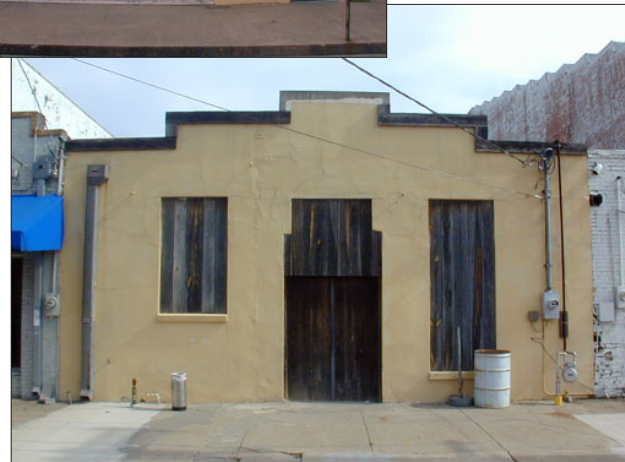
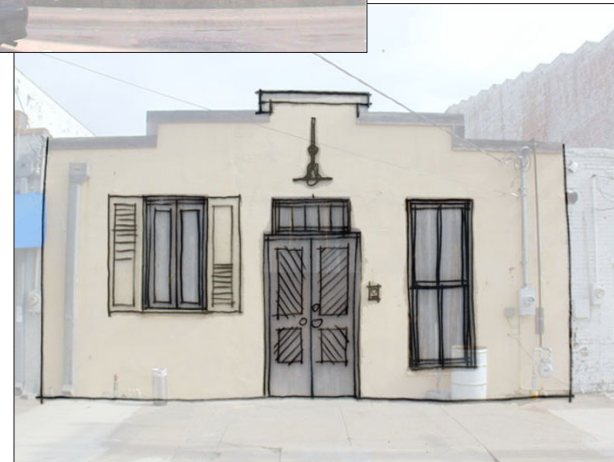
**108 South Main Street**  
**(Back is 109 S. Bryan, A&M Plastic Engravers)**

- Poor downspout termination
- Rust stain under leader head is a result of leaking
- Rust and paint failure on metal cornice
- Cracking through stucco
- Paint deterioration
- Chimneys exhibit deterioration
- Building in need of cleaning

- Tie downspout into underground drainage system.
- Repair leader head.
- Update utilities while ensuring compliance.
- Resolder any areas of joint failure.
- Clean, repaint and restore metal cornice.
- Remove stucco from brick as long as it does not harm the brick. If the removal process harms the masonry, patch all holes with stucco matching the original compound. Paint stucco to match.
- Restore chimneys. Repoint areas where mortar has deteriorated with mortar matching the original in composition, color and profile.
- Clean building in a manner that is not harmful to the brick or mortar.
- Restore window and door openings in a historically accurate manner.
- Restore storefront and reconstruct entry doors in a historically accurate manner.
- Ensure entry is ADA compliant.
- Remove infill panels.
