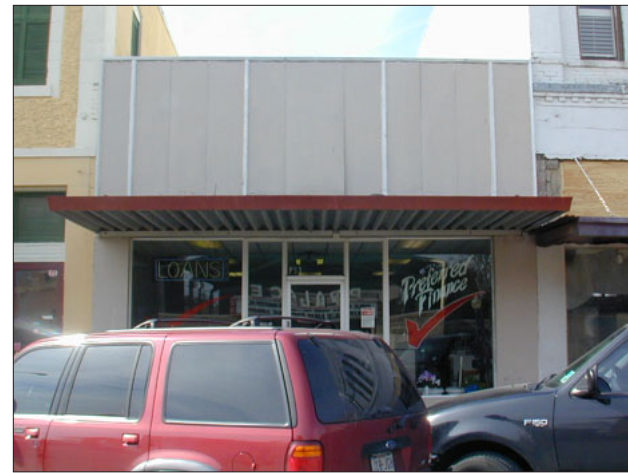
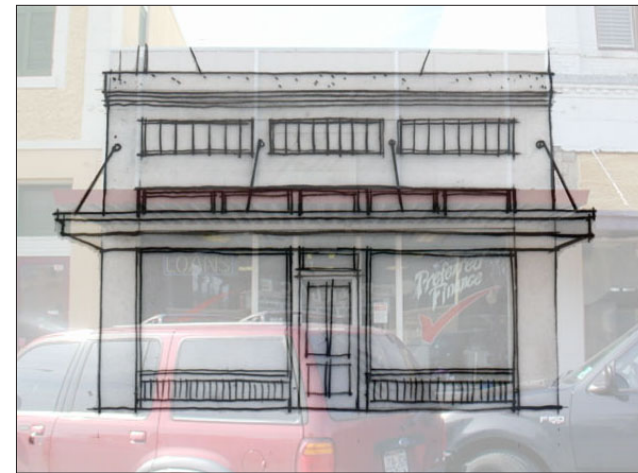
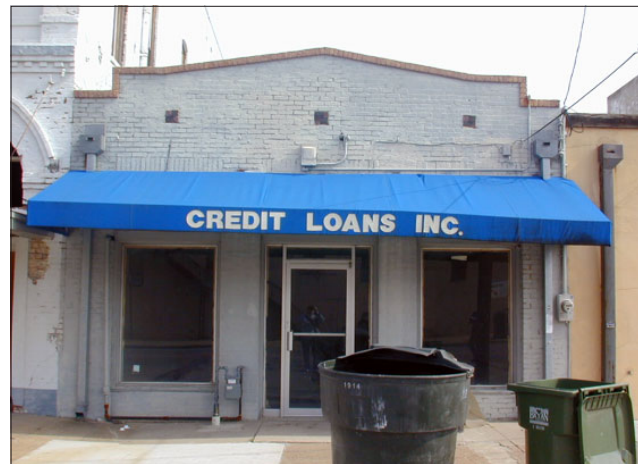
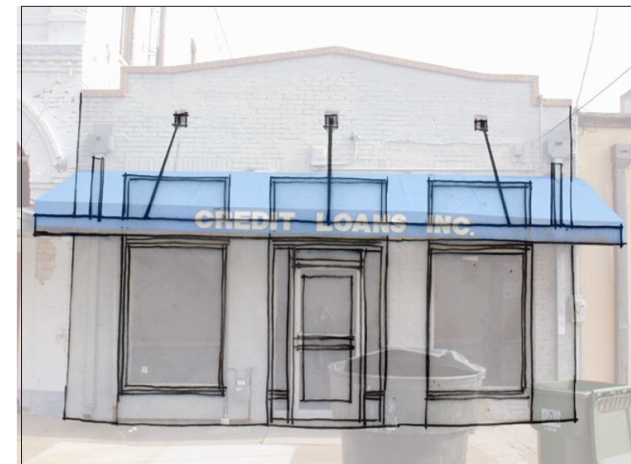
# 106 South Main Street

- Canopy drainage poorly configured against building
- Poor downspout termination
- Poor utilities configuration
- Mortar deterioration
- Efflorescence
- Building in need of cleaning
- Paint deterioration
- Moisture trapped by paint
- Door entry is not ADA compliant

- Reconstruct canopy on the front facade of the building, based on original design, ensuring proper drainage.
- Reconfigure downspouts so that they drain freely into an underground drainage system.
- Update utilities while ensuring code compliance.
- Determine cause of mortar deterioration and repoint as necessary with mortar matching the original in composition, color and profile. Areas that have been unsympathetically patched or pointed with Portland cement should be repointed with compatible mortar.
- Clean building in a manner that does not harm the masonry or mortar.
- Ensure that entry is ADA compliant.
- Remove the paint from the bricks in the gentlest means possible.
- Restore original storefront to include original door and window design and add canopy to both front and back facades.

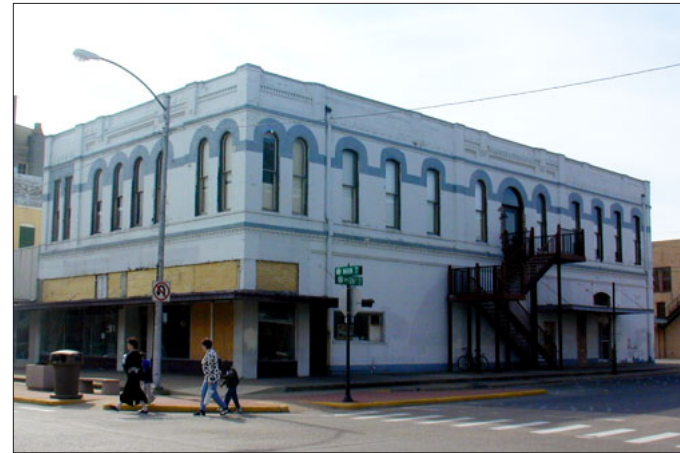
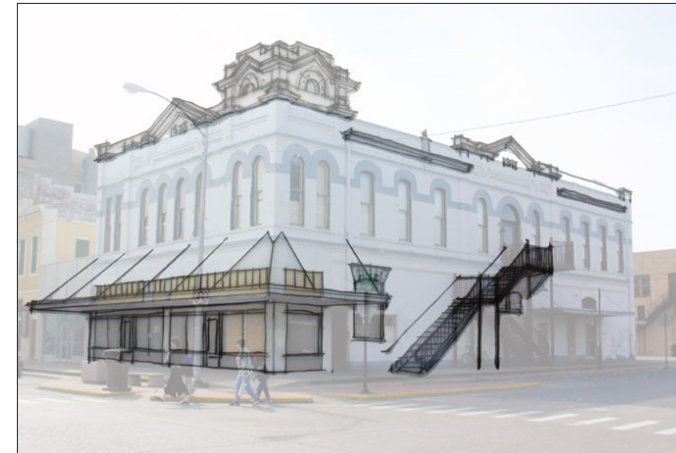
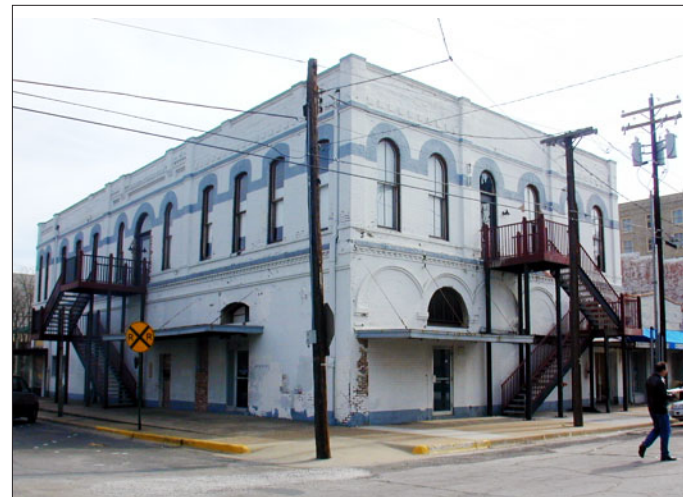
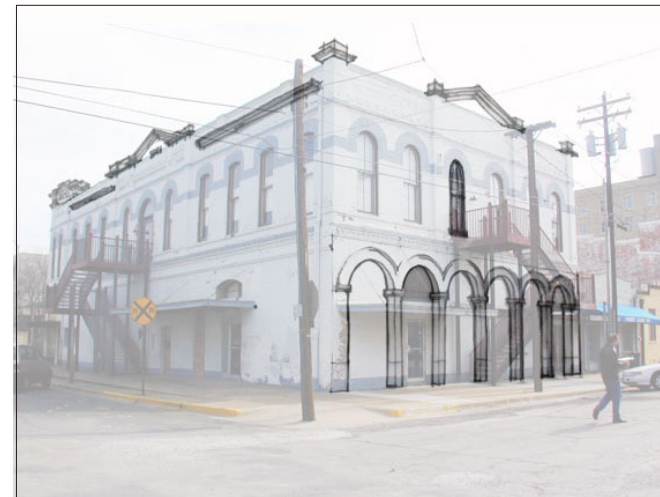
# 104 South Main Street

- Masonry and mortar deterioration
- Biological staining
- Building in need of cleaning
- Plant growth located in the gutter of the canopy on the north facade
- Cracking along mortar joints
- Spalling
- Mortar deterioration
- Severe paint deterioration
- Wood rot
- Holes in masonry
- Door entry is not ADA compliant

- Determine cause of mortar and masonry deterioration and repoint as necessary with mortar matching the original in composition, color and profile.
- Perform test to determine if paint removal from the brick will not damage the masonry. If not, remove the paint in the most gentle means possible.
