Existing Condition

Existing Conditions Analysis:

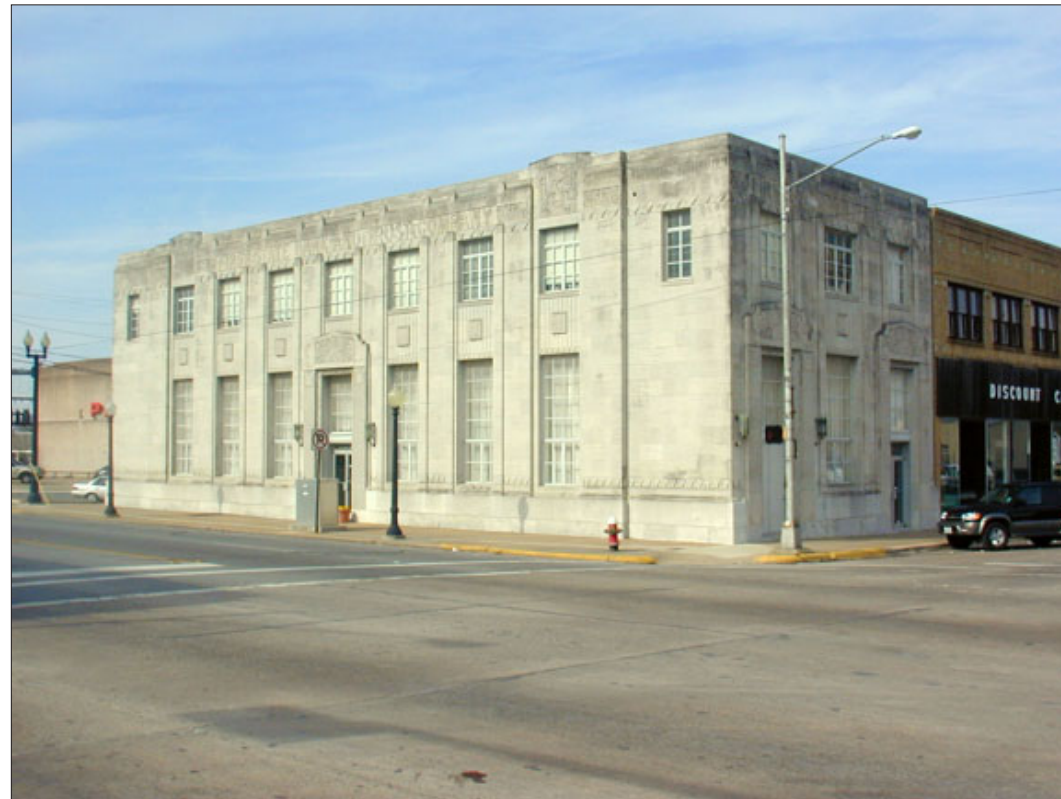
**100 West William Joel
Bryan Parkway**

- Possible negative drainage on south side
- Biological staining
- Minor mortar deterioration
- Previously sandblasted
- Some spalling along the base of the building
- Steel casement windows are in good to fair condition

General description: Two story building situated at the end of the block. The building is composed of Leuders limestone with a marble base. The composition and detailing on this building is a prime example of Art Deco architecture and was executed beautifully. The building still features its original light fixtures. The building has its original steel casement windows but the doors have been replaced with modern glass and aluminum ones.

- Regrade site so that water drains away from the building
- Determine cause of mortar deterioration and repair as necessary with mortar matching the original in composition, color and profile.
- Restore and repair deteriorated metal casement windows
- Ensure that entry is ADA compliant.
- Clean building in a manner that does not harm the masonry or mortar.

Front Facade and Side: Clean and tuck-point limestone masonry (scaffolding not included); prepare and repaint existing steel casement windows; restore original entry system.
\$83,500.00

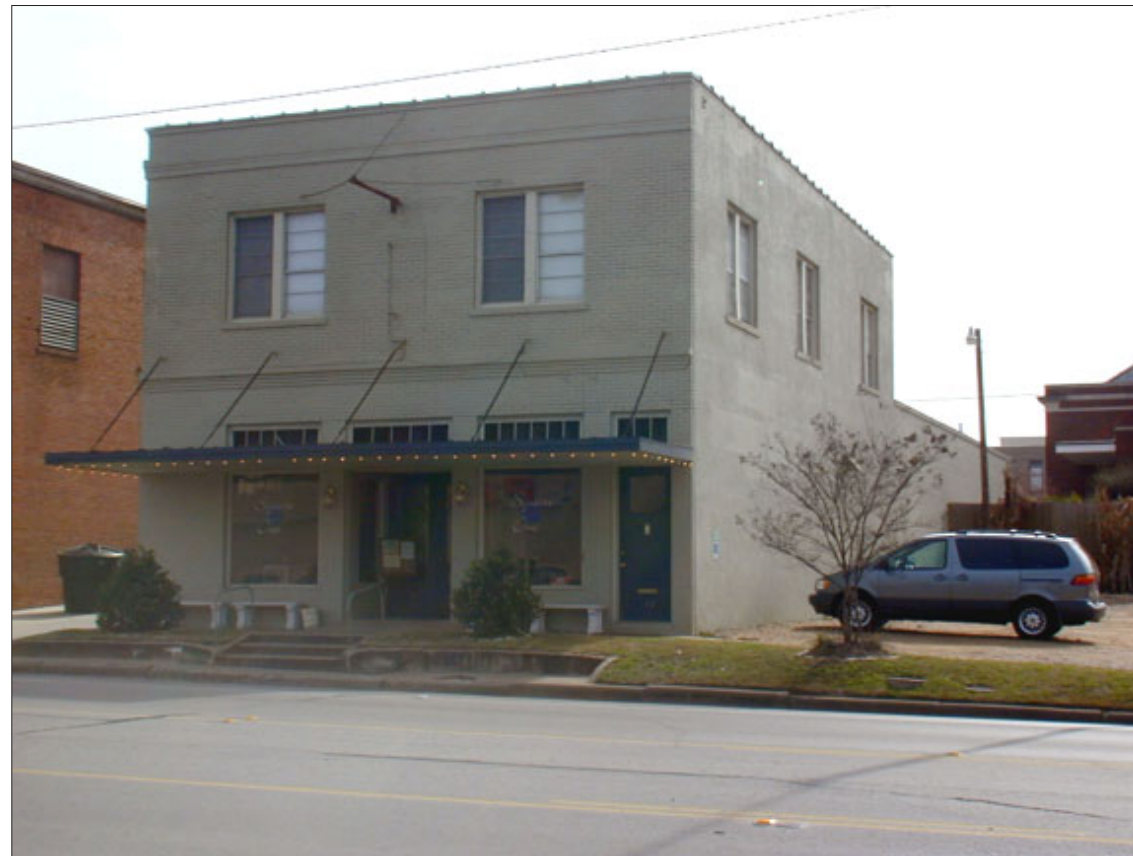
**211 West William Joel
Bryan Parkway**

- Pooling
- Poor drainage, especially on east side
- Scupper on south side allows water to drain down side of building
- Poor downspout termination
- Mortar deterioration
- Cracking along mortar joints
- Paint over brick
- Paint deterioration
- Holes in masonry,
- Biological growth
- Rust staining
- Cracking through masonry and stucco
- Unsympathetic repointing

General description: Two story commercial building veneered in brick that has been stuccoed on the east and west sides with a one story brick addition. All facades have been painted. The north or front facade has been painted and the storefront rebuilt in a sympathetic manner. The second story has unsympathetic metal windows. The south our back facade is somewhat inaccessible due to a large privacy fence placed around the back portion of the building. The east facade faces an alley. This facade also has metal replacement windows and garage doors. The west facade has the same metal replacement windows on the second floor. A garden and parking area has been created at the southern end of this facade. The plants from this green space may be too close to the building.

- Regrade so that water drains properly away from the building.
- Reconfigure downspouts to ensure that water is not being deposited at the base of the building. If possible, tie drainage downspouts into an underground drainage system.

- Clean building in a gentle manner ensuring that the masonry and mortar are not harmed.
- Repoint mortar joints with a mortar that matches the original in color, composition and profile.

- Paint any metal surface that is in contact with the building.
- Patch holes in masonry with masonry patching compound.
- Repoint areas that have been unsympathetically repointed with mortar that matches the original in color, composition and profile.

- Perform test paint removal from brick to determine if the removal process with harm the masonry or mortar. If it does not, remove the paint in the most gentle means possible. If removing the paint is detrimental to the building, repaint the brick to prevent further paint deterioration.

- Replace existing windows with ones that are historically accurate.
- Ensure that entry is ADA compliant.

Front Facade and Side: Repair and repaint stucco; replace second floor windows with new wood windows; retain and restore lower storefront, transoms, entries, and awning.
\$26,750.00

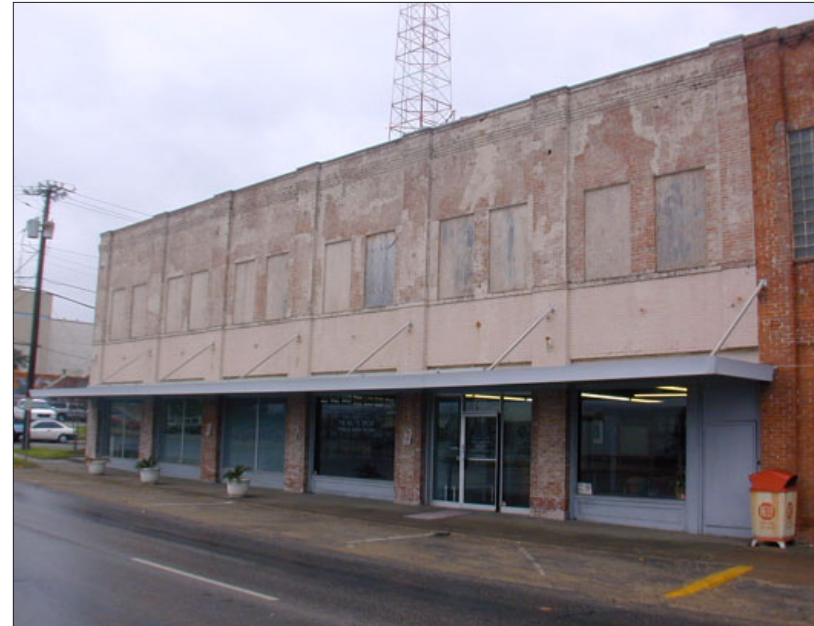
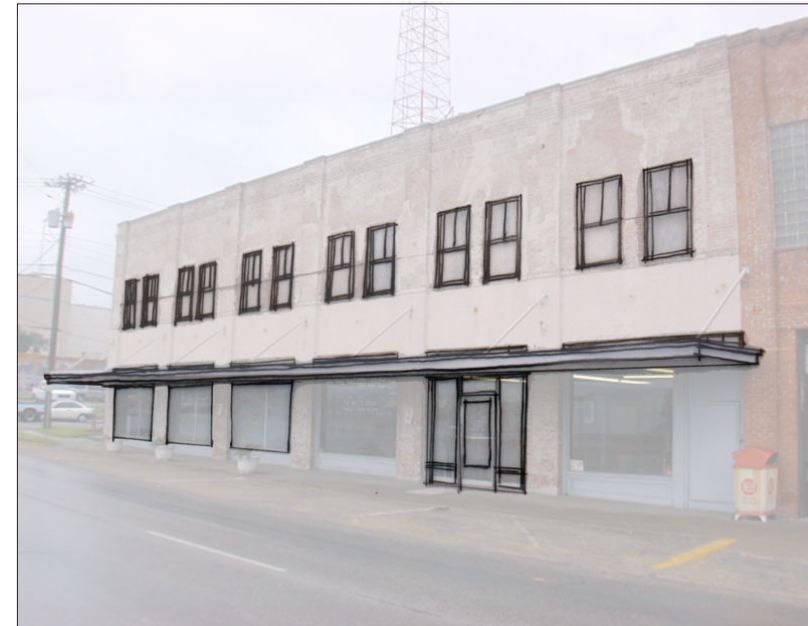
123 East William Joel Bryan Parkway

- Site exhibits lack of positive drainage
- Poor downspout termination
- Poor utilities configuration
- Masonry and mortar deterioration
- Cracking along mortar joints and through masonry
- Biological staining
- Building in need of cleaning
- Holes in masonry
- Paint deterioration
- Vines growing on the building
- Door handle is not ADA compliant

General description: Two story commercial building. The brick on the north and east facades were painted at one point, but the paint has greatly deteriorated over the years. The windows on the second floor and the transom windows have been boarded over. Several windows on the first floor have been infilled with brick. The hooks from the original canopy still remain. The original painted garage sign is somewhat readable on the back or south facade. Two “Drive In” signs are painted on the brick of the back facade as well.

- Regrade site so that water flows away from the building
- Reconfigure downspouts so that they drain freely away from the building or into an underground drainage system
- Update utilities while ensuring code compliance.
- Determine cause of mortar deterioration and repoint as necessary with mortar matching the original in composition, color and profile. Areas that have been unsympathetically patched or pointed with Portland cement should be repointed with compatible mortar.
- Clean building in a manner that does not harm the masonry or mortar.
- Patch holes in masonry with a masonry patching compound
- Remove vines growing on building
- Ensure that entry is ADA compliant.
- Remove the paint from the bricks in the gentlest means possible.
- Restore original windows
- Reconstruct original storefront and canopy

Front Facade: Chemical paint strip, repoint, and repair masonry facade (scaffolding not included); expose and restore second floor windows; restore lower displays; construct new entry system; install new wood canopy.
\$ 37,250.00

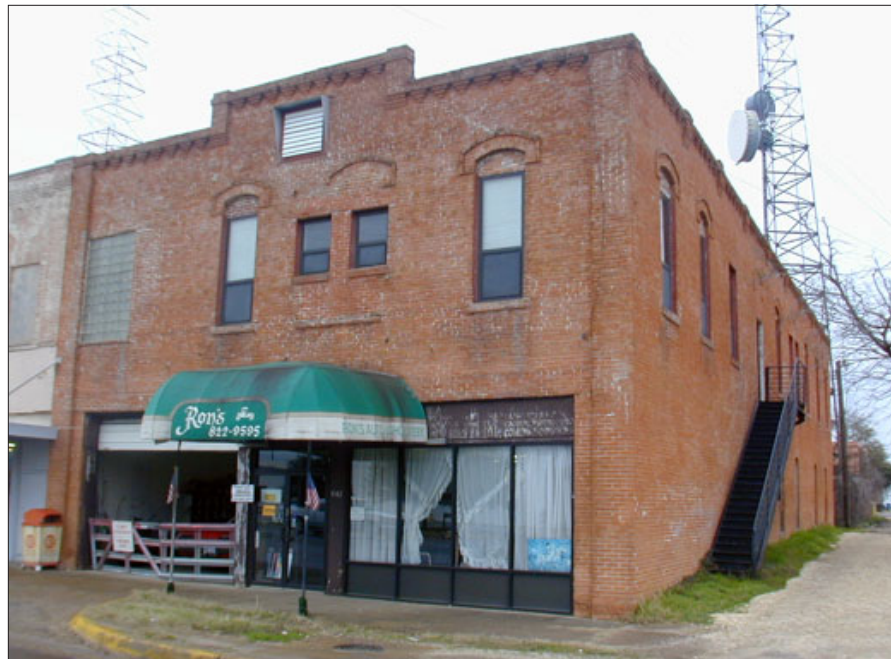
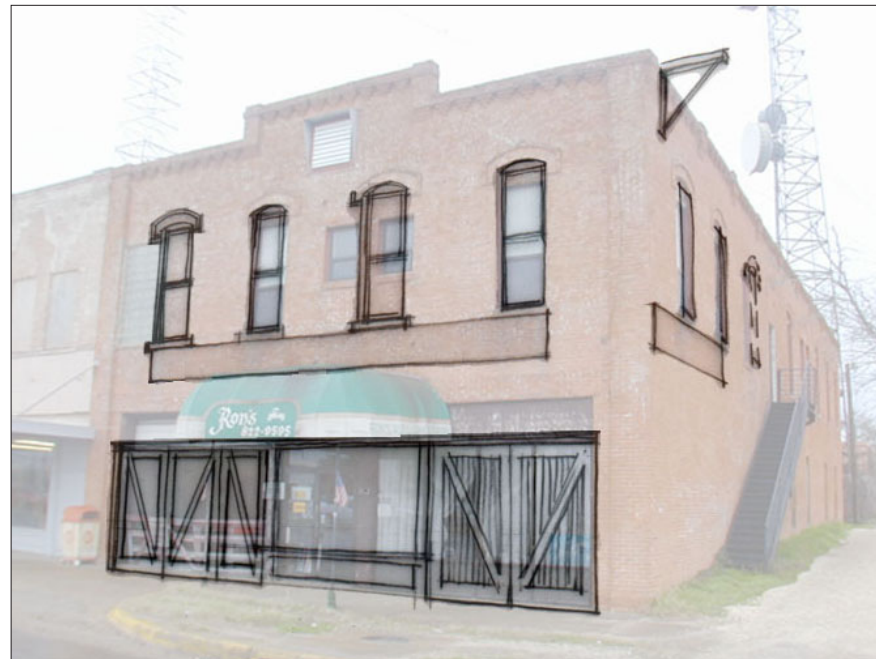
**113 East William Joel
Bryan Parkway**

- Lack of positive drainage and some areas are conducive to pooling
- Poor downspout termination causing water to be deposited at the base of the building
- Conduit attached to building
- Masonry and mortar deterioration, especially on parapet
- Corrosive spikes and pins in masonry
- Biological staining and growth
- Metal staining on brick from exterior stair case
- Brick has been sandblasted
- Efflorescence
- Spalling of brick
- Building in need of cleaning
- Plant growth located too close to the building
- Unsympathetic repointing and patching
- Holes in masonry
- Door handles are not ADA compliant

General description: Two story commercial building. According to the tenant, this building was one of the first garages in Bryan. The second floor of the building was supposedly used by the Moose Lodge. The first floor originally had two large garage doors on the south and north facades. All of the original two-over-two, double hung windows have been replaced with unsympathetic aluminum one over one lite windows. Two of the four second story windows on the front or north facade have been altered. One window has been replaced with two small aluminum windows while the other was replaced with a large area of glass block. One of the garage doors on the main facade has been filled in and an office created. The windows on the second floor of the west facade have also been altered. The metal stair case originally lead up to the third opening on the facade. Today, the stair has been moved back one opening to a window that was converted to a doorway and the original door opening was changed into a window. The back or south facade has undergone similar alterations to the front. One garage door opening has been filled in and two of the second story windows have modern additions.

- Regrade site so that water drains away from the building.
- Update utilities while ensuring code compliance.
- Determine cause of mortar and masonry deterioration and repoint as necessary with mortar matching the original in composition, color and profile. Areas that have been unsympathetically pointed with Portland cement should be repointed with compatible mortar.

- Remove corrosive spikes and pins from masonry and patch with masonry patching compound.
- Clean building in a manner that does not harm the masonry or mortar.

- Determine cause of efflorescence and biological growth, remedy accordingly
- Patch all holes in masonry with masonry patching compound
- Ensure that entry is ADA compliant.

- Restore original storefront and transom design and reconstruct original canopy (if canopy reconstruction is allowed by TxDOT).
- Remove plant growth located too close to the building.

- Paint exterior staircase to prevent further staining of brick.

Front Facade and Side: Tuck-point repair and clean masonry surfaces (scaffolding not included); demo brick infill in second floor windows where needed; install new wood windows on second floor per detail; restore lower storefront to original configuration of center display and lateral double door garage bays; construct new wood canopy; repaint exterior fire escape. \$ 42,125.00
