**BUILDING AND STANDARDS COMMISSION
STAFF REPORT**

Case #1754 – 905 Columbus Avenue

Dangerous Structures Survey Report

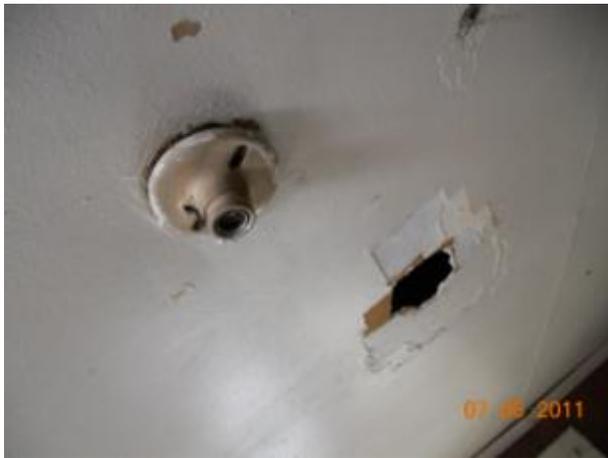
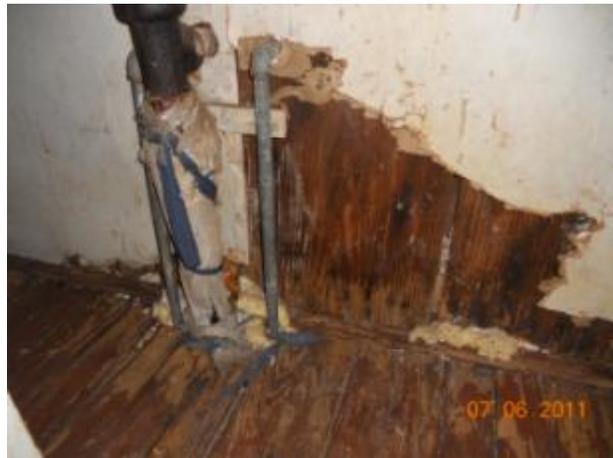
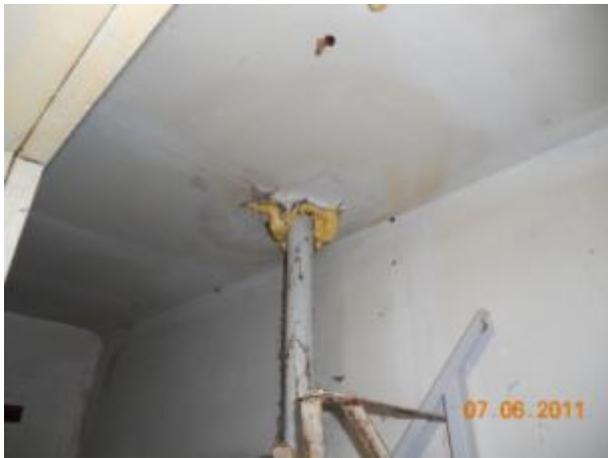
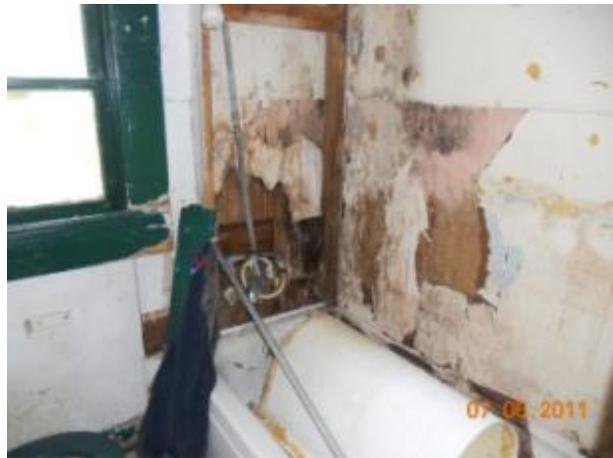
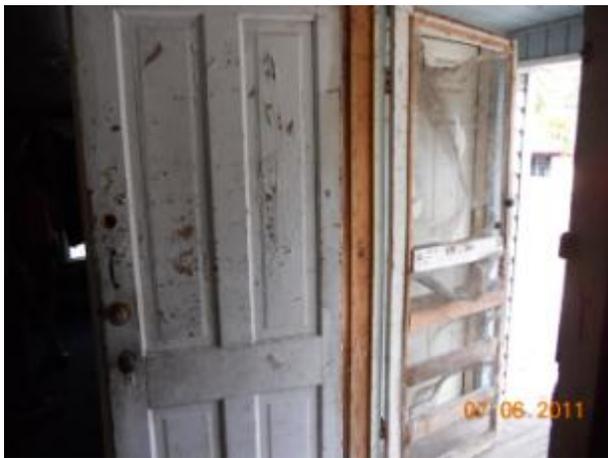
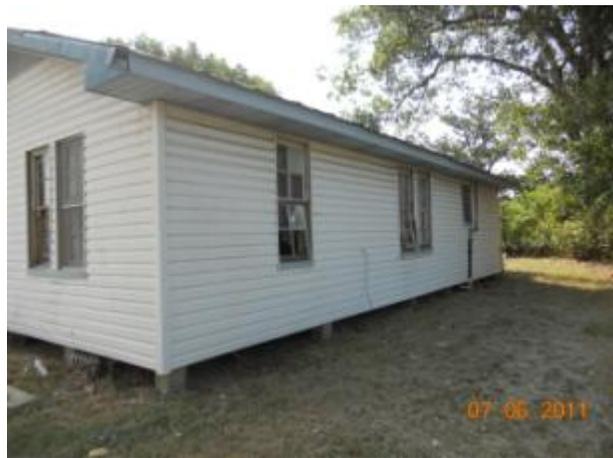
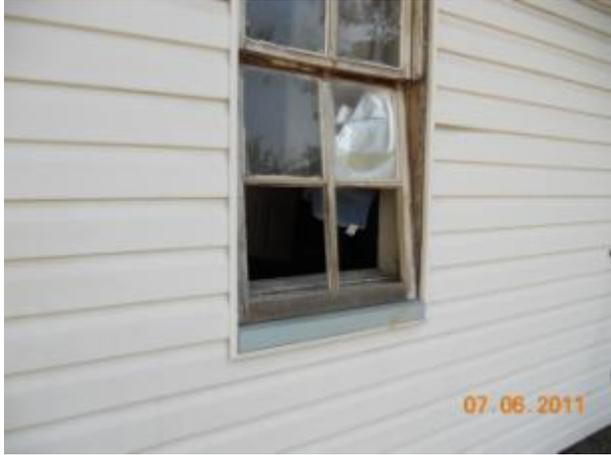
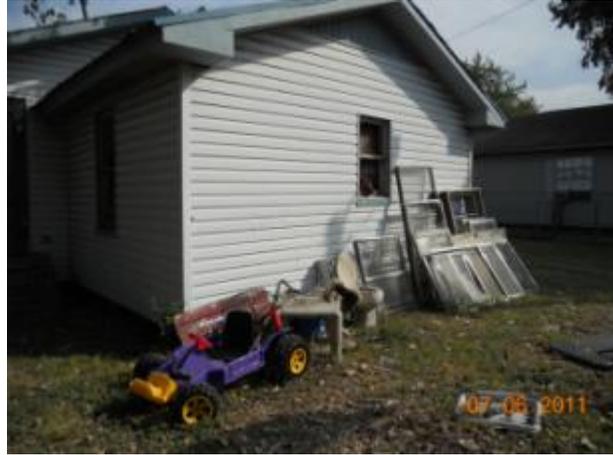
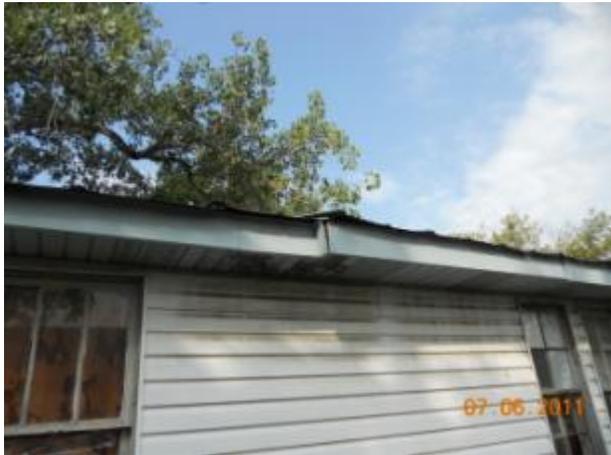
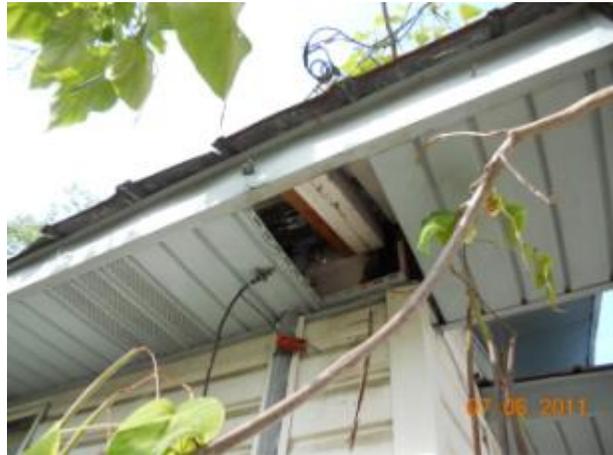
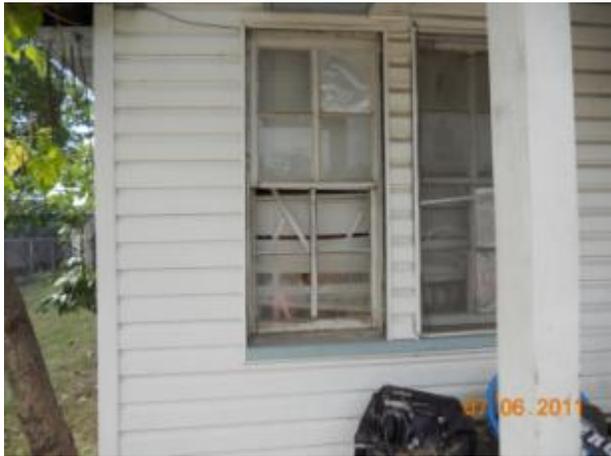
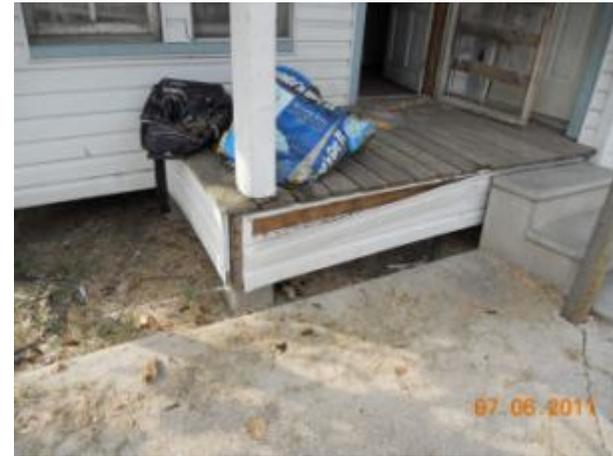
PICTURES:

COMMENTS Interior finishes damaged, porch column loose, footing at porch failing. Missing window frames and damaged window frames. House has low ceiling – 6'-8" to 7'-0" in some places. Rotten floor areas in kitchen and bath room. Openings in walls. Some walls are box frame. Open or missing covers at electrical devises. Missing glass in windows, unsecured, some window glass is broken. Missing tub surround in bath, no electrical outlet in bath, etc.

1. It has been determined upon inspection and investigation that the structure is dangerous, unsafe, or a hazard to public health and must be secured and:
- A. Be vacated OR remain unoccupied; and
 - B. Be repaired OR be demolished.
2. It has been determined upon inspection and investigation that the structure is not dangerous, unsafe, or a hazard to public health as defined by the City's Code of Ordinances.
