**BUILDING AND STANDARDS COMMISSION
STAFF REPORT**

Case #1729 – 2319 Old Hearne Road #36

Dangerous Structures Survey Report

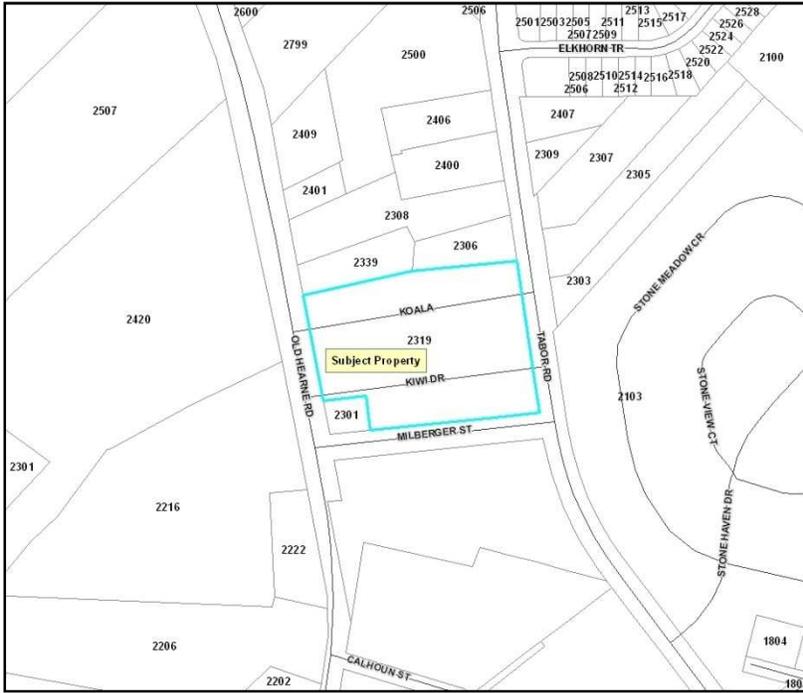
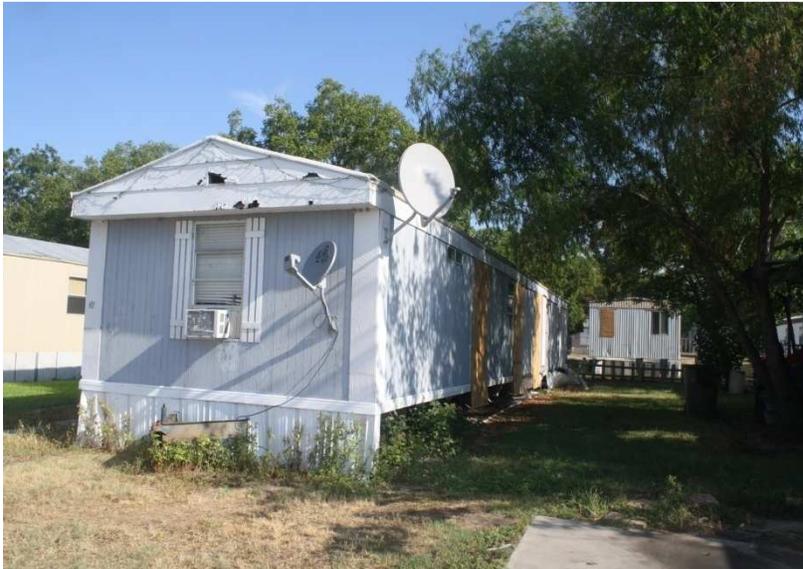
BACKGROUND: This property was brought to Code Enforcement because of the unsecured structure and the possibility of children from the mobile home park entering the structure. Notices were sent to the mobile home owner and the park owner. It has been boarded up since the initial inspection in July but continues to be a hazard to the neighborhood.

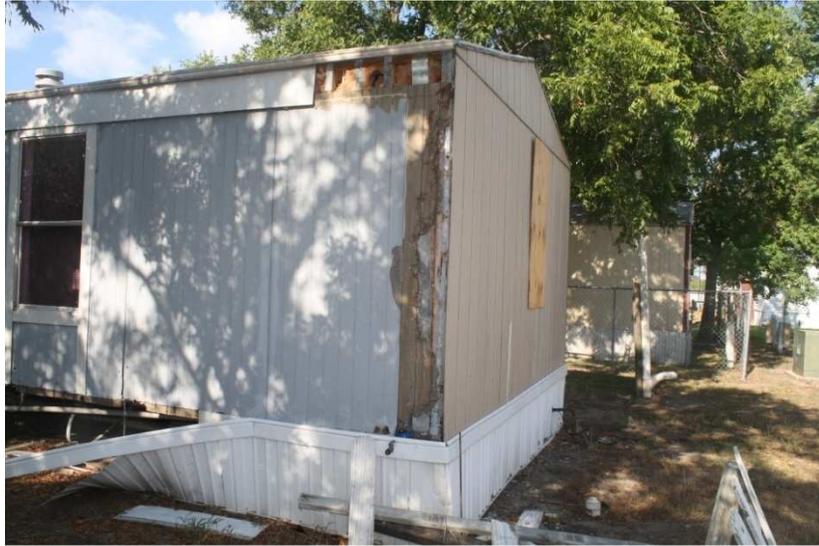
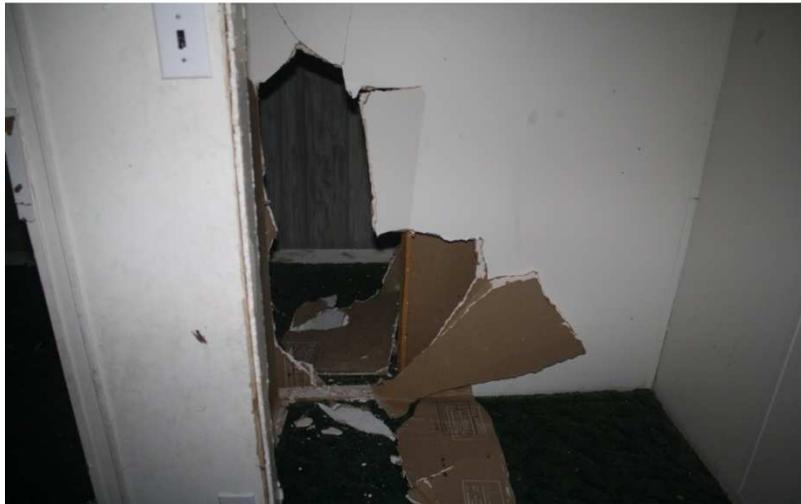
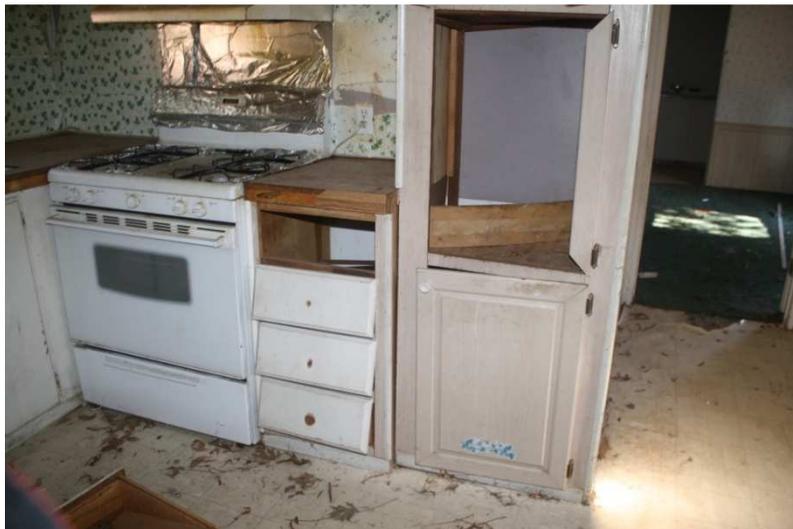
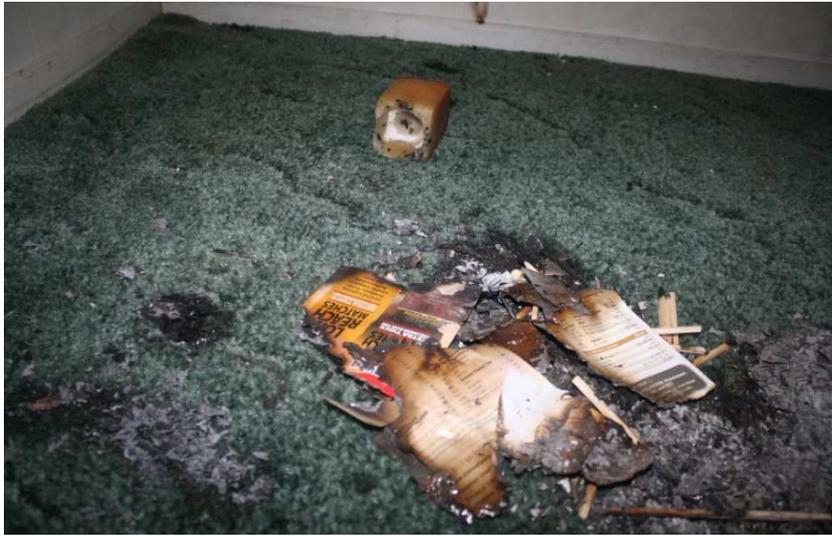
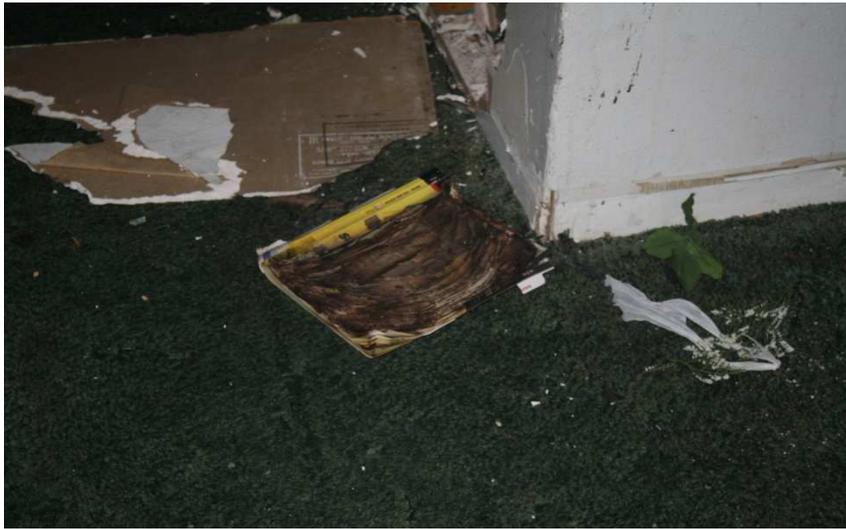
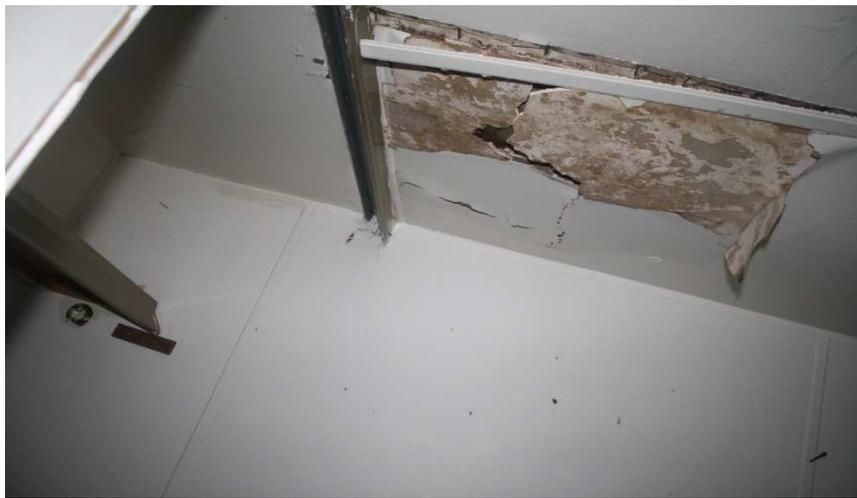
PICTURES:

Abandoned, missing ele. covers
walls rotten interior - exterior

Fire damage on carpet and walls from vandals and from being unsecured. Soft sopts in floors, wall damage around windows to structural framing due to possible a/c window units. A/C condenser missing, siding is damaged and allowing deterioration of structural frame, hole in eave trim. Structure is subject to 2009 IBC Section 116 and the city dangerous structures ordinance.

rotten siding into roof void
siding missing
rotten window sill
evidence of attempted Arson/Criminal Methicil / Drug Use
weak/rotten planks in floor
windows broken
hole in ceiling
hole in walls
mold on ceiling

- vacate the building within ____ days.
- secure the building and accessory structure(s) from unauthorized entry within 30 days.
- demolish/remove the building within 30 days.**
- demolish/remove or repair the building and accessory structure(s) within ____ days, in accordance with the schedule below:
