**BUILDING AND STANDARDS COMMISSION
STAFF REPORT**

Case #1760 – 3200 Finfeather Road

Dangerous Structures Survey Report

Re: Forensic Investigation
Avalon Apartments
3200 Finfeather Road
Bryan, Texas 77801
Gessner Engineering Project No: 11-0138

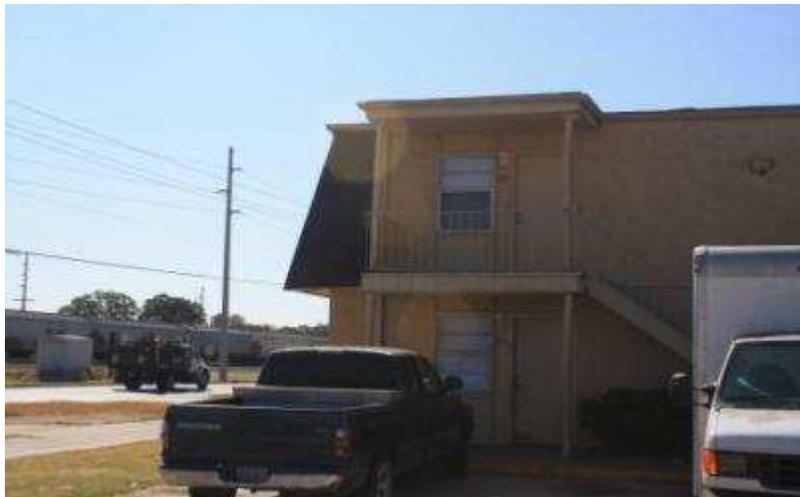
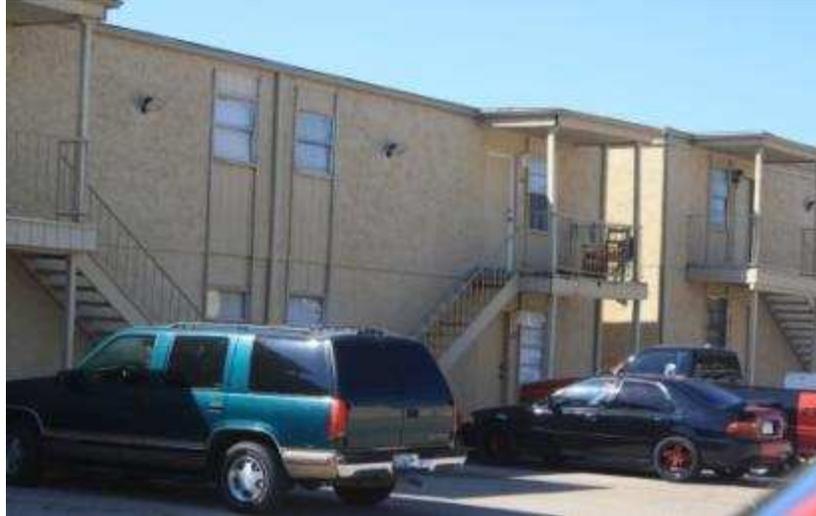
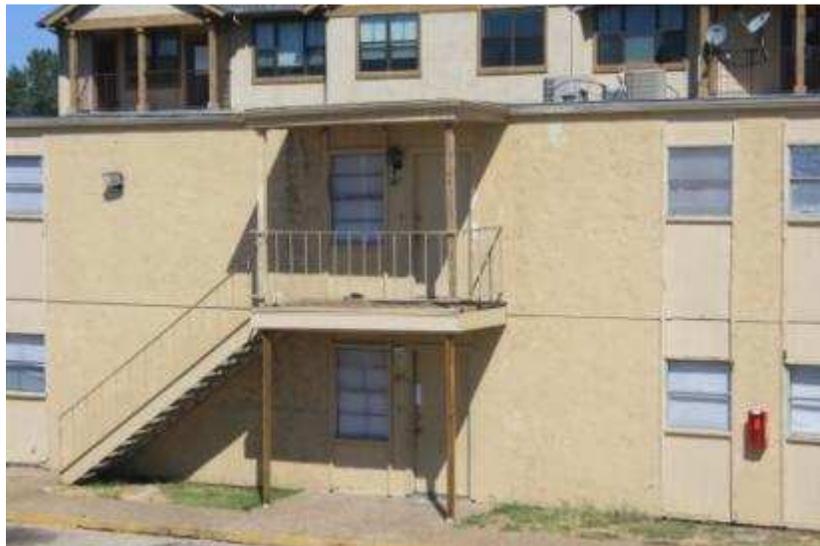
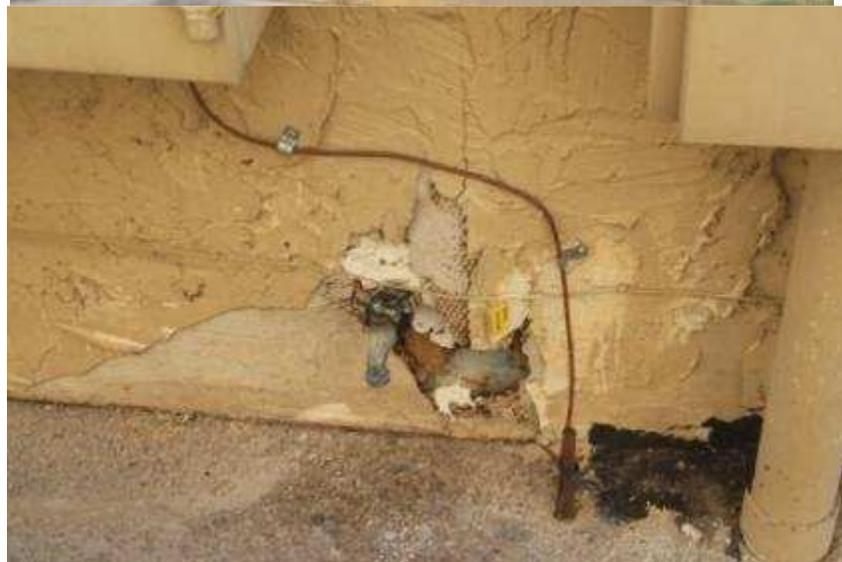
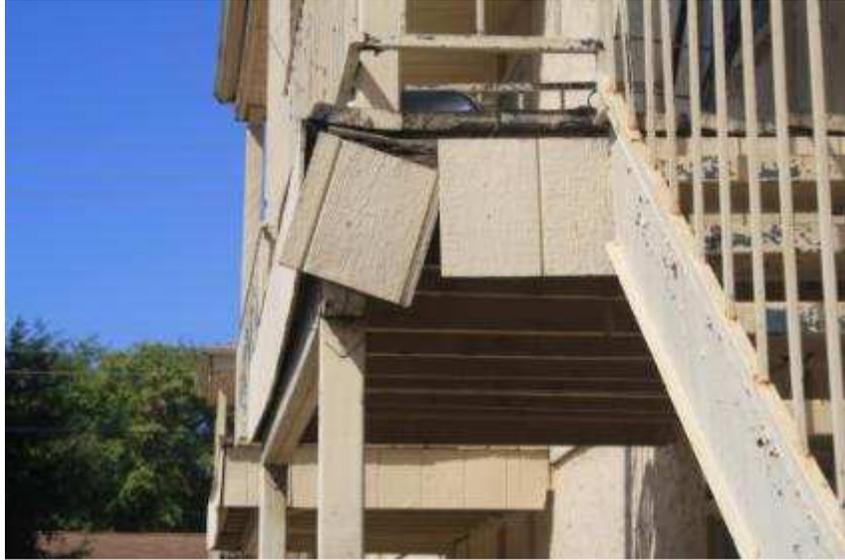
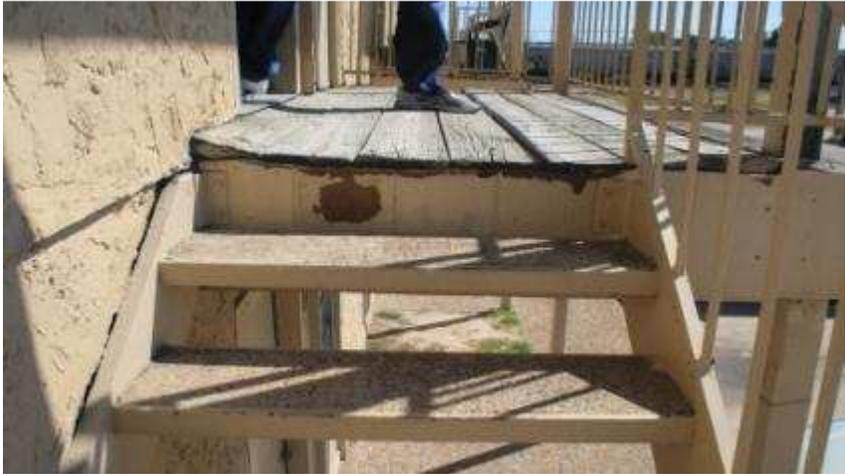
PICTURES:

Unit	Comments (Inspection date: 11.2.11) Avalon
109/209	Columns bowed; top column rotten; columns not anchored
110/210	Top of stairs board rotten; three existing columns shows deterioration
112/212	Columns rotten top and bottom, columns not anchored, top column kicked out
113/213	Bottom column loose at top
114/214	Top column loose at top
115/215	Top guard rail loose; top column loose
119/219	Hand/guard rail stairs broken; bolt missing top of stairs
112/222	Guard rail not attached to column
123/223	Guard rail not connected correctly
113	Bottom column loose at top
214	Column loose
215	Guard rail loose; column loose
119/219	Hand/guard rail broken; bolt missing top of stairs
108/107	Exterior plug out of wall
107/207	Guard rail needs to be attached to column; stair loose open next to wall
106/206	Stair loose open next to wall
105	Column loose
102/202	No bolts top of stairs
201	Column rotten
157/257	Loose column; stairs unsafe; bolts missing top of stairs

159/259	Stairs loose open next to wall; column loose top
160/260	Loose column
162/262	Guard rail repair with a piece of plywood; new bolts loose top of stairs
263	Columns rotten
264	Column resting on rotten wood
266	Porch landing joist rotten
268	Porch landing joist rotten
170/270	Porch landing joist rotten; column resting on rotten wood; guard rail loose
171/271	Columns rotten
172/272	Columns rotten
242	Guard rail repaired with plywood
243	Column rotten; guard rail loose

Complete all repairs to all buildings for siding/stucco, porch, decks, Columns, beams, guardrails, and stairs. Seal exterior envelope. Follow original engineer's report for repairs and submit engineer's report to city after repairs are made.
