**BUILDING AND STANDARDS COMMISSION
STAFF REPORT**

February 27, 2012

Case #1821 – 2002 Newton Street

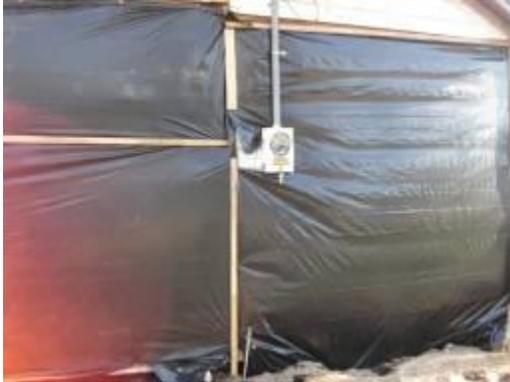
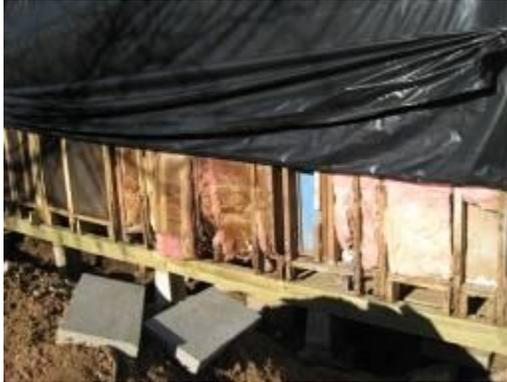
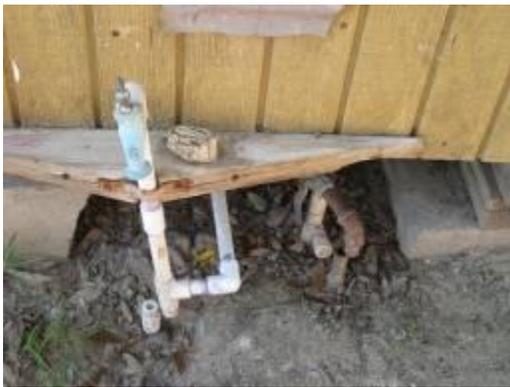
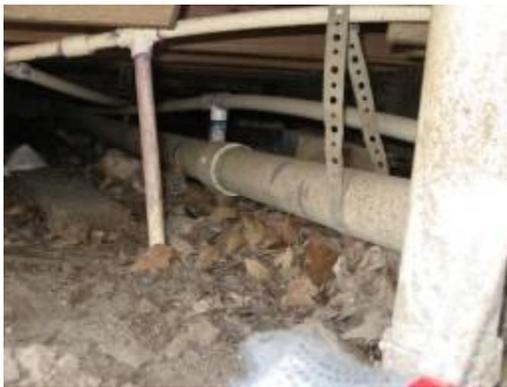
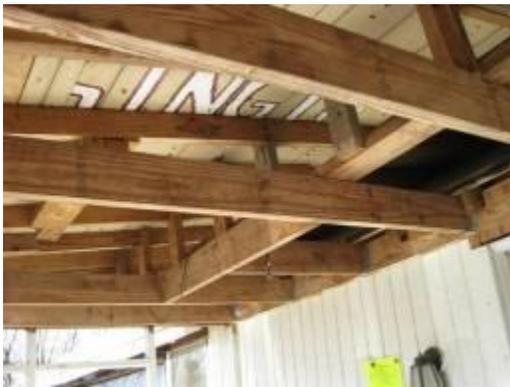
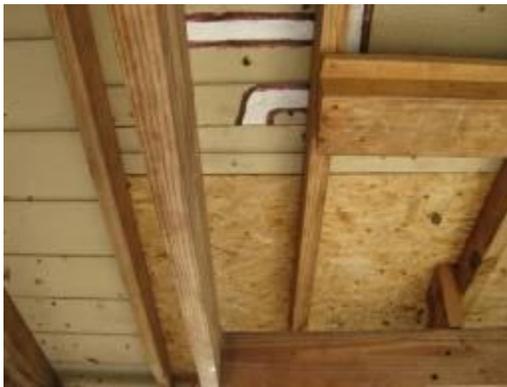
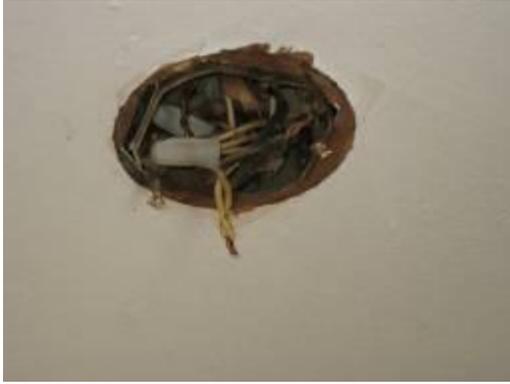
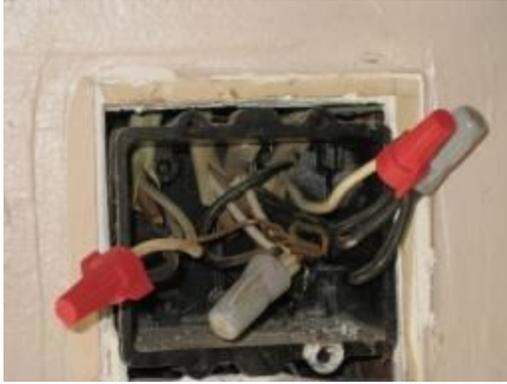
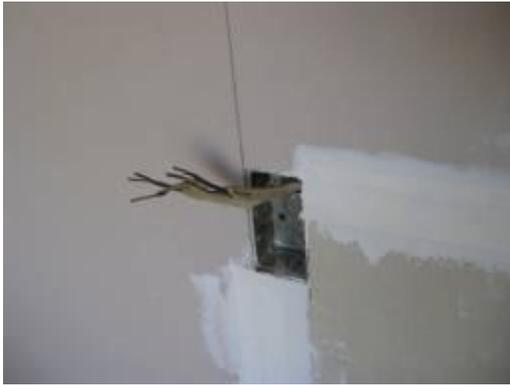
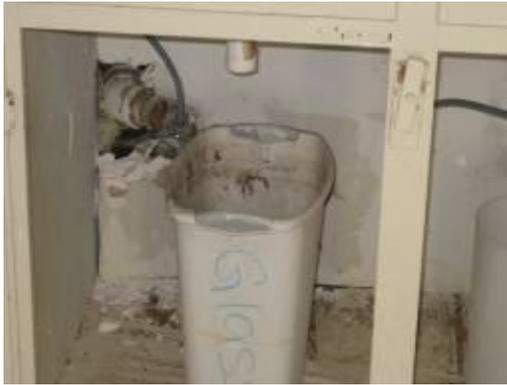
Primary Structure

COMMENTS HOUSE: ① ROOF SHINGLES NOT TRIMMED CORRECTLY IN SOME AREAS, ② GRADE TOO HIGH ON ^{NORTH} SOUTH & FRONT (WEST) OF HOUSE (CAUSING EXTENSIVE ROT & DECAY TO SILL BEAM AND 2X4 WALL FRAMING) ③ ROTTEN FLOOR BD ON PORCH ④ KITCHEN SINK NOT PLUMBED (DRAINING TO BUCKET) ⑤ NOT ALL WALLS HAVE INSULATION. ⑥ ^{EXTERIOR} WALLS NEEDS NEW SIDING & MOISTURE BARRIER / WINDOWS NOT INSTALLED PROPERLY OR FLASHED PER CODE (?) GAPS AT BOTTOM EDGE OF TUB (DAYLIGHT) NEED NEW TUB SURROUND. ⑧ EXPOSED WALL FRAMING - MAJORITY DOES NOT MEET CODE. ⑨ ACCESSORY STRUCTURE: FLOOR FRAMEN ON GROUND - PARTICLES BOARD SUB FLOOR HAS HOLES & DETERIORATION, PORCH NOT BOLT TO CODE.

1. FOUNDATION BEAMS ROTTEN

2. PILINGS SINKING

3. WALL STUDS SHOW INSECT DAMAGE

4. SLOPING FLOORS

5. EXPOSED ELECTRICAL WIRES / UNPERMITTED ELECTICAL WORK

8. UNPERMITTED ADDITIONS TO HOUSE SHOWING STRUCTURAL ISSUES

- vacate the building within ____ days.
- secure the building and accessory structure(s) from unauthorized entry within 30 days.
- demolish/remove the accessory structure(s) within 30 days.**
- demolish/remove or repair the main house within 90 days, in accordance with the schedule below:**

<u>Deadline</u>	<u>Task</u>
30 days	Submit plans, building permit application etc. for repairs to main house. Obtain building permit, electrical permit, mechanical permits, and plumbing permits.
60 Days	Repair foundation, floor framing, exterior wall framing and call for inspections prior to covering work. Install new wall insulation and moisture barrier at all exterior walls call for inspections prior to covering. Complete electrical repairs, mechanical repairs, and plumbing repairs and have sub contractors call for inspections.
90 Days	Complete all exterior and interior repairs, install crawl space skirting and vents per city code, grade exterior ground to slope away from structure, call for final inspections and obtain Certificate of Occupancy.

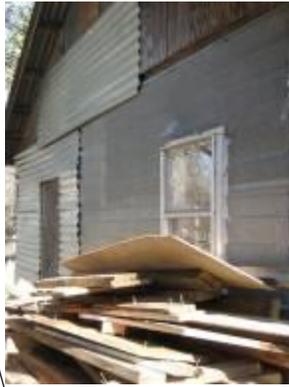
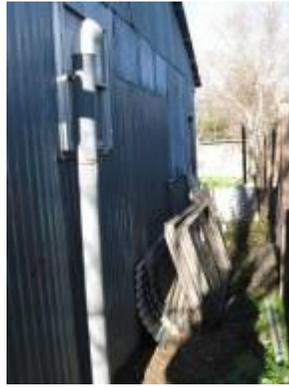
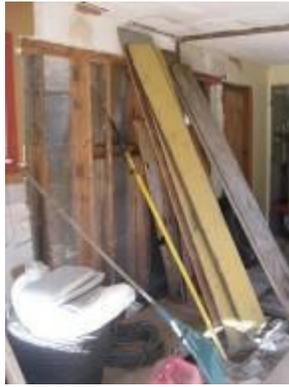
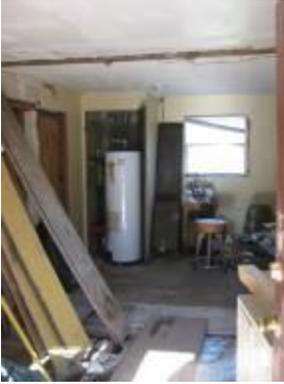
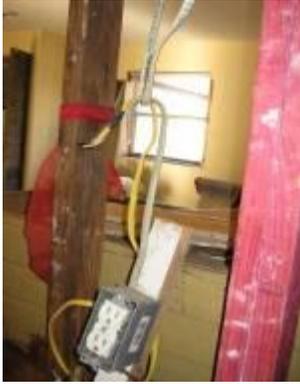
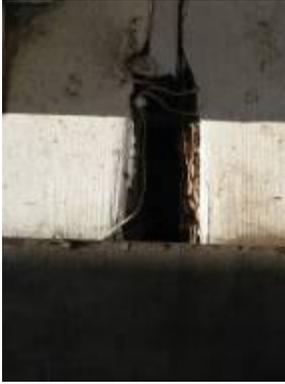
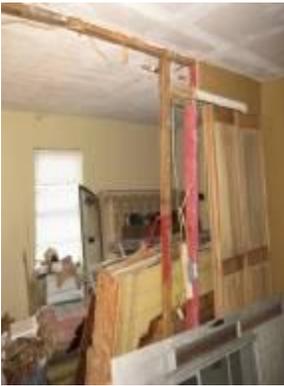
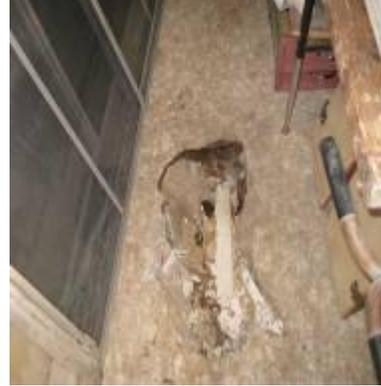
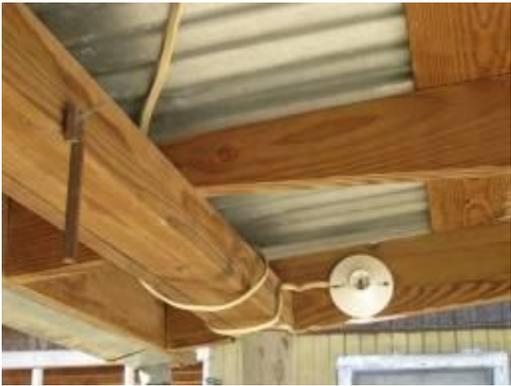
Storage building converted into dwelling

On September 7, 2010, Code Enforcement received a call from a concerned citizen advising that one of the two accessory structures on this property had no utilities and was being leased out by the landlord, Roy Sanchez. At this time the accessory structure was found occupied and without utilities. Four tenants were residing in this accessory structure and paying rent to Roy Sanchez. Since then, we had to re-locate those tenants who were living in this accessory building that was converted illegally into a dwelling without Conditional Use Permit and/or building permit approval. The original structure was a garage for vehicles.

COMMENTS GAS meter at property, No electric meter, and water meter box has water in it. Small storage building on Southeast side of lot has been demolished and larger garage building that was illegally converted into dwelling has started to be demolished inside. Walls being torn down and holes in the
