**BUILDING AND STANDARDS COMMISSION
STAFF REPORT**

Case #1894 – 2316 Rountree Drive

Dangerous Structures Survey Report

2316 Rountree - Rear Building

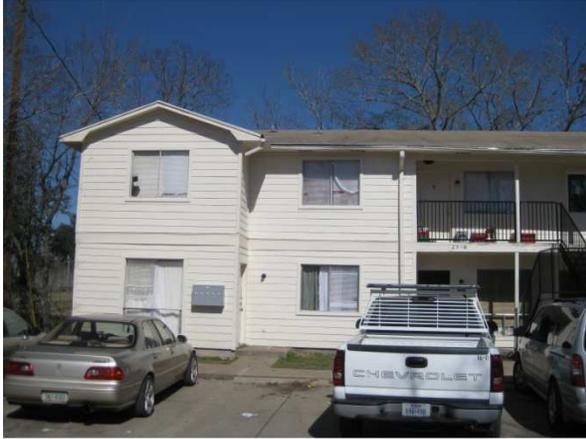
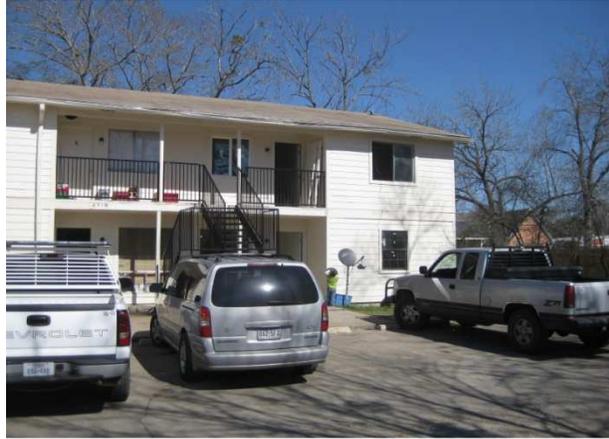
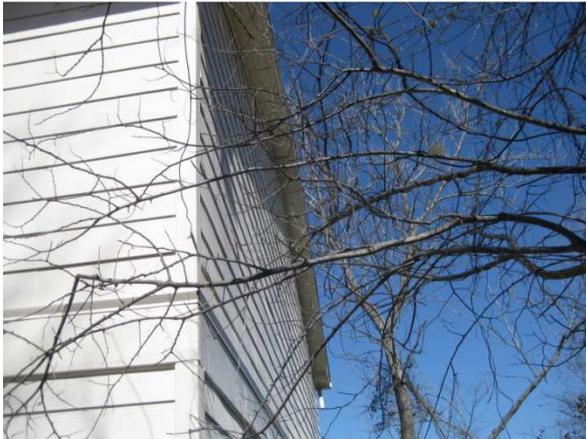
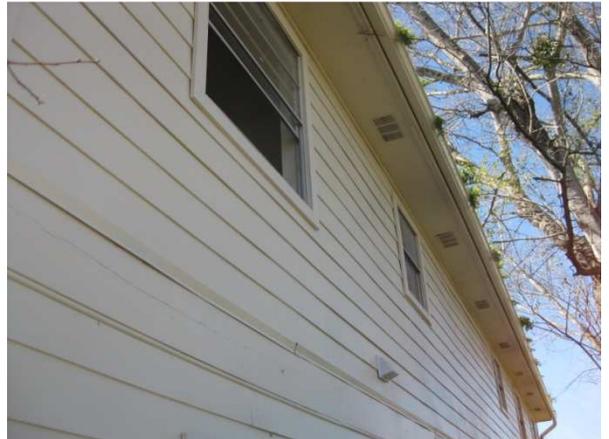
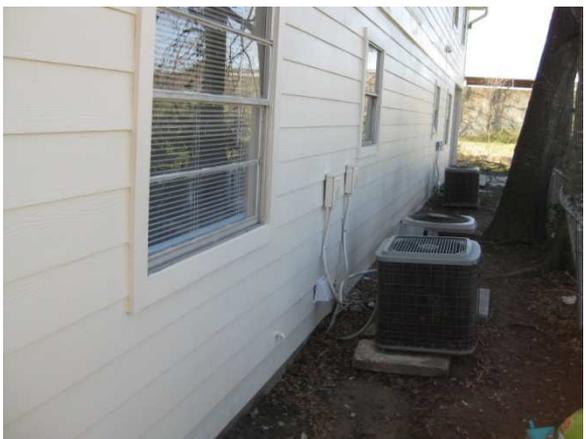
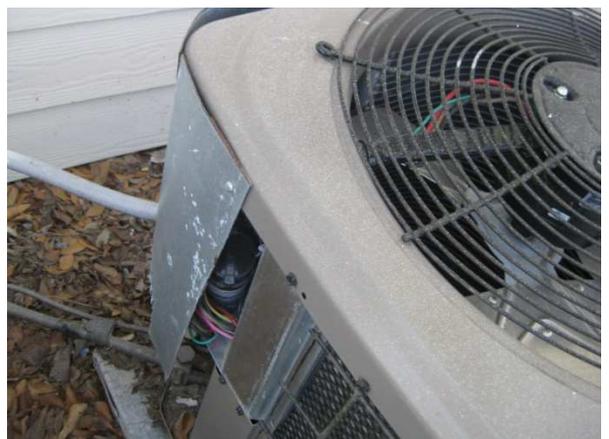
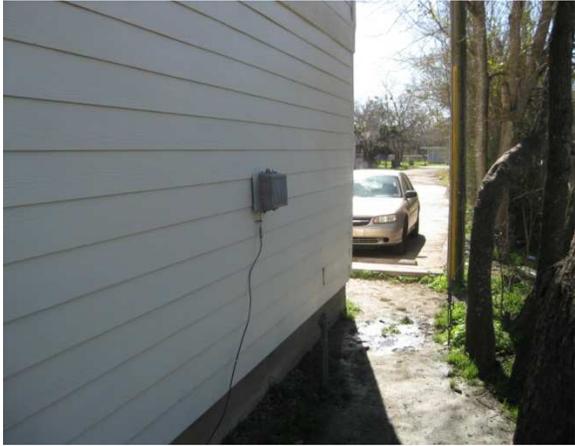
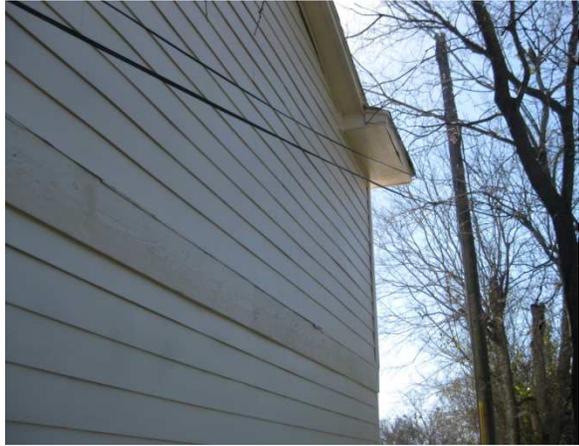
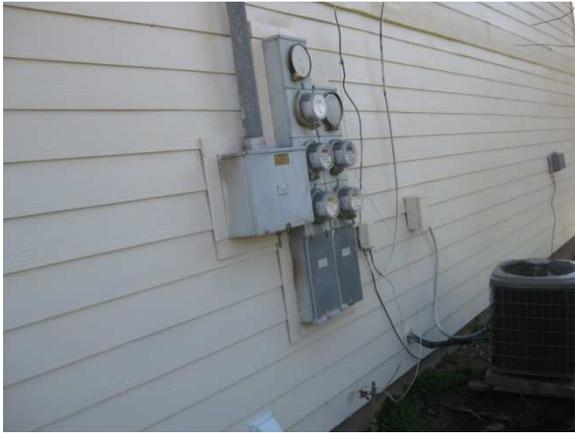
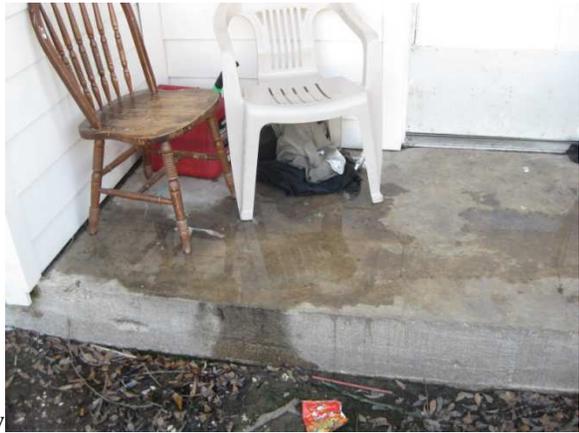
NEW PICTURES 2/13/13

APARTMENT STRUCTURE (5 UNITS):

- Demolition and removal of front buildings.**(COMPLETED, INSPECTED, AND CLOSED)**
- Install electrical disconnects w/ seal tight ends for all A/C power supply lines.
(COMPLETED AND READY FOR INSPECTION)

- Inspect/Install if needed where applicable, the correct size wire and breakers need for A/C service. **(COMPLETED AND READY FOR INSPECTION)**
- Install flow switches, programmable thermostats, and re-plumb condensate drain lines with CPVC pipe for all units.**(COMPLETED AND READY FOR INSPECTION)**

- Install A/C pad for condenser unit.**(COMPLETED AND READY FOR INSPECTION)**
- Replace/Install (2) A/C condenser disconnects with whips and seal tight fittings.**(COMPLETED AND READY FOR INSPECTION)**

- Repair/Install new lap siding and trim for entire exterior.**(COMPLETED AND READY FOR INSPECTION)**
- Repair/Replace balcony OSB decking w/ concrete decking.**(COMPLETED AND READY FOR INSPECTION)**

- Repair/Replace stair/balcony wood railing with wrought iron railing.**(COMPLETED AND READY FOR INSPECTION)**
- Replacement/Install of new secured mail boxes.**(COMPLETED AND READY FOR INSPECTION)**

- Caulking/Painting of total exterior building.**(COMPLETED AND READY FOR INSPECTION)**
- Replacement/Repair of (3) window panes with (1) complete window install. Windows on landings are required to have safety glass. Only window panes that are broken will be serviced.**(IN PROGRESS)**

- Replacement/Repair all exterior landing lights. Install "J" boxes and flood light in (2) exterior application.**(IN PROGRESS)**
- Replacement/Repair of all cracked or damaged plug socket, lights switches, covers, lights, and ext. for all units.**(IN PROGRESS)**

- Repair/Replace electrical panel/box in Unit "F".**(IN PROGRESS)**

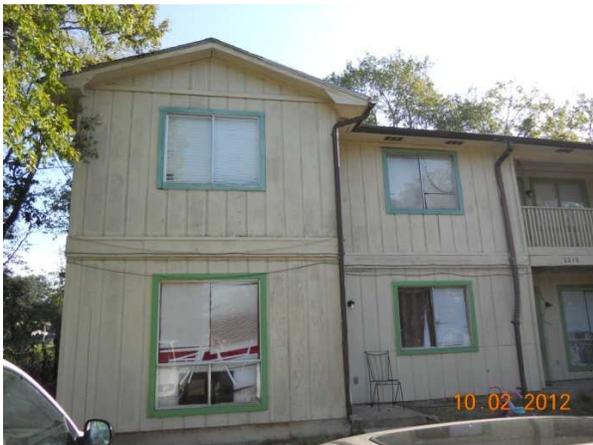
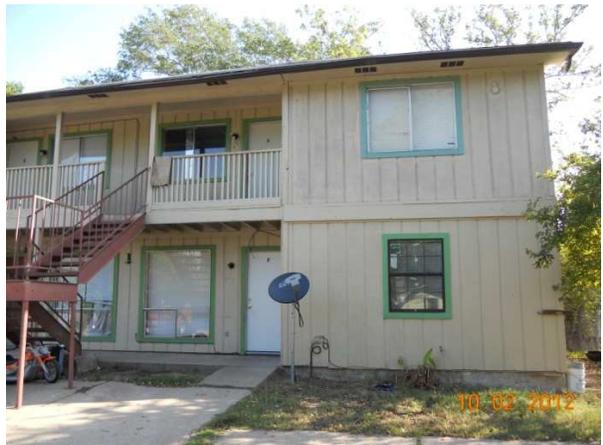
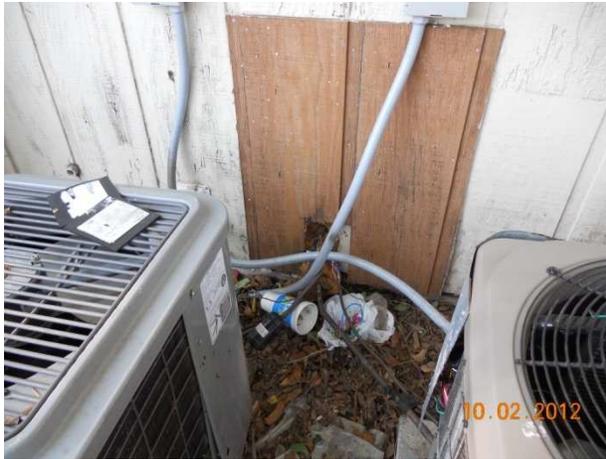
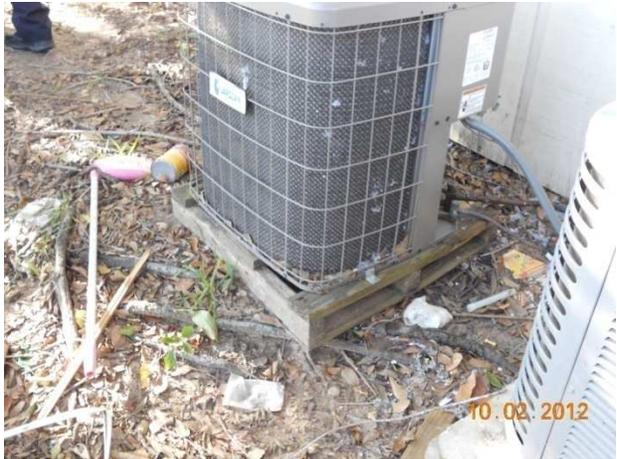
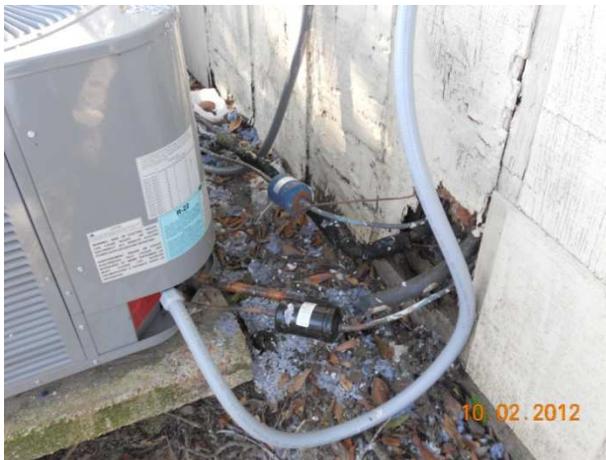
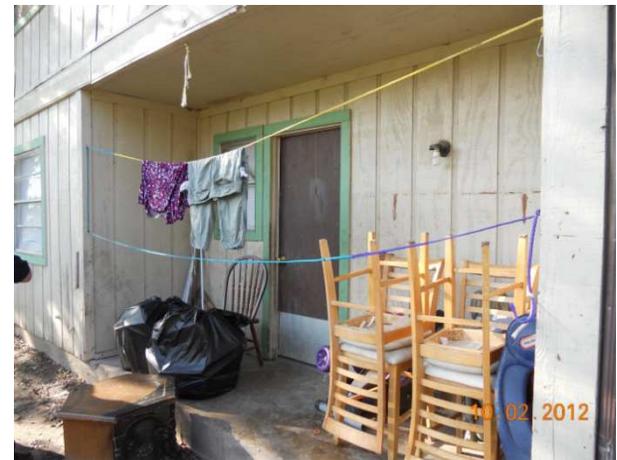
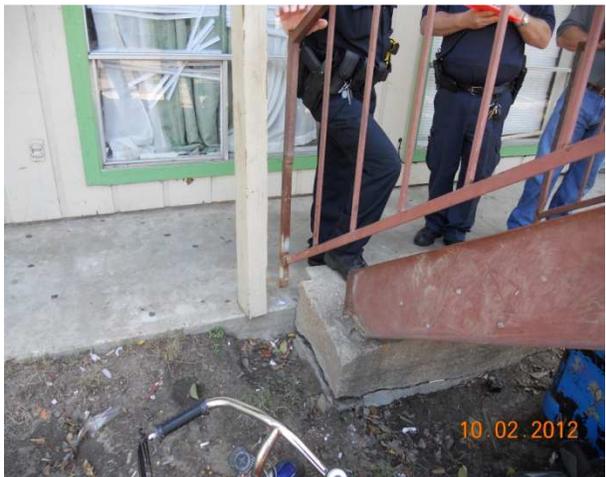
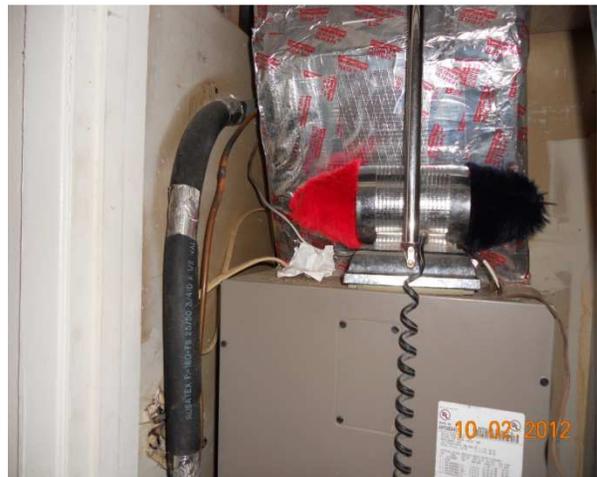
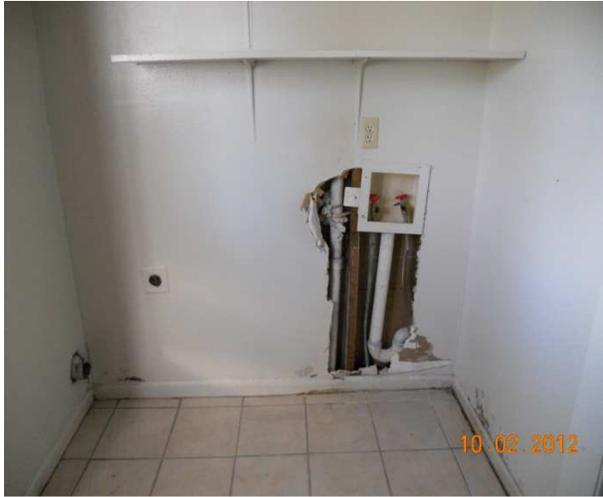
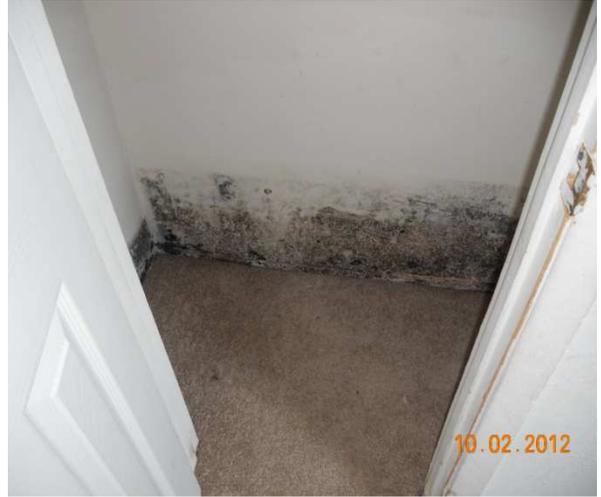
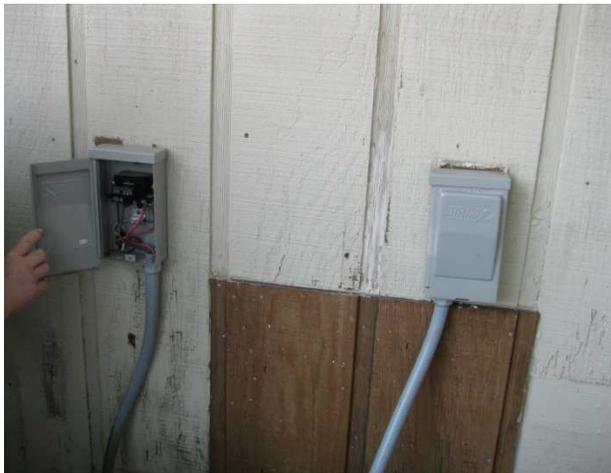
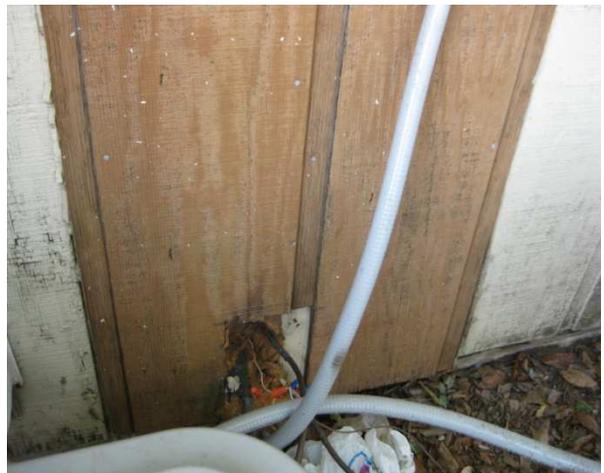
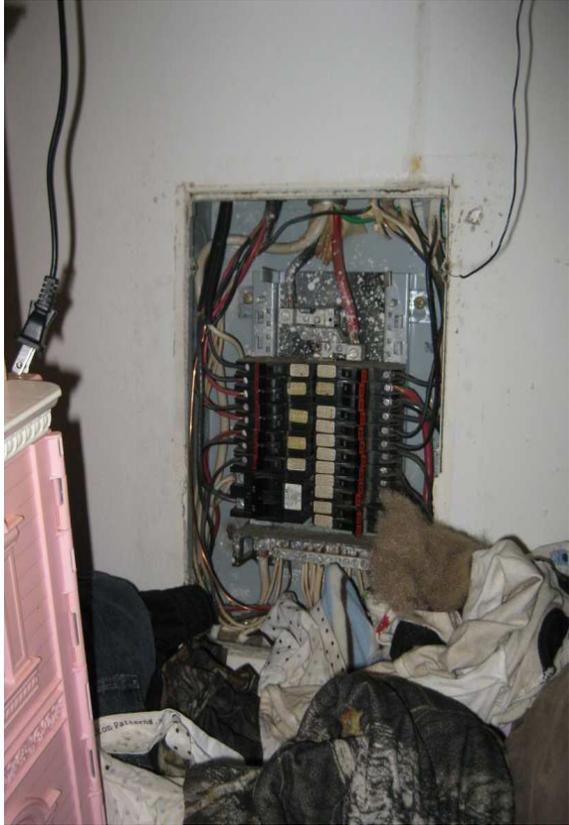
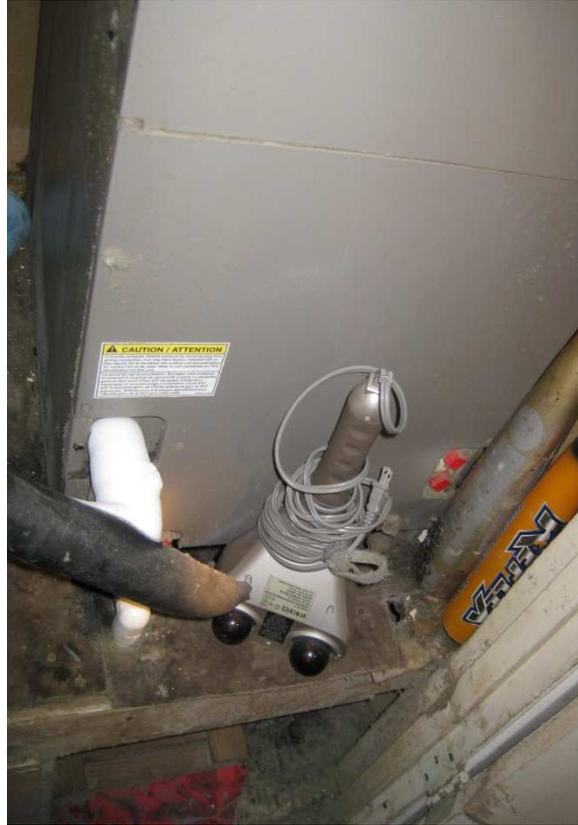
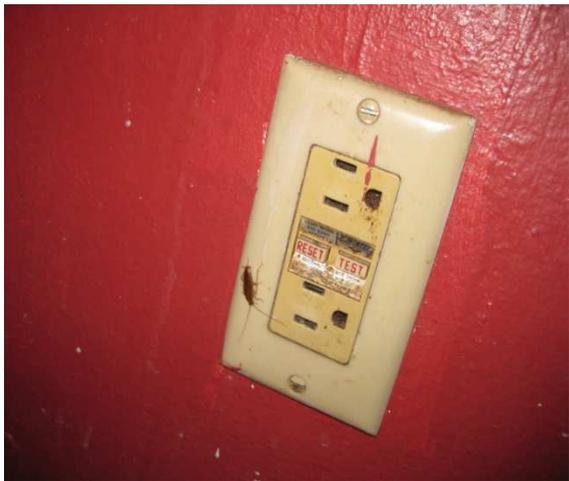
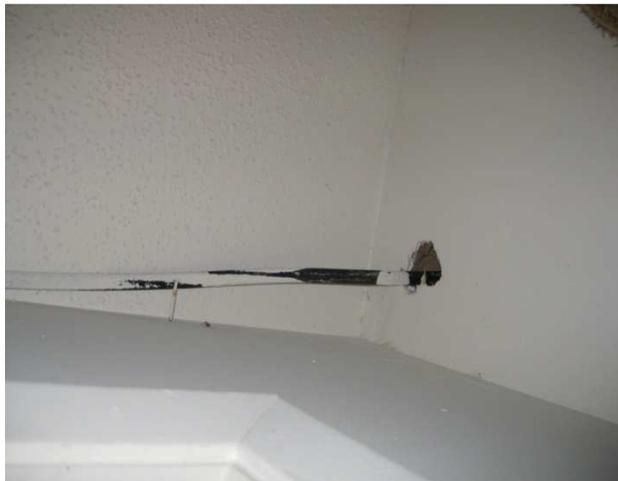
PICTURES TAKEN 10/2/12:

Exterior Conditions: Loose siding - holes in siding not sealed
Trash and debris on property
Newer HVAC unit
Loose dryer vent covers
Windows with broken glass

All units: Gas furnaces changed out to electric without permits. Wiring added from electrical panel to heater is exposed in closet in places – holes punched in sheet rock and not sealed. Breakers added for electric heat appear to be oversized and not matching with wire size.

Missing electrical panel covers.

Dead fronts missing at exterior HVAC units at disconnects

One exterior HVAC unit installed with wood shipping crate under – sign of no permit obtained. Most seal tite cords are loose. Exposed wiring. Holes too large and not sealed where wiring and refrigerant lines enter wall – allowing damage to framing.

Missing screws at dead fronts on electrical panels.

Openings in guard rails do not meet current code.

Guardrails in poor condition, right side guard going up exterior stair is broke loose, other rusted areas

Second floor balcony patched with plywood overlay.

Exterior light fixtures with out covers.

Damaged / loose treads at exterior stairs.

Missing or damaged downspouts and gutters.

Tree branches and vegetation need to be trimmed away from electrical service

Parking lot in poor condition

Unit "C": Ceiling finish damage in living area from something leaking above in bath room.
Pest control needed, roach problem.
Missing panel cover at electrical panel in closet – exposed wires – fire hazard

Unit "G": Glass not installed in window sash correctly at living room window
Kitchen light switch partially blocked by upper cabinets
Soft floor in kitchen
Missing deadfront cover in electrical panel in bedroom closet

Unit "F": New window installed at front bedroom, no permits on record
Open wall in washer/dryer closet
Garbage disposal with extension lamp cord for power

Unit "D": Missing porch light
Mold in back bedroom and bedroom closet
Tub surround is in poor condition – holes, etc.

<u>Deadline</u>	<u>Task</u>
7 days	provide proof of pest control measures for all units and apply for building permit for repairs to interior and exterior of the building per items below
30 days	<p>Electrician, plumber, and mechanical (HVAC) contractor to finish repairs and call for final inspections:</p> <ul style="list-style-type: none"> • HVAC units previously replaced without permits – make sure all electrical and mechanical work complies with current codes and make repairs to make safe and bring into code compliance. • remove or conceal exposed wiring in closets • re-install all panel covers • install dead front covers at exterior mechanical unit disconnects • install exterior mechanical units on code approved pads (i.e., not on wood shipping crate) • install all missing screws at exterior electrical panels • secure the HVAC unit seal tite cords and replace damaged cords. • install new or repair existing exterior lights • verify/install correct sized wiring and breakers for electric heaters. • insulate refrigerant lines at exterior units per energy code and install locking refrigerant caps per current code. • clean all A/C coils in each unit. • install correct cord and plug for disposal in unit F. • repair water heaters in attic and bring into current code compliance. • HVAC disconnects need to be accessible – remove old gas furnace vents not in use, re attach disconnects closer to door of closet.

- **Have electrician go thru each unit for electrical clean up.**
- **Make sure all panels at exterior and electrical panels in interior have covers and are labeled per NEC.**

Call for final building inspections of interior of all units:

- **repair all damaged sheetrock areas in each unit.**
- **repair ceiling finishes in unit C – check for plumbing leaks**
- **install new glass per code at window in unit G**

- **repair soft sub-floor in kitchen of unit G**
- **clean mold from back bedroom and closet in unit D**
- **repair or replace tub surround in unit D**
- **repair open wall in unit F**

- **secure all second floor guardrails securely; add additional intermediate vertical railings or balustrades at porch guard rail to close openings so that a 4” sphere will not pass through**

- **remove all trash and debris from site**
- **close off openings at floor at ceiling at HVAC unit closets and around duct work with sheetrock.**
- **Install smoke detectors in each bedroom and areas outside bedrooms per new state law.**

- **Make sure new windows and glass at windows near stairs have safety glass per code.**
- **Provide fire extinguishers for the complex and units as directed by the Fire Department.**
