**BUILDING AND STANDARDS COMMISSION
STAFF REPORT**

June 23, 2014

Case #1988 – 2000 Kazmeier Plaza

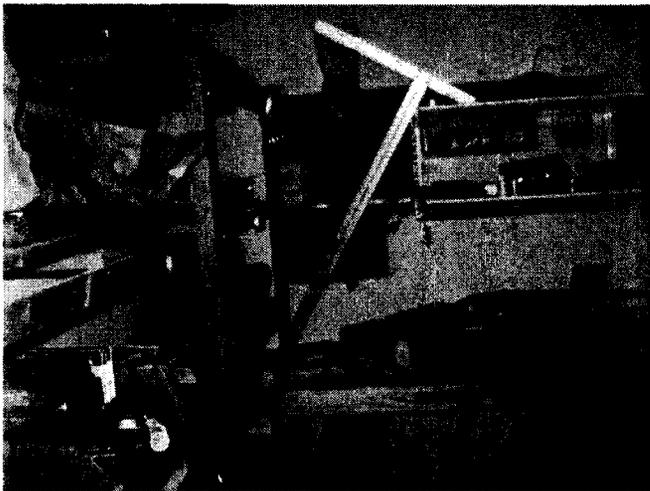
Storage Room

- Hole in wall under wall a/c unit

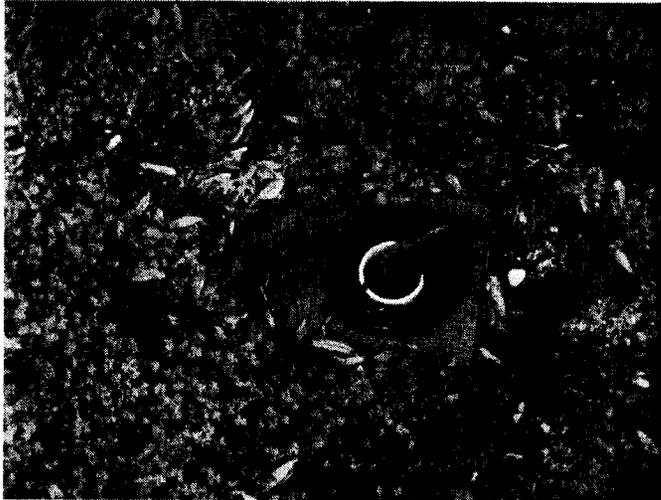
- Wall a/c unit is missing cover and appears in bad condition
- Water heater vent is touching sheetrock
- Dryer vents are touching sheetrock
- Area drain missing grates by swimming pool equipment and other areas on property – need grates to prevent debris, leaves, etc. from entering storm drains

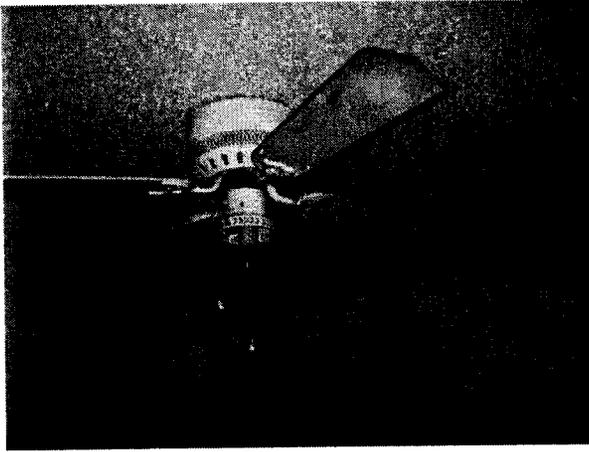
- Fence around patio is loose – needs to be secured so it does not fall over or removed.
- Water spots on bath room ceiling (unit #2 above has signs of roof leaks)
- Ceiling fan missing light bulb cover - needs to be replaced/reinstalled.

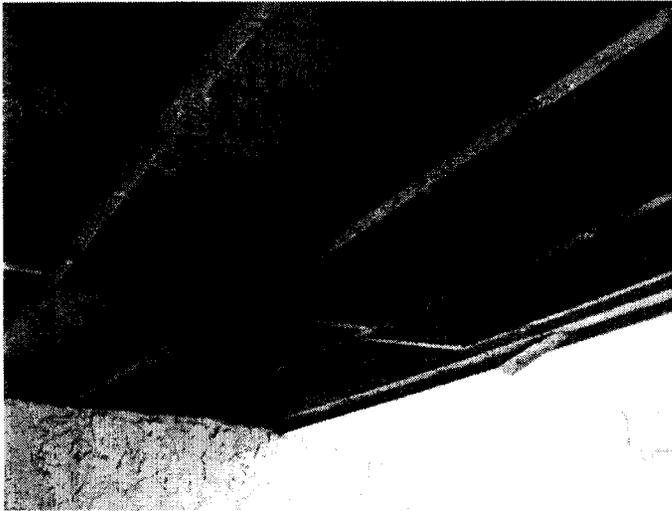
Unit #3:

- SD in bedroom needs replacing
- Needs unit # replaced on door
- No GFI in kitchen/bathroom
- Ceiling damage in bath room
- Cracked plug in dining room
- Joist damage and deflection at breezeway

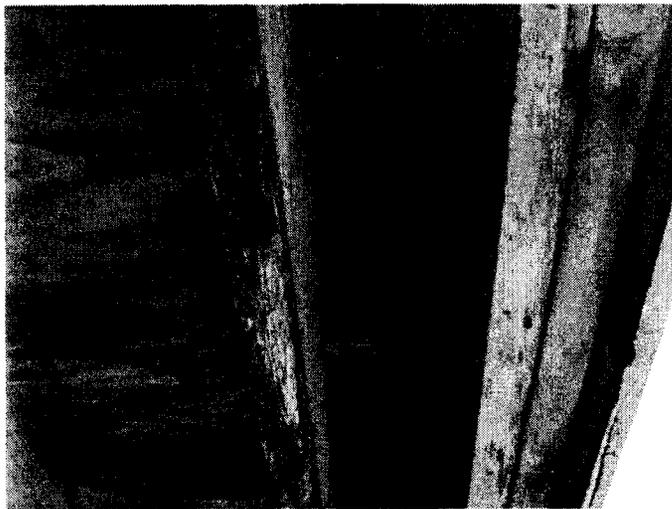
- Part of sub floor is rotten away at breezeway exposing concrete topping from above

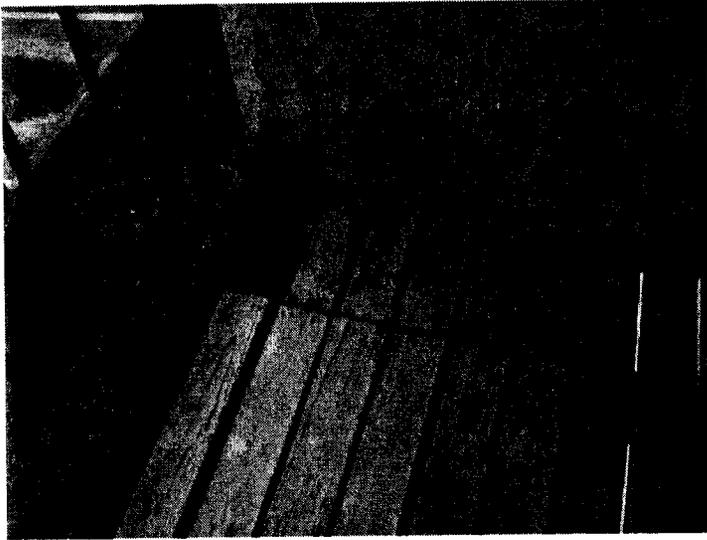
Unit #6: _____

- Rotten wood on balcony

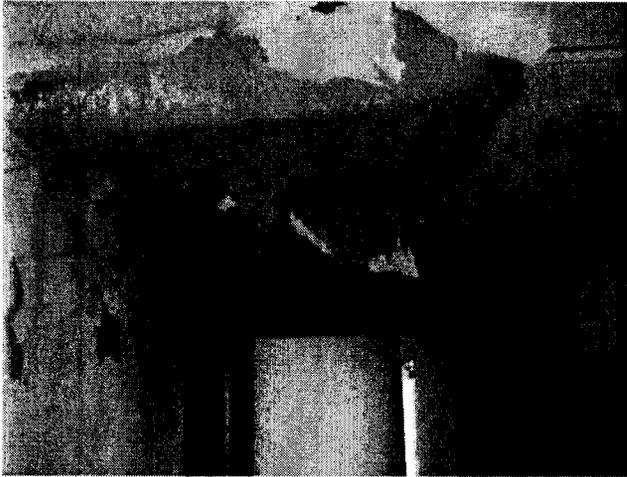
- Kitchen ceiling damaged
- Water heater missing cover
- Severe Ceiling damage from water heater leak

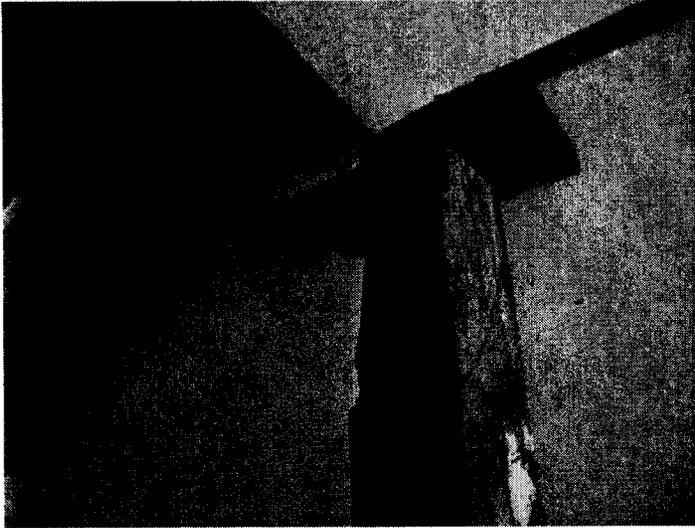
Unit #21

- Needs stucco repairs at exterior walls
- Questionable repairs to support columns in breezeway – need structural engineer’s report

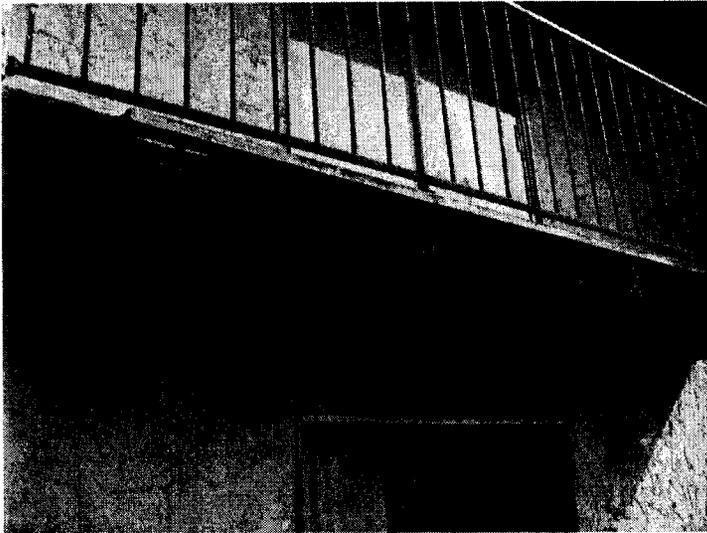
- Exterior balcony is missing out rim board – need structural engineer’s report

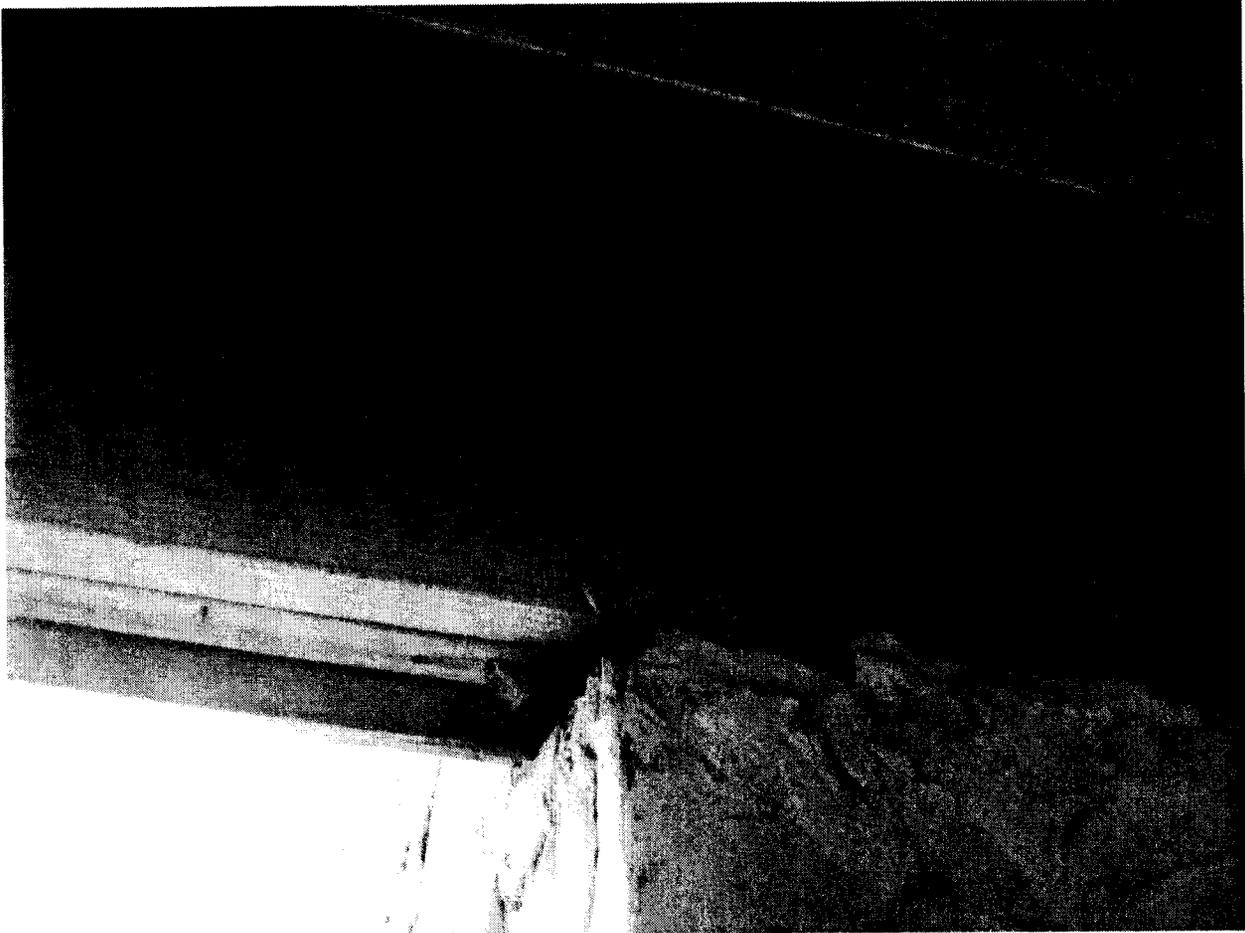
Unit 33:

- Questionable framing repairs at breezeway – need structural engineer's report
