BUILDING AND STANDARDS COMMISSION
STAFF REPORT

Case #1988 – 2000 Kazmeier Plaza ("Saddle Ridge Apartments")

Dangerous Structures Survey Report

Case # 1988

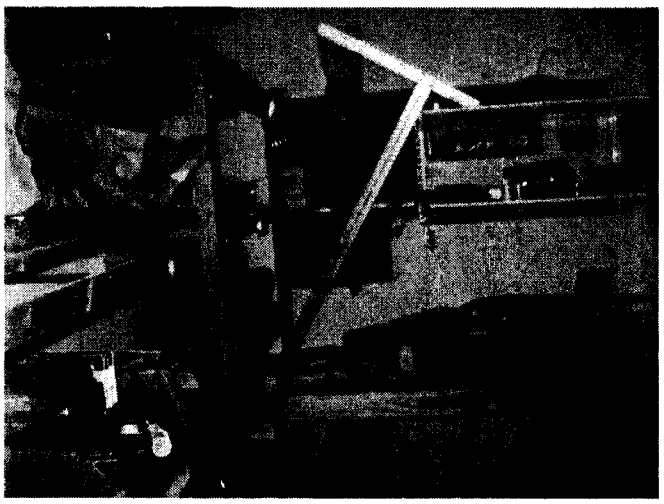
Storage Room

- Hole in wall under wall a/c unit

- Wall a/c unit is missing cover and appears in bad condition
- Water heater vent is touching sheetrock
- Dryer vents are touching sheetrock
- Area drain missing grates by swimming pool equipment and other areas on property – need grates to prevent debris, leaves, etc. from entering storm drains

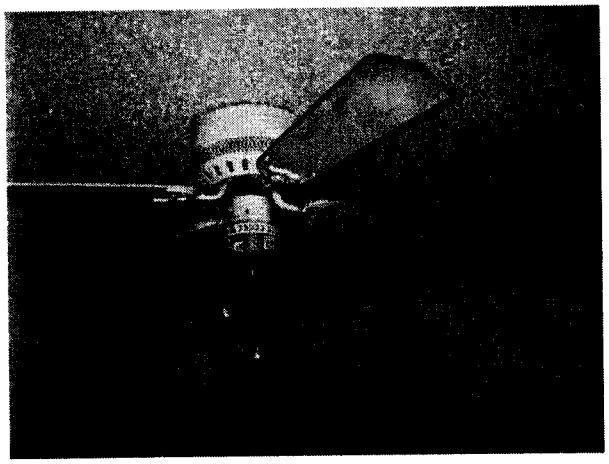
- Fence around patio is loose – needs to be secured so it does not fall over or removed.
- Water spots on bath room ceiling (unit #2 above has signs of roof leaks)
- Ceiling fan missing light bulb cover - needs to be replaced/reinstalled.

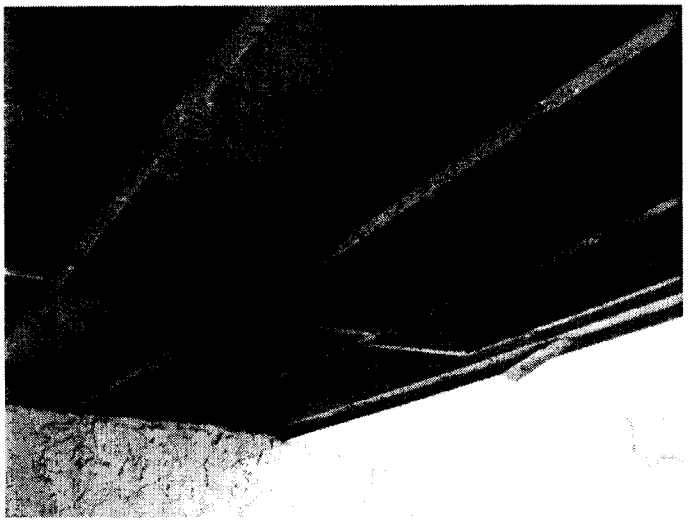
Unit #3:

- SD in bedroom needs replacing
- Needs unit # replaced on door
- No GFI in kitchen/bathroom
- Ceiling damage in bath room
- Cracked plug in dining room
- Joist damage and deflection at breezeway

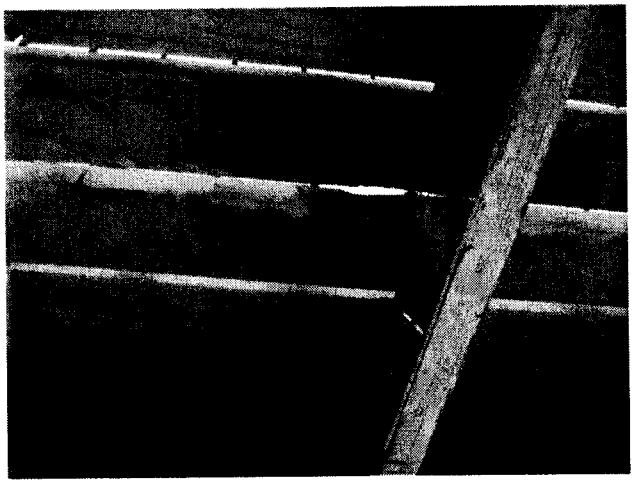
- Cover missing on HVAC unit
- No vent fan
- Missing parts of cabinets, sinks, etc.
- Fire damage at exterior balcony

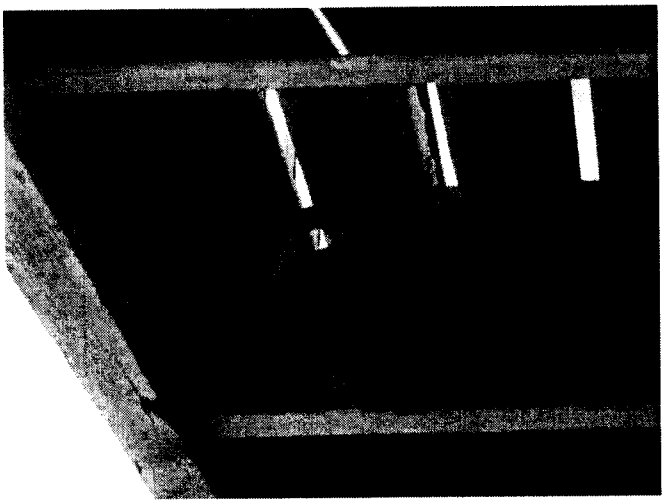
- Damaged joist at exterior balcony

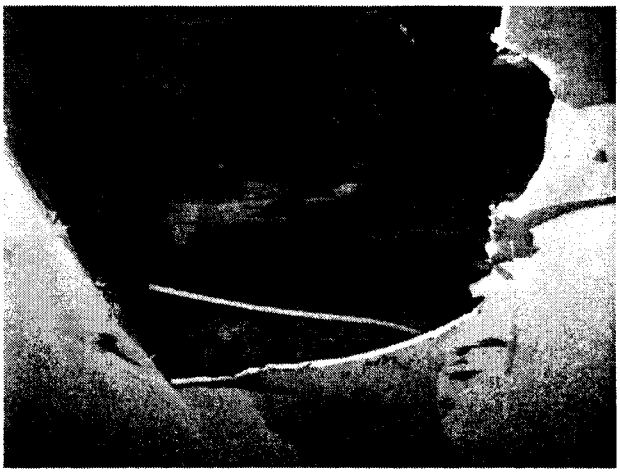
Unit 30: vacant requires building permit and asbestos survey

- No cover on plug under kitchen sink
- Mold damage under kitchen sink
- Broken plugs in bedroom
- Broken toilet
- Ceiling damage in bedroom

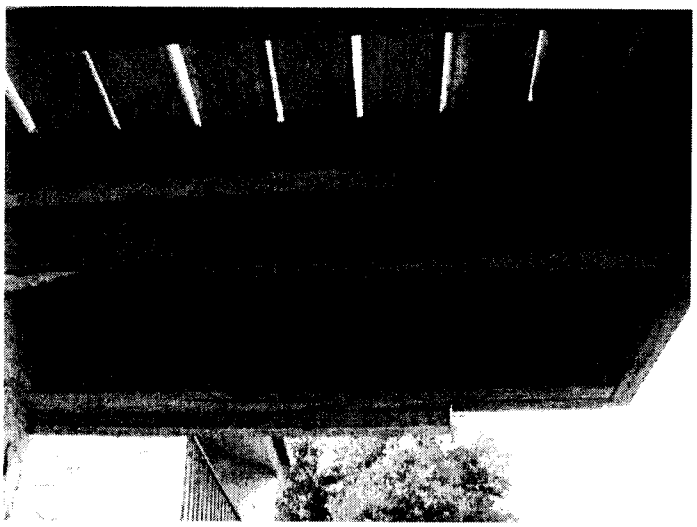
Unit 45:

- Water leak under kitchen sink
- Ceiling leaks in hallway, bedroom and bathroom areas
- Damage to joists at exterior balconies / rot
- Questionable repairs at exterior balconies – need structural engineer's report
