BUILDING AND STANDARDS COMMISSION
STAFF REPORT

July 27, 2015

CITY OF BRYAN

Case # 2078 – 609 East Martin Luther King Jr. Street

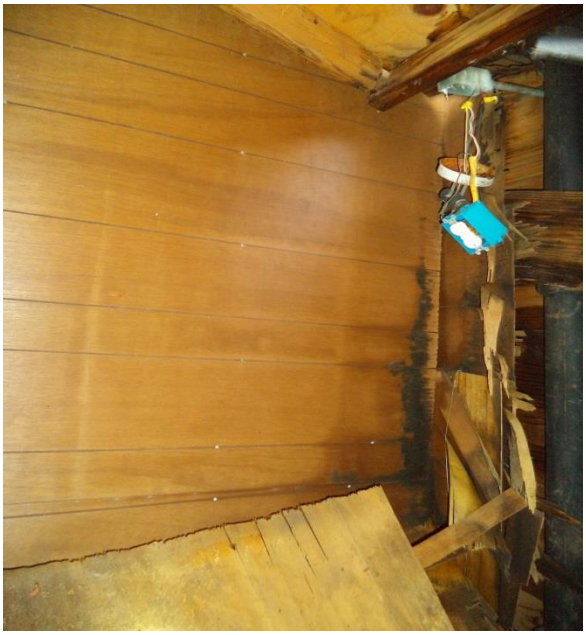
Siding damage, plumbing not to code, unsecured window

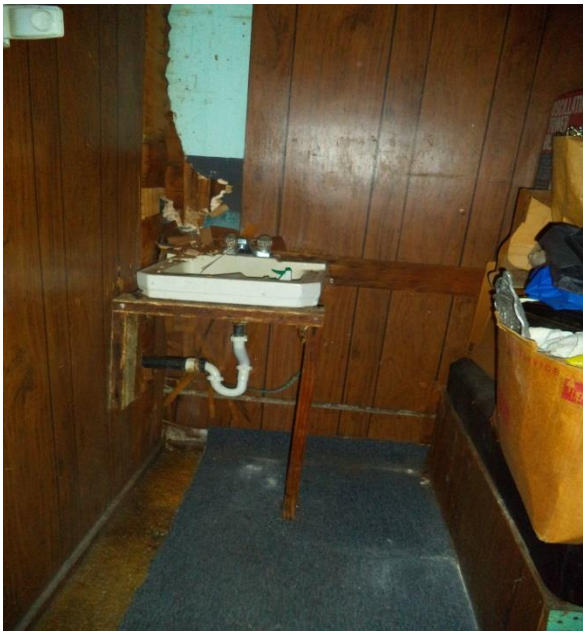
Damaged electrical, rotten walls, hole in roof

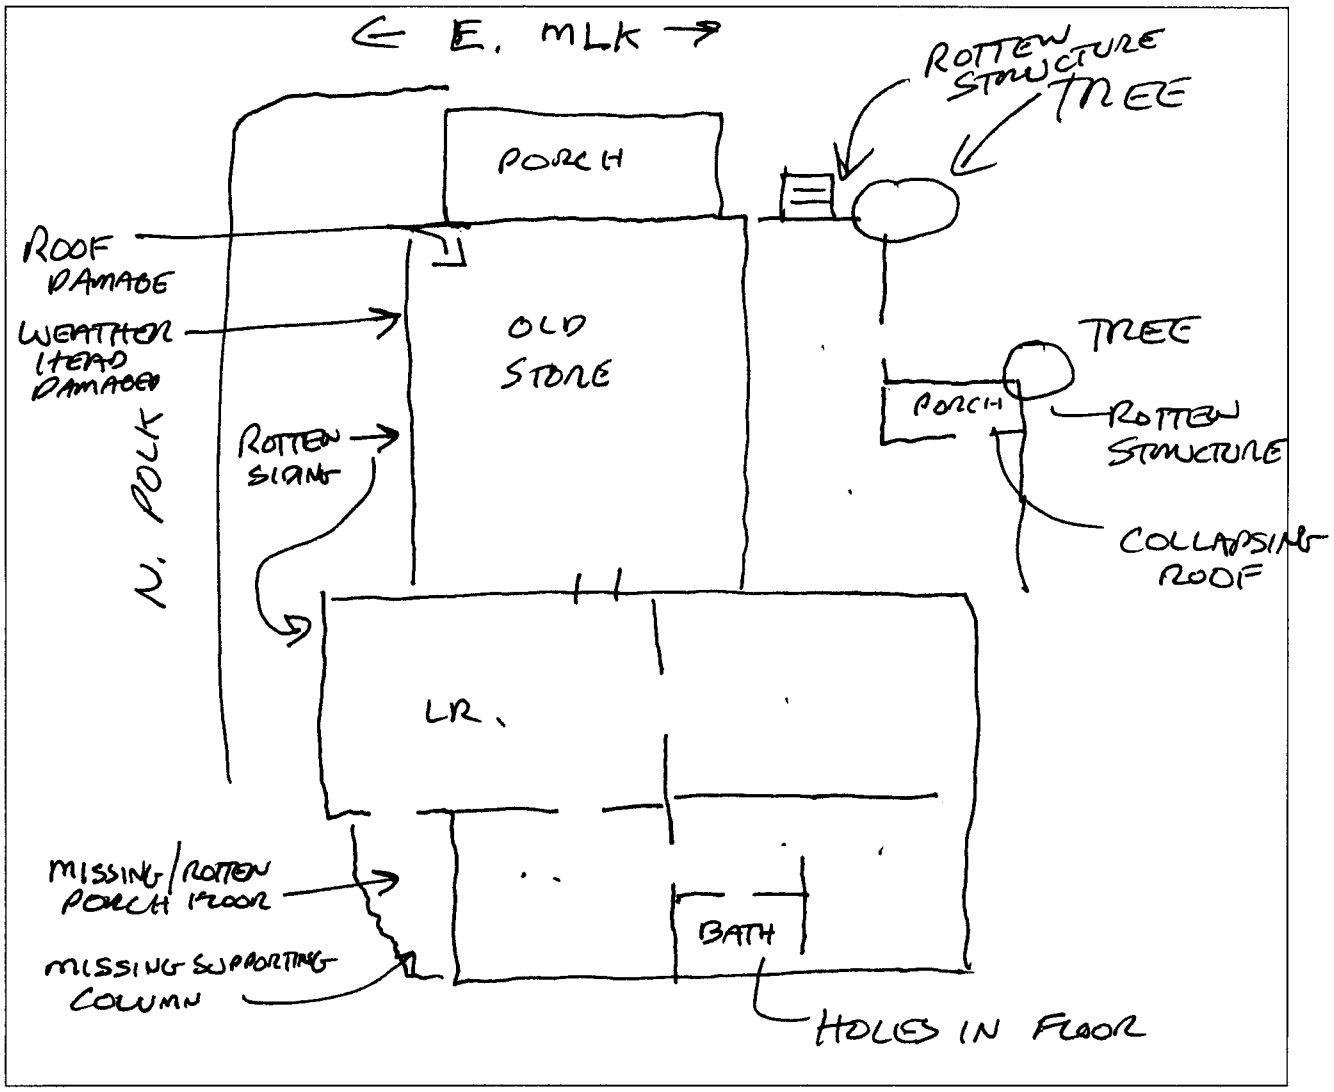
D. **FLOOR PLAN** (if necessary)

COMMENTS (1.) FRONT DOOR OF HOUSE UNSECURED (2.) ROTTEN SIDING (3.) HOLES IN FLOOR (AT BATH AND AT WATER HEATER (4.) MISSING FRONT PORCH COLUMN (5.) DAMAGED EXTERIOR WINDOWS (6.) DAMAGED PORCH FLOOR (7.) MISSING CRAWL SPACE SKIRTING (8.) OLDER TWO PRONG PLUGS (2 WIRE SYSTEM) (9.) ROTTEN BATH ROOM FLOOR (10.) TOILET NOT WORKING (11.) LOOSE ELECTRICAL FIXTURES (12.) DAMAGED INTERIOR FINISHES

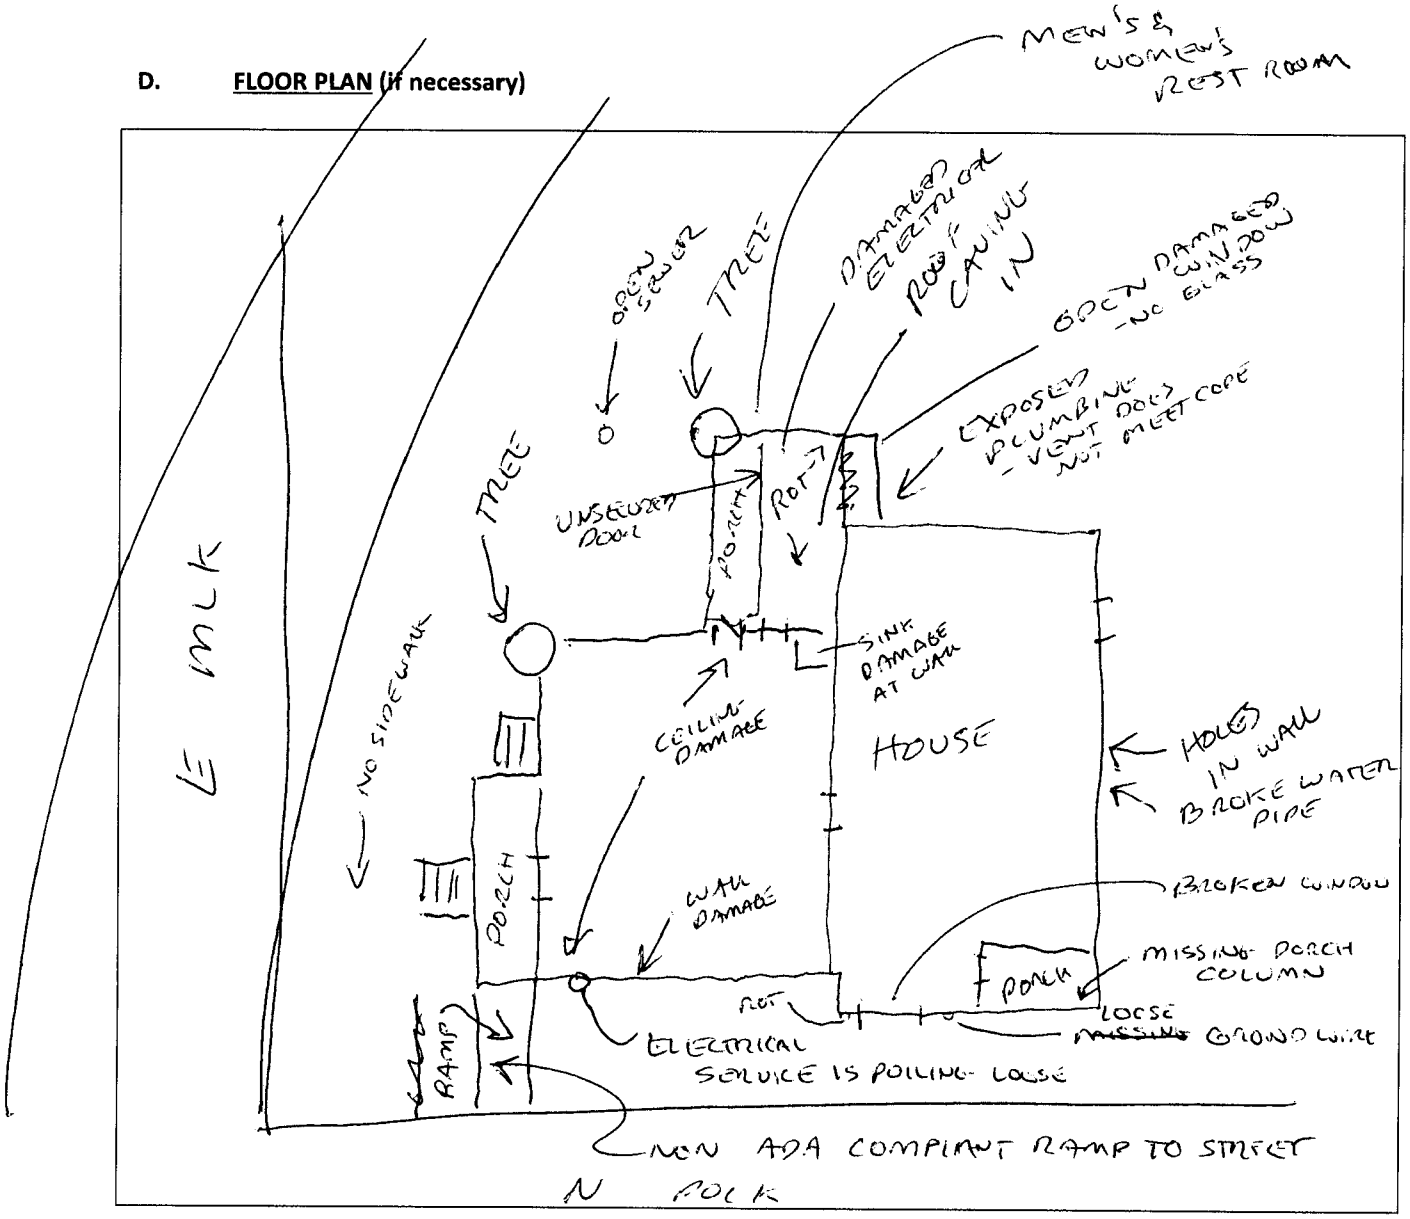
D. **FLOOR PLAN (if necessary)**

COMMENTS (1.) HOUSE UNSECURED (2.) WOMEN'S REST ROOM UNSECURED (3.) MEN'S RESTROOM UNSECURED (4.) DAMAGED ELECTRICAL IN REST ROOMS, OPEN WIRING, ETC. (5) REST ROOM PORTION IS COLLAPSING - ROTTEN WALLS, ROOF, FLOOR - HOLES IN FLOOR, WALLS & ROOF (6.) EVIDENCE OF ROOF LEAKS WITH INTERIOR FINISH DAMAGE, (7.) DAMAGE AROUND SINK TO WALLS & FLOOR (8) CEILING DAMAGE - EVIDENCE OF ROOF LEAKS (9.) RAMP AT FRONT PORCH DOES NOT MEET ADA AND SLOPES TO STREET (10.) SEVERAL TREES ARE GROWING TOO CLOSE TO STRUCTURE & HAVE CAUSED DAMAGE TO STRUCTURE, (11.) HOLES IN ROOF ABOVE REST ROOMS (12.) SIDING DAMAGE (13) OPEN SEWER YARD CLEAN OUT (14.) EXTERIOR DOOR LEADING TO DOOR OF MEN'S ROOM DOES NOT MEET CODE FOR LANDINGS (15.) SEVERAL EXTERIOR DOORS DO NOT MEET CODE FOR MEANS OF EGRESS
