Building name: Old Bryan Marketplace

202 South Bryan Avenue

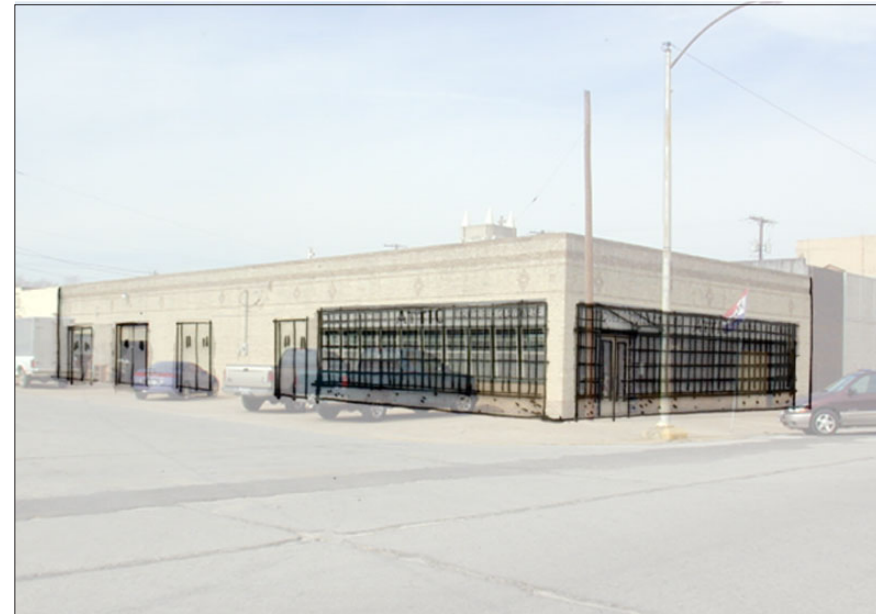
- No positive drainage away from the building
- Only one downspout on the south side drains this building
- Tar drippings on brick
- Biological staining
- Mortar deterioration, especially at parapet
- Cracking along mortar joints
- Brick at parapet are deteriorating
- Non-original storefront, doors, and windows
- Repointing with incompatible mortar high in portland cement
- Storefront has been infilled and enclosed in an incompatible manner

- Regrade site so that water flows away from the building.
- Evaluate drainage system to see if one downspout is adequately drains building. If not, additional downspouts and scuppers may be needed.
- Clean building in a manner that is not harmful to the mortar or masonry.
- Determine and remedy cause of mortar deterioration and cracking along mortar joints; repoint as necessary with mortar matching the original in composition, color and profile.
- Install parapet cap after brick is repointed.
- Remove incompatible mortar and repoint masonry with mortar matching the original in composition, color and profile.
- Reconstruct storefront in a style that is more compatible with the architecture.
- Ensure that entry is ADA compliant.

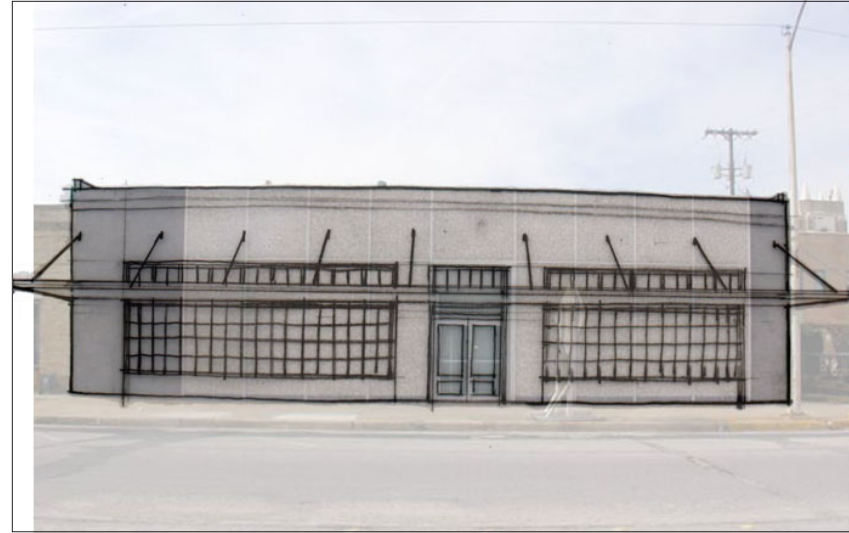
Proposed Improvements

- Pooling noted on north facade and poor drainage on west facade
- Steel casement windows in need of rehabilitation
- Minor biological staining
- Metal staining
- Paint deterioration along window sills
- Building in need of cleaning
- Areaway drain is clogged
- Non-original tile and aluminum slipcover on east facade

- Regrade site so that water drains away from the building.
- Update utilities while ensuring code compliance.
- Clean building in a manner that does not harm the masonry or mortar.
- If unpainted adjoining metal is staining the masonry, it should be primed and painted to prevent further damage.
- Ensure that entry is ADA compliant.
- Restore and repair windows.
- Remove non-original slipcover.
- Restore storefront and reconstruct canopy in a historically accurate manner.
