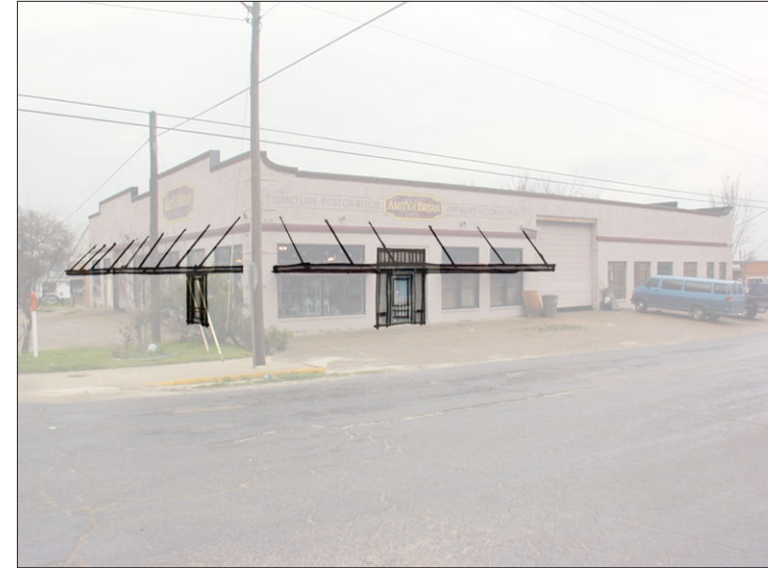
Proposed Improvements

*NOTE: The sketch image depicted in the **Proposed Improvements** photo is partially conjectural since historic photos of the building were not available. This sketch exhibits typical features and elements indicative of historic building types from period Main Street structures in Downtown Bryan.*

- Restore original storefront with original door and window design and reconstruct original canopy.
