Building name: Unknown

Building use: Storage

217 West 27th Street

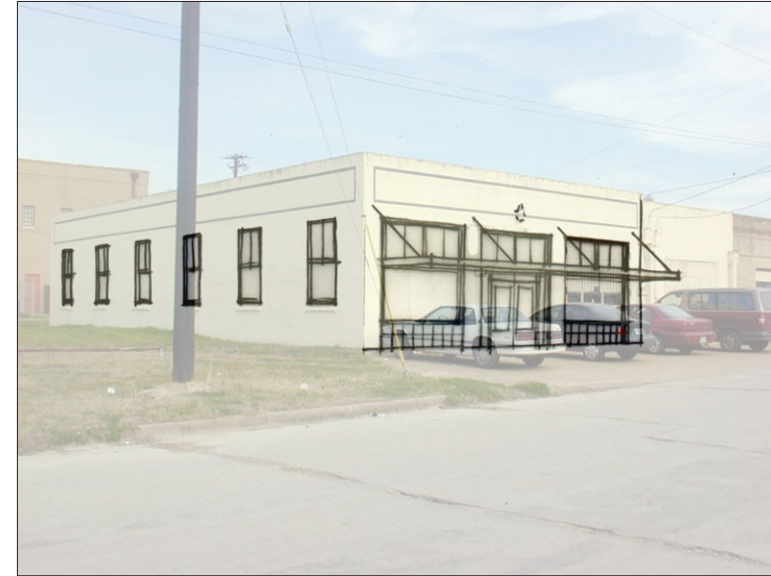
Proposed Improvements

*NOTE: The sketch image depicted in the **Proposed Improvements** photo is partially conjectural since historic photos of the building were not available. This sketch exhibits typical features and elements indicative of historic building types from period Main Street structures in Downtown Bryan.*

- Regrade site so that water flows away from the building.
- Construct downspout system so that water drains freely away from the building or into an underground drainage system and repair clogged drain.
- Update utilities while ensuring code compliance.
- Clean building in a manner that does not harm the masonry or mortar.
- Ensure that entry is ADA compliant.
- Patch holes and cracks in masonry with compatible masonry patching compound.
- Repaint stucco on building.
- Uncover windows and doors, and restore or replace with ones that are historically compatible.
- Restore storefront in a historically compatible manner.

Front Facade and Side: Repair stucco and repaint; remove coverings from windows on side of building; restore original storefront, transoms, and entry system per detail; install new wood canopy.
\$ 35,000.00
