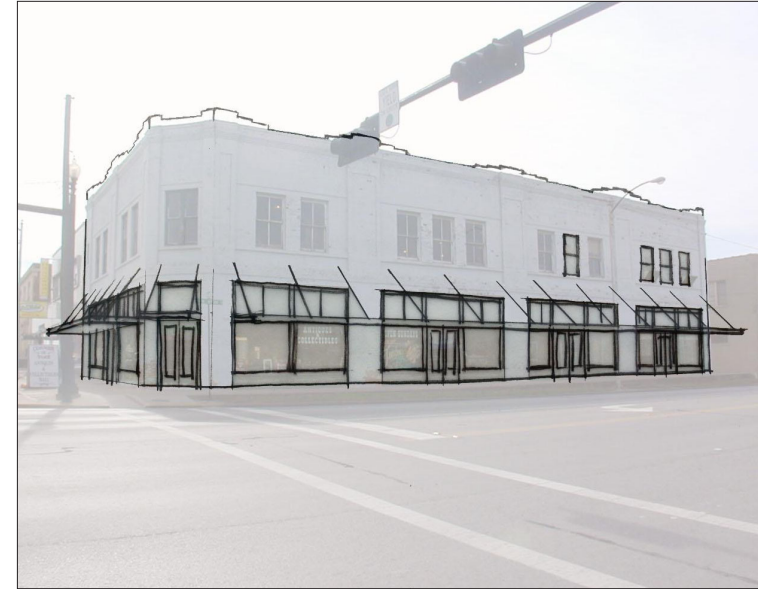
108 North Bryan Avenue

- Marginal positive drainage along west facade
- Gutter leaks and fair downspout termination
- Minor lintel corrosion
- Mortar deterioration, especially around base of west service door and parapet
- Cracking through masonry and mortar joints caused by metal jacking
- Spalling
- Biological staining
- Metal staining
- Unpainted adjoining metal
- Inadequate waterproofing of parapet on west facade
- Building in need of cleaning
- Incompatible repointing
- Holes in masonry
- Paint deterioration
- Paint coating trapping moisture
- Door handles are not ADA compliant

- Regrade site so that water flows away from the building.
- Repair drainage system so that water drains freely away from the building or into an underground drainage system.

- Update utilities while ensuring code compliance.
- Metal lintels should be replaced with new metal lintels.
- Determine cause of mortar deterioration and repoint as necessary with mortar matching the original in composition, color and profile. Areas that have been unsympathetically patched or pointed with Portland cement should be repointed with compatible mortar.

- Clean building in a manner that does not harm the masonry or mortar.
- Patch any holes in the masonry with a masonry patching compound.
- Paint any adjoining metal.

- Ensure that entry is ADA compliant.
- Remove paint from masonry in the most gentle means possible. If paint removal harms the brick, repaint the brick on a regular schedule to prevent paint deterioration.

- Restore and repair windows.
- Properly waterproof parapet wall with the aid of an experienced professional.
- Restore storefront and reconstruct canopy.

- Reconstruct parapet.

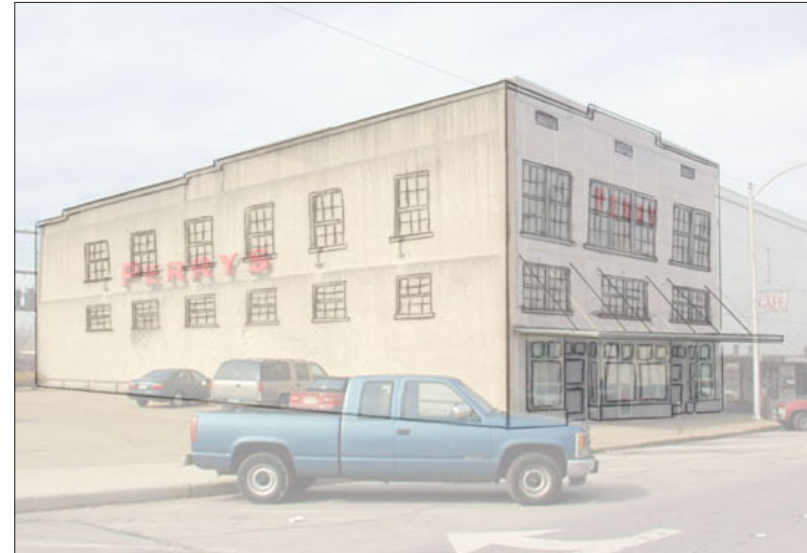
118 North Bryan Avenue

- Poor downspout termination
- Conduit attached to the building
- Cracking through masonry and mortar joints
- Spalling
- Biological staining and growth
- Metal staining
- Building in need of cleaning
- Holes in masonry
- Painted brick
- Paint deterioration
- Door handles are not ADA compliant

- Reconfigure downspout system so that water flows freely away from the building or into an underground drainage system.
- Update utilities while ensuring code compliance.
- Metal lintels should be replaced with new metal lintels.
- Repoint building as necessary with mortar matching the original in composition, color and profile.
- Clean building in a manner that does not harm the masonry or mortar.
- Patch any holes in the masonry with a masonry patching compound.
- Paint any adjoining metal.
- Ensure that entry is ADA compliant.
- Remove paint from masonry in the most gentle means possible as long as the removal process does not harm the brick.
- Restore and repair windows.
- Remove slipcover and restore front facade.
- Restore storefront, including transom windows, and reconstruct canopy in a historic manner.

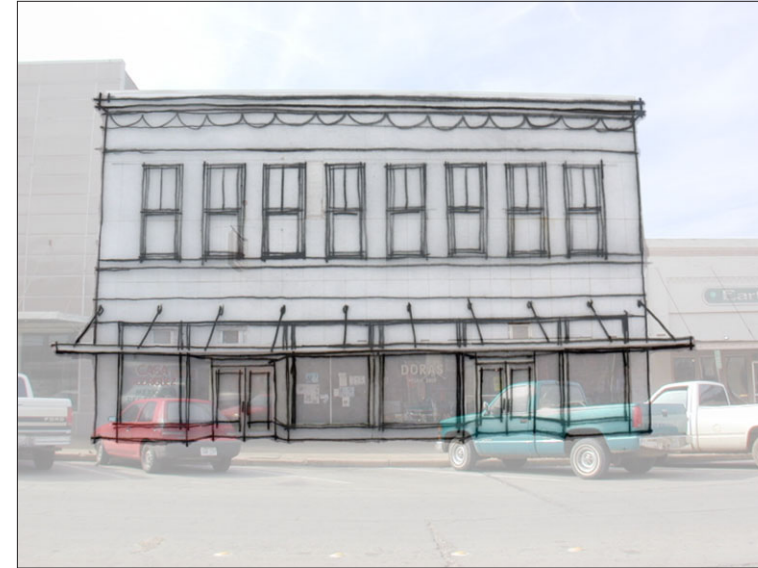
208 North Bryan Avenue

- Poor downspout termination
- Rusting downspout causing staining on wall
- Conduit attached to building
- Mortar deterioration
- Cracking through stucco
- Rust staining on slipcover
- Biological staining
- Building in need of cleaning

- Reconfigure downspout system so that water drains freely away from the building or into an underground drainage system.
- Update utilities while ensuring code compliance.
- If possible, remove stucco from west facade without harming the building. If not, determine cause of masonry deterioration and repair as necessary with stucco matching the original in composition and color.
- Repoint areas where mortar has deteriorated with a mortar matching the original in composition, color and profile.
- Clean building in a manner that does not harm the masonry or mortar.
- Ensure that entry is ADA compliant.
- Restore and repair windows.
- Remove slipcover and restore the front facade, including the storefront.
- Reconstruct canopy to reflect building's original historic design.

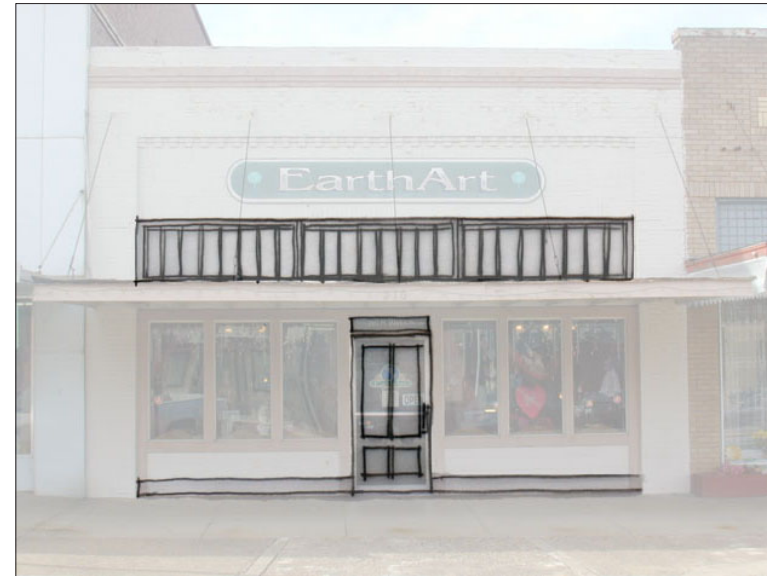
**212-214
North Bryan Avenue**

- Poor downspout termination
- Corrosion of west service door lintel, possible minor corrosion of storefront lintel
- Mortar deterioration, especially around base of west service door and parapet
- Minor cracking through masonry and mortar joints
- Spalling
- Biological staining
- Efflorescence under paint
- Building in need of cleaning
- Paint deterioration
- Paint coating trapping moisture
- Wooden canopy deteriorating

- Reconfigure downspout system so that water drains freely away from the building or into an underground drainage system.
- Update utilities while ensuring code compliance.

- Metal lintels should be replaced with new metal lintels, depending on the level of corrosion.
- Determine cause of mortar deterioration and repoint as necessary with mortar matching the original in composition, color and profile. Areas that have been unsympathetically patched or pointed with Portland cement should be repointed with compatible mortar.

- Clean building in a manner that does not harm the masonry or mortar.
- Determine cause of efflorescence and remedy accordingly.
- Ensure that entry is ADA compliant.

- Remove paint from masonry in the most gentle means possible.
- Restore and repair windows, including transom windows.
- Restore storefront along with period style door, and reconstruct canopy to reflect the original historic design.

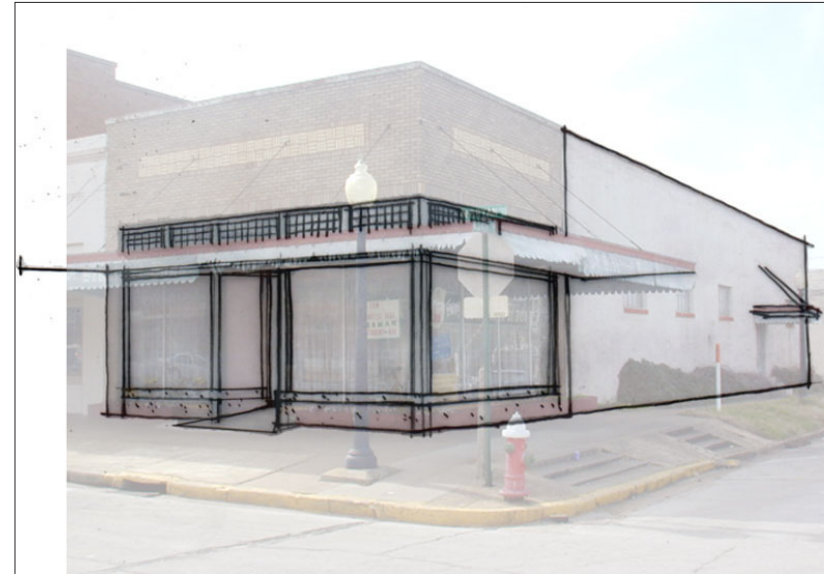
216 North Bryan Avenue

- Poor downspout termination
- Minor corrosion of storefront lintel
- Masonry deterioration
- Cracking through stucco
- Severe cracking and crazing of parapet stucco
- Metal staining
- Spalling
- Biological staining
- Building in need of cleaning
- Landscaping against building on north and west facades
- Paint deterioration

- Reconfigure downspout system so that water drains freely away from the building or into an underground drainage system.
- Update utilities while ensuring code compliance.
- Metal lintels should be replaced with new metal lintels, depending on the level of corrosion.
- Determine cause of masonry deterioration and repair as necessary with stucco matching the original in composition and color.
- Clean building in a manner that does not harm the masonry or mortar.
- Ensure that entry is ADA compliant.
- Restore and repair windows.
- Restore storefront and reconstruct canopy to reflect the original design.

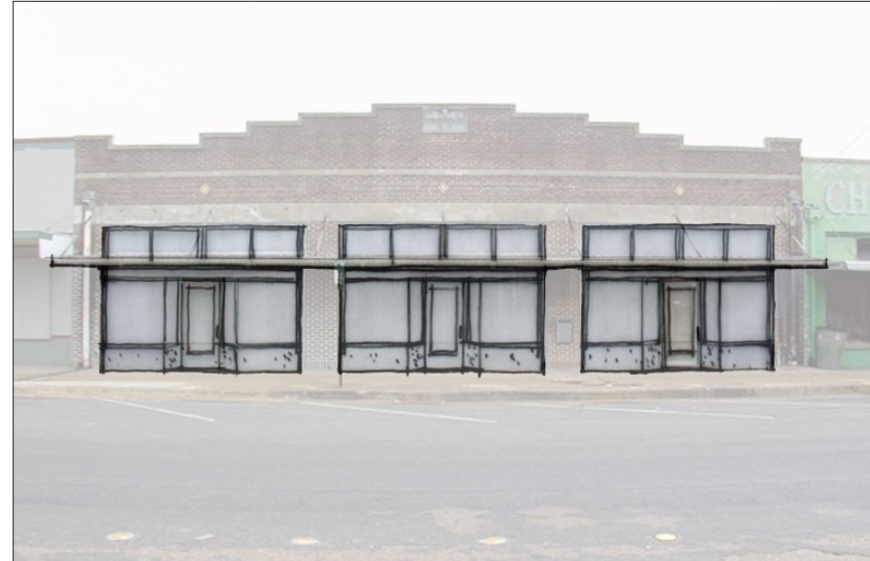
218 North Bryan Avenue

- Lack of positive drainage on west side and some areas are conducive to pooling
- Poor downspout termination causing bricks to erode at the base of the building
- Conduit attached to building
- Masonry and mortar deterioration
- Portions of wall covered in roofing mastic
- Corrosive spikes and pins in masonry
- Biological staining
- Spalling of brick
- Some brick have been painted
- Building in need of cleaning
- Unsympathetic repointing and patching; some holes in brick have been filled in with expanding insulation foam
- Door handles are not ADA compliant

- Regrade site so that water drains away from the building.
- Update utilities while ensuring code compliance.
- Determine cause of mortar and masonry deterioration and repoint as necessary with mortar matching the original in composition, color and profile. Areas that have been unsympathetically pointed with Portland cement should be repointed with compatible mortar.
- Remove corrosive spikes and pins from masonry and patch with masonry patching compound.
- Clean building in a manner that does not harm the masonry or mortar.
- Remove expanding insulation foam and patch brick with a masonry patching compound.
- If it is determined that paint or roofing mastic is harming the brick, remove the material in a manner that does not harm the brick.
- Ensure that entry is ADA compliant.
- Restore original storefront and transom design and reconstruct original canopy.

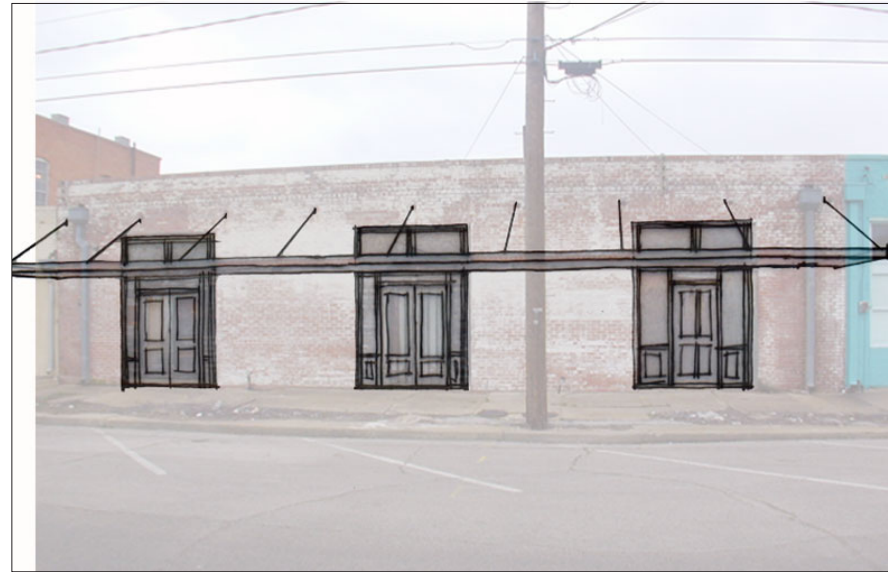
304 North Bryan Avenue

- Ponding and poor drainage conditions at west side
- Poor downspout termination
- Mortar deterioration
- Cracking along mortar joints
- Poorly configured utility service
- Biological staining
- Building in need of cleaning
- Transoms have been infilled
- Holes in masonry
- Exposed brick has been painted
- Door handles and approach do not comply with ADA regulations
- Corrosive spikes and/or pins embedded in masonry

- Regrade site and reconfigure downspouts so that they drain underground, either into the sewer system or at street level. Ensure that the downspouts are free of debris and drain freely away from the building.
- Determine and remedy cause of mortar deterioration and cracking along mortar joints; repoint as necessary with mortar matching the original in composition, color and profile.
- Update utilities while ensuring code compliance.
- Clean building in a manner that does not harm the masonry or mortar. Determine if paint is causing accelerated deterioration and if so, remove paint in the most gentle means possible.
- Remove corrosive spikes and pins and fill all holes in brick with masonry patching compound.
- Ensure that entry is ADA compliant.
- Restore original openings, including doors and transoms.
- Reconstruct canopy to reflect the historic nature of the building.

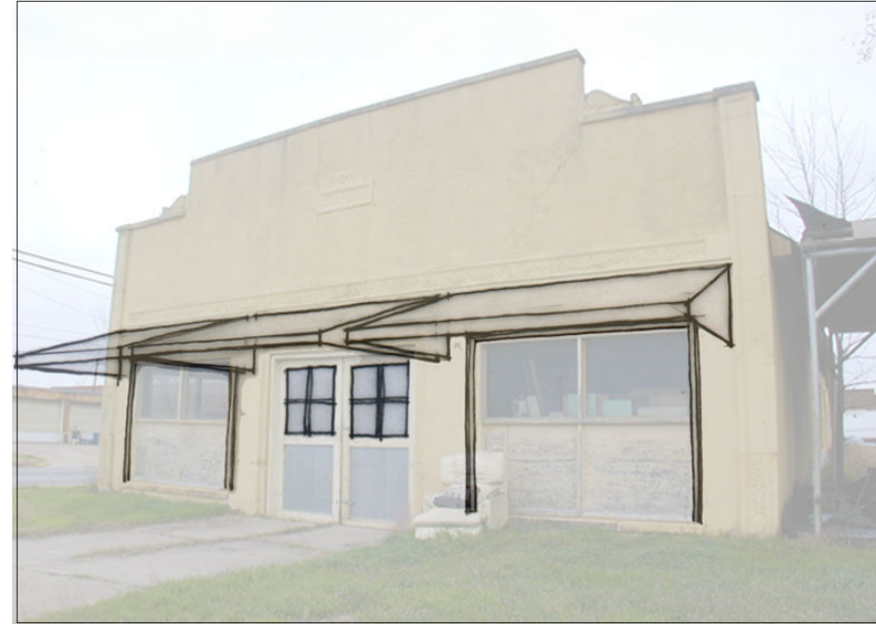
413 North Bryan Avenue

- Very poor drainage conditions causing deterioration and biological growth
- Building does not have any drainage system
- Old gutter located on south facade is falling off of building
- Trees and plants growing too close to the base of the building
- Facia board missing in several areas
- Masonry deterioration
- Cracking through masonry
- Biological staining and growth
- Building in need of cleaning
- Wood rot
- Metal jacking of lintels on east side, causing cracking through mortar.
- Unoriginal windows.
- Several windows and a door have been boarded over or infilled
- Holes in stucco

- Regrade site so that water drains freely away from the building.
- Provide drainage system so that water is not deposited at the base of the building.
- Update utilities while ensuring code compliance.
- Reconfigure electrical services and remove conduit from building's exterior.
- Repair or replaced rotted wood.
- Determine cause of stucco deterioration and repair as necessary with stucco matching the original in composition.
- Clean building in a manner that does not harm the stucco.
- Fill holes in stucco with patching compound.
- Ensure that entry is ADA compliant.
- Restore original window and door openings and transoms.
- Remove trees and brush near the base of the building.
- Replace corroded metal lintels and repoint mortar joints with mortar matching the original in composition, color and profile.
