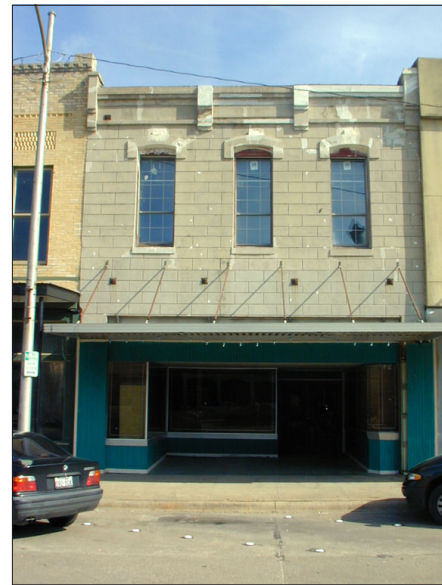
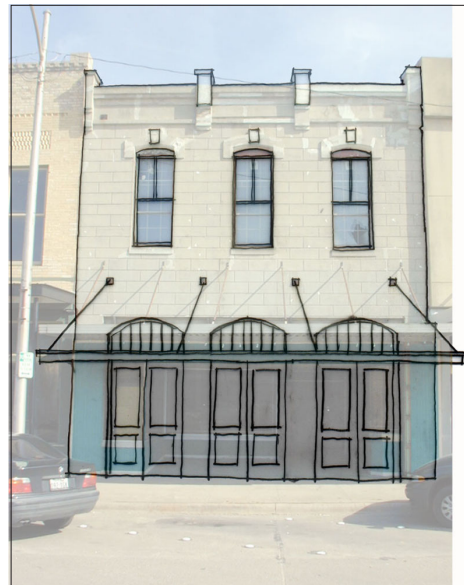
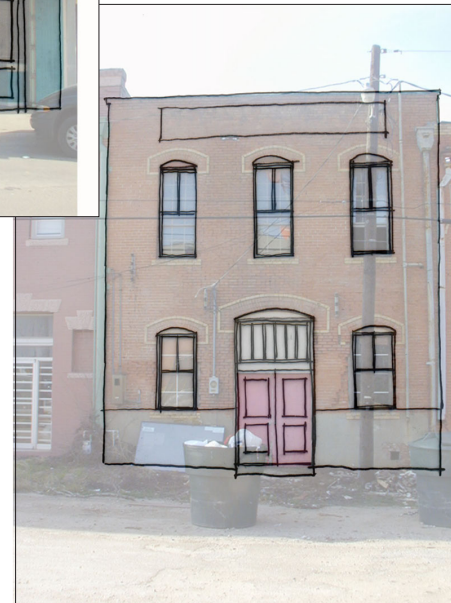
- Questionable drainage along east facade
- Poor downspout termination
- Scupper allowing water to drain down the side of the building
- Conduit attached to building
- Very poor service configuration
- Sever mortar and masonry deterioration on east facade
- Cracking through mortar joints
- Minor parge coat deterioration
- Biological staining
- Holes in masonry
- Cracking and patching of stucco surface
- Building in need of cleaning
- Displaced and missing brick

- Regrade site so that water drains away from the building.
- Reconstruct downspouts so that they are tied into an underground drainage system.
- Insure that two downspouts provide adequate drainage and if so, remove scupper and infill with brick matching the original.

- Update utilities while ensuring code compliance.
- Stop moisture infiltration that is causing mortar and masonry deterioration.
- Once moisture problem is controlled, reset displaced brick and replace missing brick with brick that matches the original.

- Repoint building using a mortar that matches the original in color, composition and tooling.
- Remove parge coat and replace damaged brick with new matching the original.

- Patch stucco facade in a compatible manor.
- Restore and repair existing historic window and door openings.
- Reconstruct storefront and canopy to match the original design.

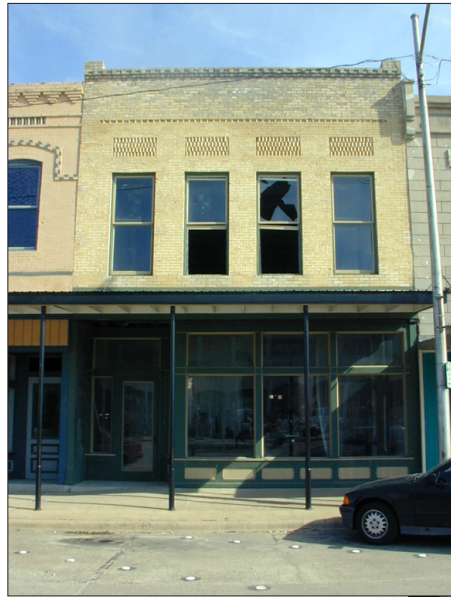
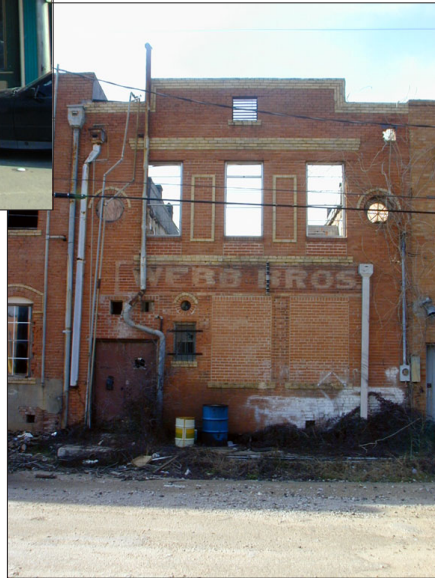
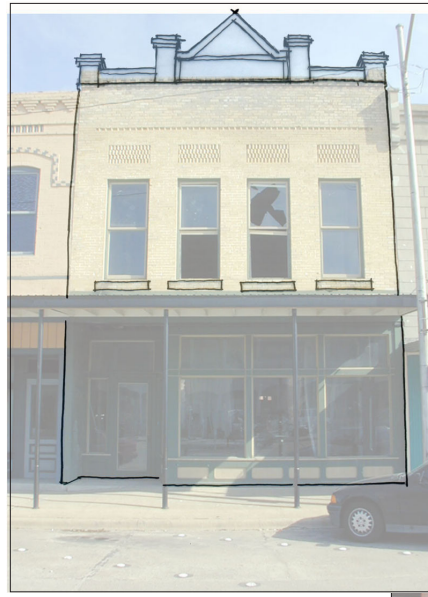
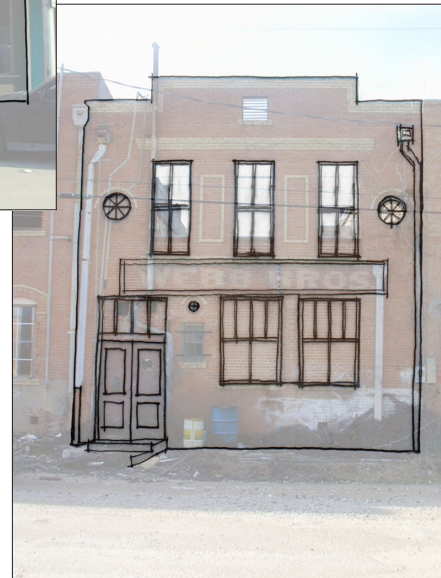
- Pooling water around base of building
- Lack of positive draining
- Back sidewalk overgrown not allowing the water to drain freely
- Poor downspout termination
- Masonry deterioration
- Spalling
- Mortar deterioration
- Biological staining
- Cracking along mortar joints
- Building in need of cleaning
- Holes in masonry where downspout was located
- Unsympathetic repointing
- Plant growth too close to the building

- Regrade site to ensure positive drainage away from the building.
- Ensure downspouts drain away from the building or tie them into underground drainage system.
- Update utilities while ensuring compliance.
- Remove plant growth next to the building.
- Repoint areas where mortar has deteriorated with mortar matching the original in composition, color and profile.
- Clean building in a manner that is not harmful to the brick or mortar.
- Reconstruct roof.
- Patch holes in masonry with compatible brick and mortar.
- Restore window and door openings in a historically accurate manner.
- Restore storefront, canopy and parapet in a historically accurate manner.
- Ensure entry is ADA compliant.
- Check for environmental concerns (oil pit).

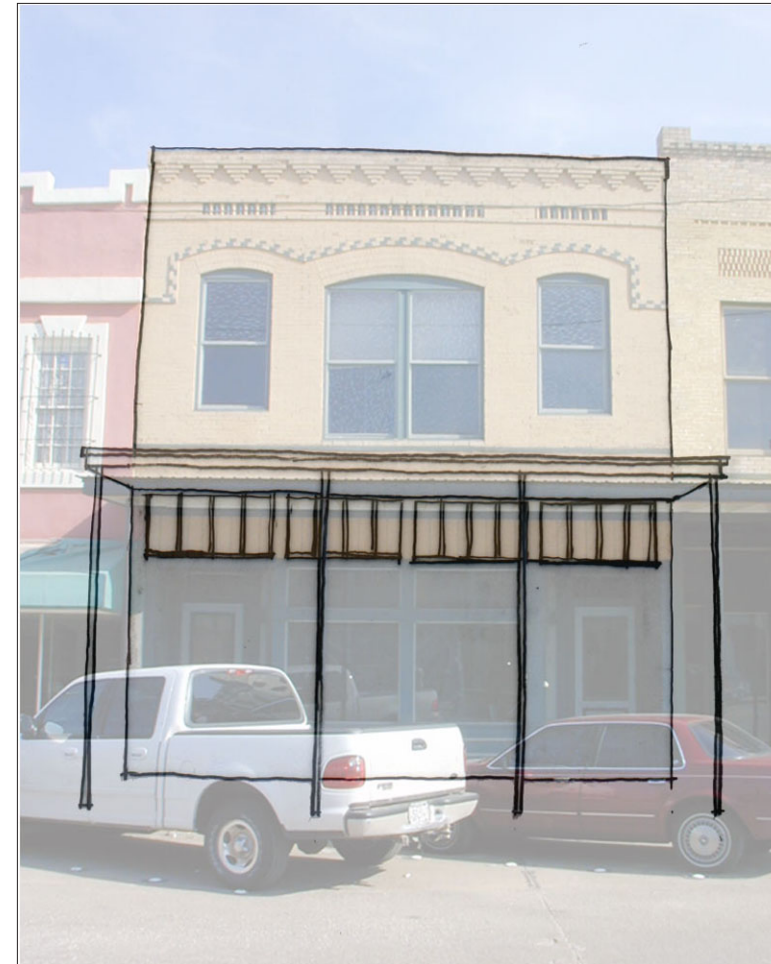
- Pooling water around base of building
- Lack of positive drainage
- Disjointed/disconnected downspouts
- Poor downspout termination
- Underground drainage needed
- Masonry deterioration
- Spalling
- Mortar deterioration
- Biological staining
- Building in need of cleaning
- Tar dripping on brick
- Paint deterioration

- Regrade site to ensure positive drainage away from the building.
- Ensure downspouts drain away from the building or tie them into underground drainage system.
- Restore downspouts.
- Update utilities while ensuring compliance.
- Repoint areas where mortar has deteriorated with mortar matching the original in composition, color and profile.
- Clean building in a manner that is not harmful to the brick or mortar.
- Restore window and door openings in a historically accurate manner.
- Restore storefront, canopy and parapet in a historically accurate manner.
- Ensure entry is ADA compliant.

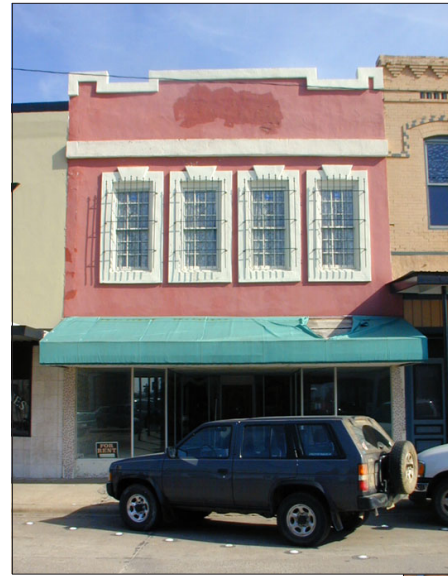
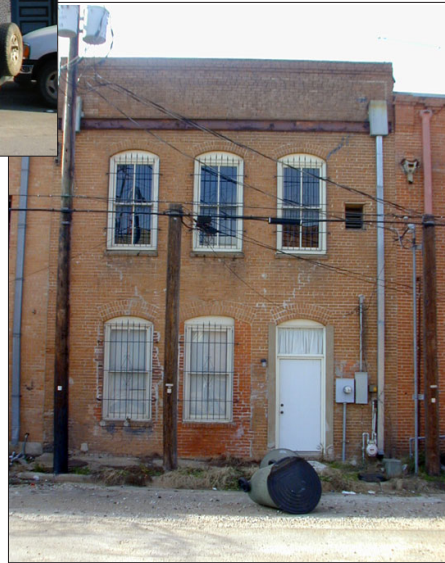
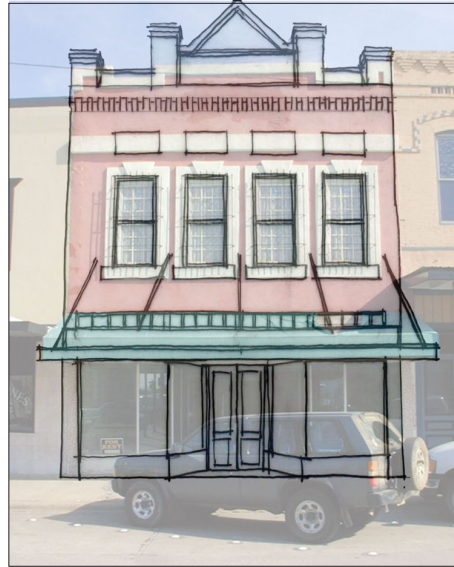
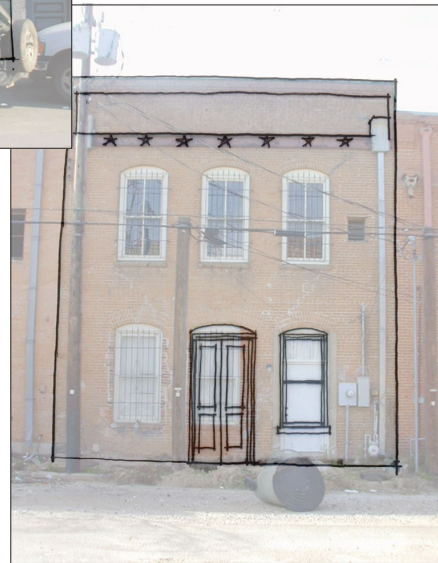
- Poor downspout termination
- Incompatible downspouts with overflow boxes
- Mortar deterioration
- Cracking through mortar joints
- Cracking through masonry
- Incompatible repointing
- Conduit attached to building
- Very poor service configuration
- Biological staining
- Building in need of cleaning
- Missing tile on modern storefront

- Replace downspouts with ones that are historically accurate and configure them so that they connect into an underground drainage system.
- Update utilities while ensuring code compliance.
- Repoint building using mortar that matches the original in color, composition and profile.
- Clean building in a manner that does not harm the masonry or mortar.
- Ensure that entries are ADA compliant.
- Restore and repair existing historic windows.
- Remove incompatible burglar bars from windows.
- Restore first floor opening on the east facade to their original configuration.
- Reconstruct west parapet.
- Reconstruct entry doors, windows and storefront on the west facade in a historically accurate manner.
- Reconstruct canopy to match the original.

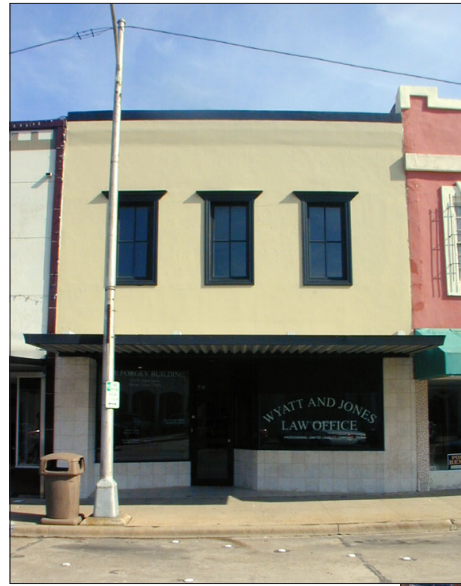
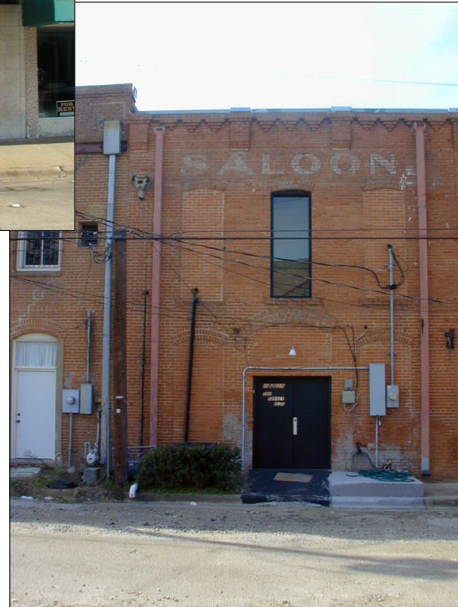
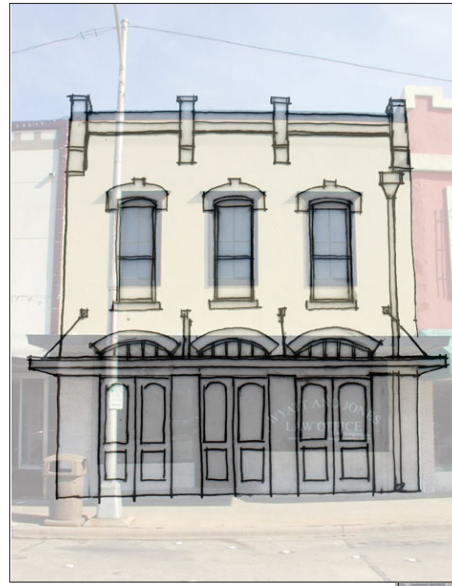
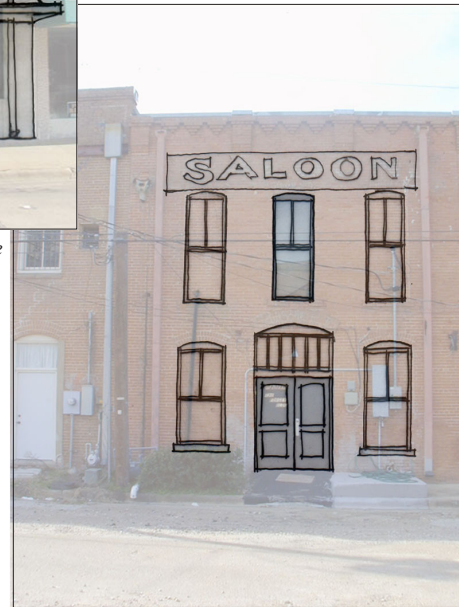
- Poor downspout termination on east facade allowing water to damage the brick
- Poor drainage conditions on east side
- Conduit attached to building
- Poor service configuration
- Biological staining
- Mortar deterioration
- Minor spalling

- Reconfigure downspout so that it is connected to an underground drainage system.
- Regrade site so that water drains freely away from the building.
- Update utilities while ensuring code compliance.
- Clean building in a manner that does not harm the masonry or mortar.
- Repoint areas where mortar has deteriorated with a mortar matching the original in color, composition and tooling.
- Restore original window and door openings in a historically compatible manner.
- Remove unsympathetic storefront and stucco slipcover and reconstruct or restore the main facade to match the original.
- Remove modern canopy and replace with one that is historically compatible.

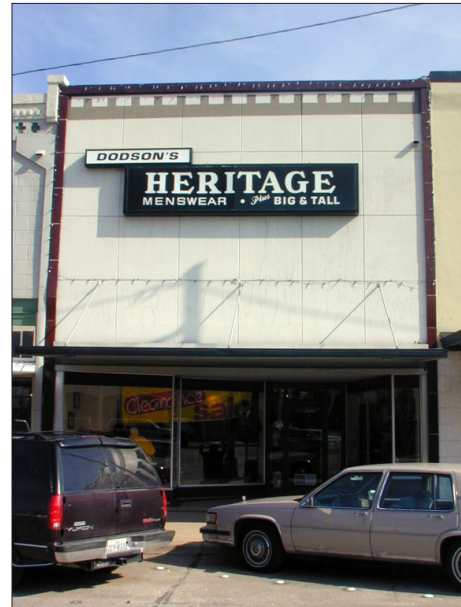
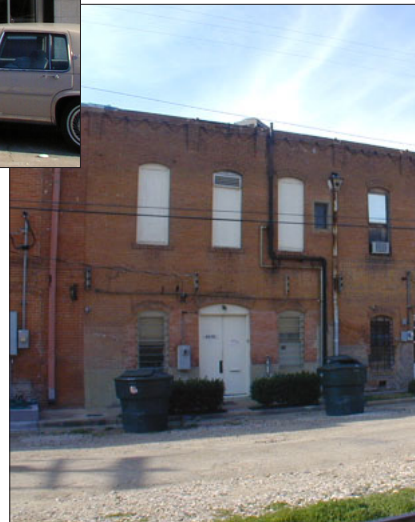
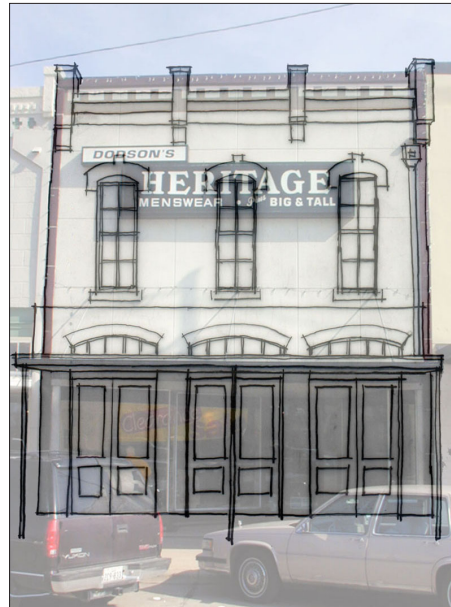
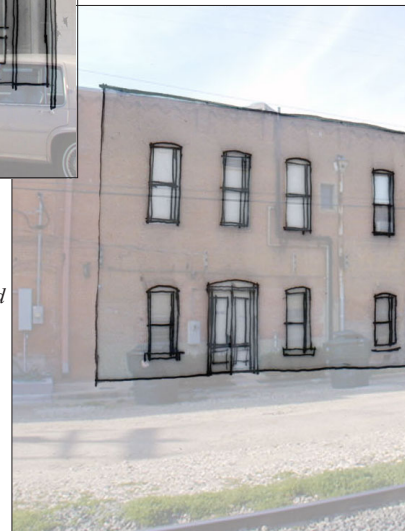
- Scuppers allow water to drain down side of building
- Poor downspout termination
- Underground drainage needed
- Masonry deterioration
- Spalling
- Severe mortar deterioration
- Biological staining
- Rust staining
- Cracking along mortar joints
- Building in need of cleaning
- Bitumous coating at parapet cap
- Cracks in stucco

- Ensure downspouts drain away from the building or tie them into underground drainage system.
- Ensure utilities are updated while ensuring compliance.
- Repoint areas where mortar has deteriorated with mortar matching the original in composition, color and profile.
- Clean building in a manner that is not harmful to the brick or mortar.
- Paint any metal in contact with the building.
- Remove bitumous coating from brick if possible without damaging the masonry.
- Restore window and door openings in a historically accurate manner.
- Remove stucco from storefront and restore storefront, canopy and parapet in a historically accurate manner.
- Remove parge coat.
- Ensure entry is ADA compliant.

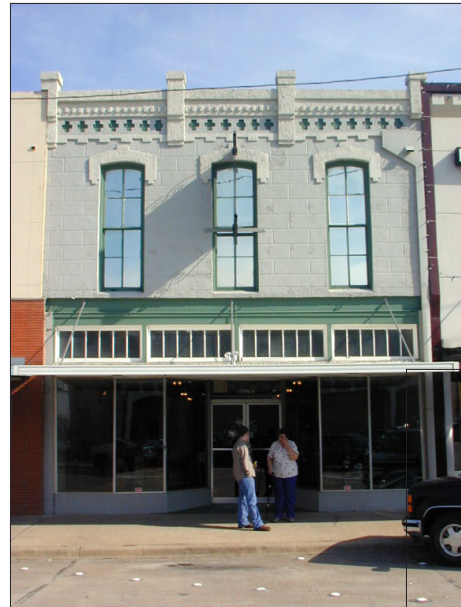
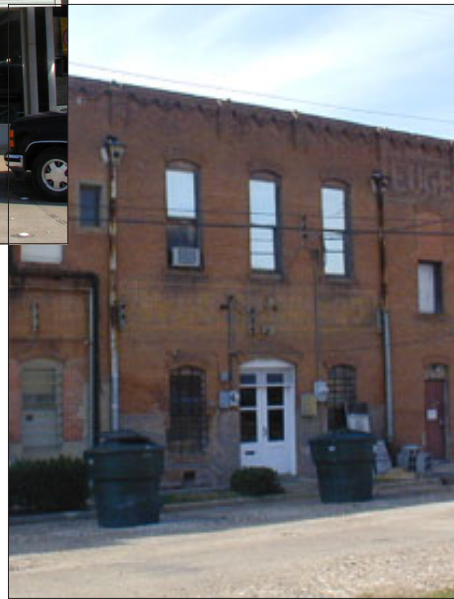
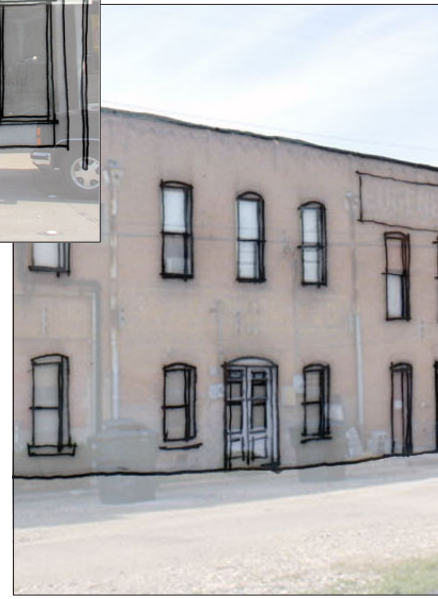
- Poor downspout termination on east facade allowing water to damage the brick
- Poor drainage conditions on east side
- Conduit attached to building
- Poor service configuration
- Biological staining
- Mortar deterioration
- Dislodged brick on east facade
- Deteriorated stucco parge coat
- Areas of the stucco have been painted

- Reconfigure downspout so that it is connected to an underground drainage system.
- Update utilities while ensuring code compliance.
- Clean building in a manner that does not harm the masonry or mortar.
- Repoint areas where mortar has deteriorated with a mortar matching the original in color, composition and tooling.
- Reset any dislodged brick using mortar as described above.
- Remove stucco parge coat only if the removal process does not harm the masonry.
- Remove paint from stucco in the most gentle means possible if the masonry is not harmed in the process.
- Restore original wood windows and door.
- Restore painted sign on the east facade.
- Reconstruct storefront, including entry doors, to match the original.
- Reconstruct canopy to match the original.

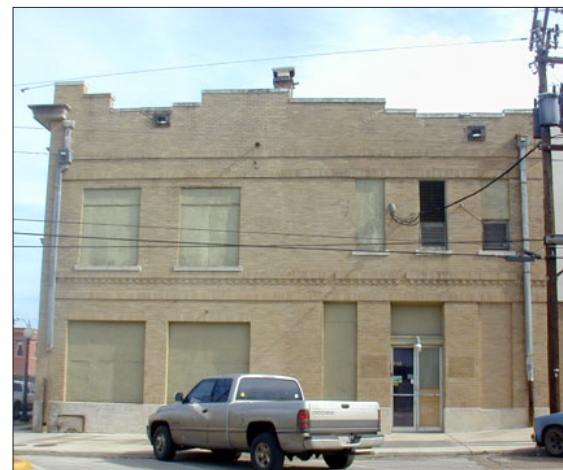
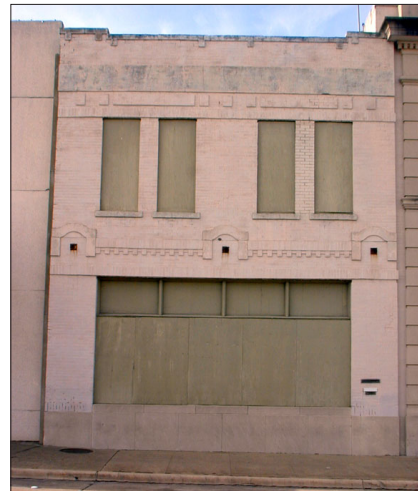
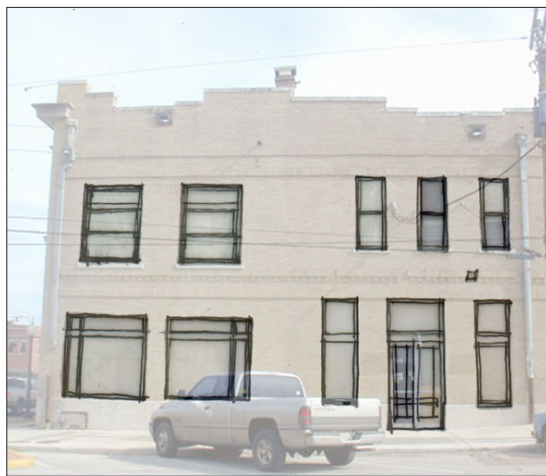
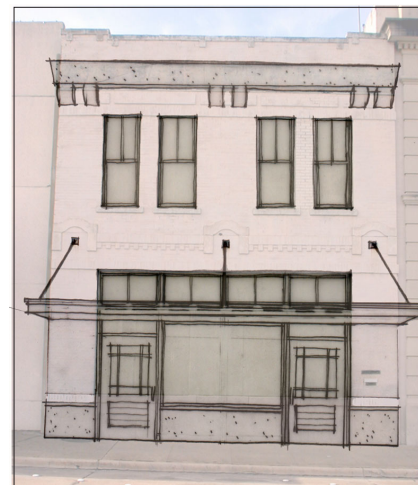
- Disjointed/Disconnected downspout allowing water to deposit on the building
- Mortar deterioration around scupper
- Biological staining
- Metal staining
- Building in need of cleaning
- Holes in masonry
- Wood rot in some windows
- Paint deterioration located on windows, water table, and brick
- Paint over brick
- Spalling
- Metal jacking has caused mortar deterioration and movement
- Cracking along mortar joints and through masonry

- Reconstruct downspout and reconnect it to the underground drainage system.
- Examine leader heads and scuppers to determine if they are draining properly and contributing to mortar deterioration.

- Remove any corrosive spikes and pins from masonry.
- Paint any corroding metal that is in contact with the building.
- Clean building in a manner that does not harm the masonry or mortar.

- Repoint areas that exhibit mortar deterioration using a mortar that matches the original in color, composition and tooling.
- Restore historic windows.

- Remove a test area of paint from the brick to determine if the removal process will damage the brick. If it is determined that the paint can be removed, do so in the most gentle means possible. If the paint should not be removed, repaint the test area and inspect the painted brick on a regular schedule of maintenance.

- Replace incompatible doors with ones that are more historically accurate.
- Arrest further damage caused by the corrosion of metal lintels by replacing them with new metal lintels.

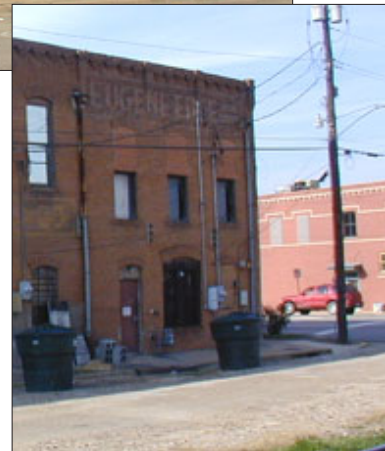
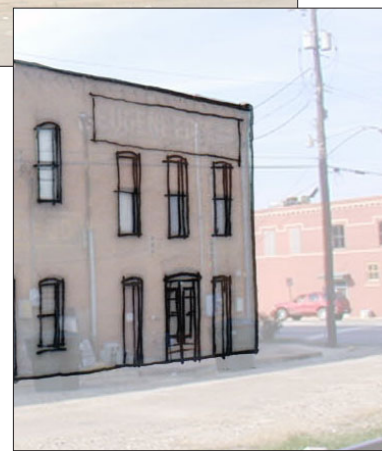
# 120 North Main Street

- Differential Settling
- Severe mortar deterioration
- Cracking through mortar joints
- Cracking through stones
- Masonry deterioration
- Spalling
- Cracking through stucco
- Biological staining
- Cracking along mortar joints
- Cracking through masonry
- Building in need of cleaning
- Holes in masonry
- Wood rot
- Paint deterioration
- Unsympathetic patching

- Examine downspout to ensure that it is not leaking or overflowing and causing mortar deterioration.
- If differential settling appears to be serious, have structure evaluated by a structural engineer.
- Update utilities while ensuring compliance.
- Repoint areas where mortar has deteriorated with mortar matching the original in composition, color and profile.
- Clean building in a manner that is not harmful to the brick or mortar.
- Remove unsympathetic patching and patch all holes in masonry with a masonry patching compound.
- Restore window and door openings in a historically accurate manner.
- Remove stucco and unoriginal brick veneer from building and restore storefront, canopy and windows in a historically accurate manner.
- Ensure entry is ADA compliant.

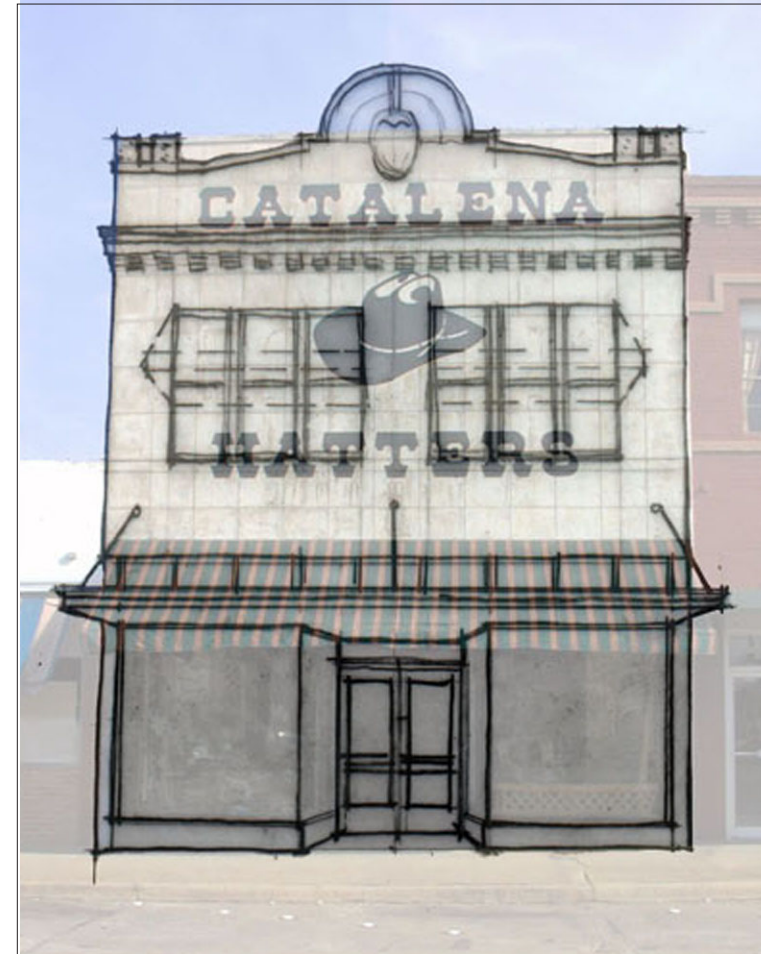
## 201 North Main Street

- Pooling and lack of positive drainage on alley side
- Improper gutter slope and poor downspout termination
- Mortar deterioration visible on east and north facades
- Original windows covered
- Biological staining
- Building in need of cleaning
- Stucco lintel deterioration
- Holes in masonry
- Paint on brick

- Regrade site to ensure proper drainage away from the building.
- Reconfigure drainage system so that downspouts drain at a proper slope and distance away from the building or into an underground drainage system.

- Repoint areas where mortar has deteriorated with mortar matching the original in composition, color and profile.
- Patch holes in masonry with a masonry patching compound.

- Repair stucco lintels.
- Test masonry to determine if the removal of paint from the brick will harm the building. If not, remove the paint in the most gentle means possible.

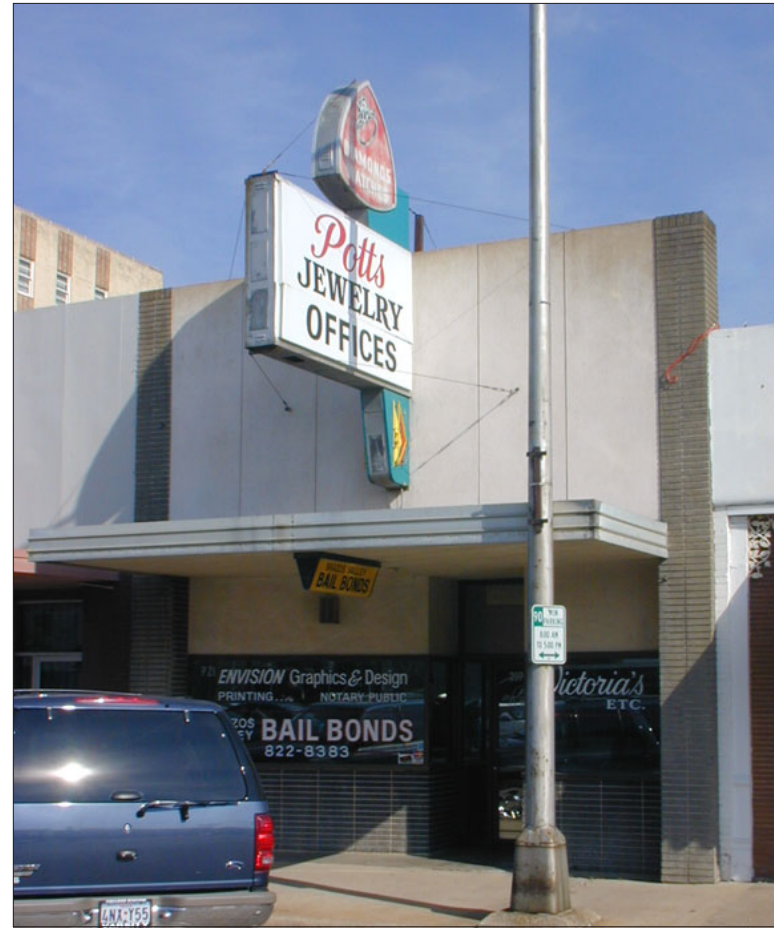
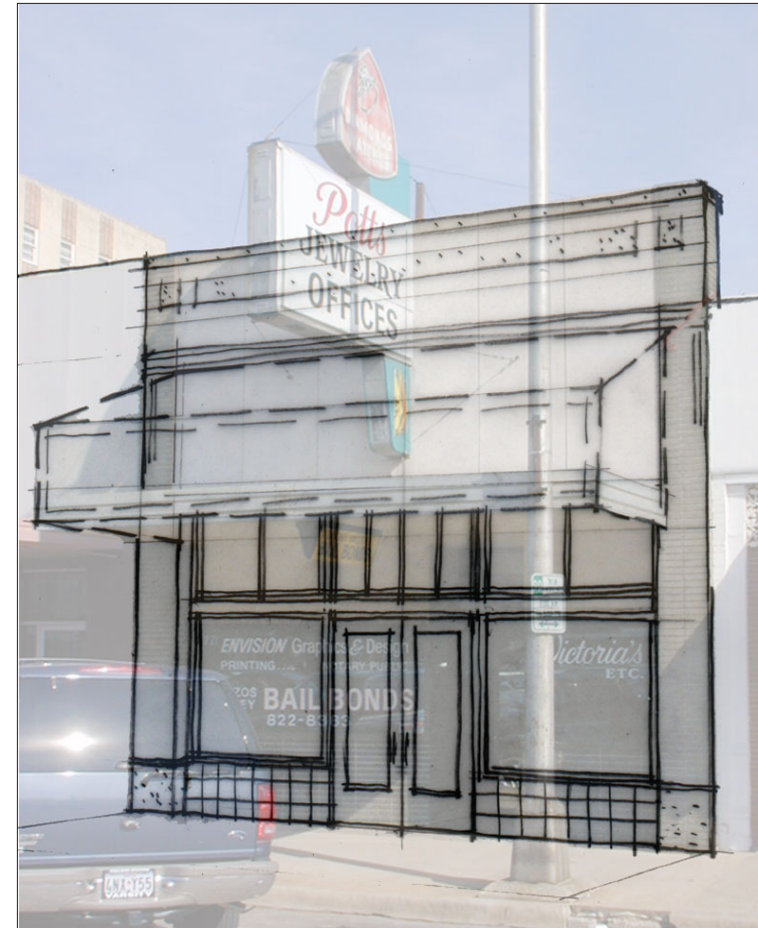
## 206 North Main Street

- Poor downspout termination on east facade of building
- Ponding and negative drainage conditions on east side of building
- Minor differential settling
- Conduit attached to building
- Poor service entry and configuration on east side
- Iron and rust staining
- Mortar deterioration
- Cracking through mortar joints
- Cracking through masonry
- Holes in masonry
- Unsympathetic repointing with caulk
- Portion of east facade is covered in roof coating

- Reconfigure downspout so that it is connected to an underground drainage system.
- Regrade site so that water flows away from the building.
- Update utilities while ensuring code compliance.
- Clean building in a manner that does not harm the masonry or mortar.
- Prime and paint any metal that is in contact with the building.
- Repoint areas where mortar has deteriorated with a mortar matching the original in color, composition and tooling.
- Remove caulk and repoint areas with mortar that matches the original in color, composition and tooling.
- Remove roof coating only if the removal process does not harm the masonry.
- Restore door opening of east facade.
- Remove current storefront and restore or reconstruct storefront in a historically accurate manner.
- Reconstruct canopy in a historically accurate manner.

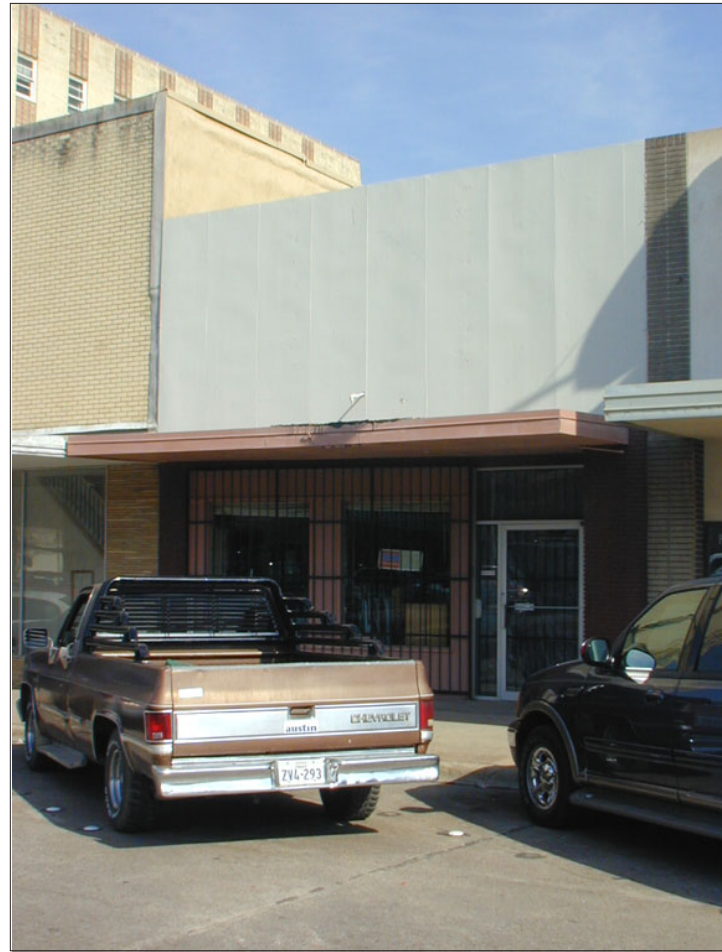
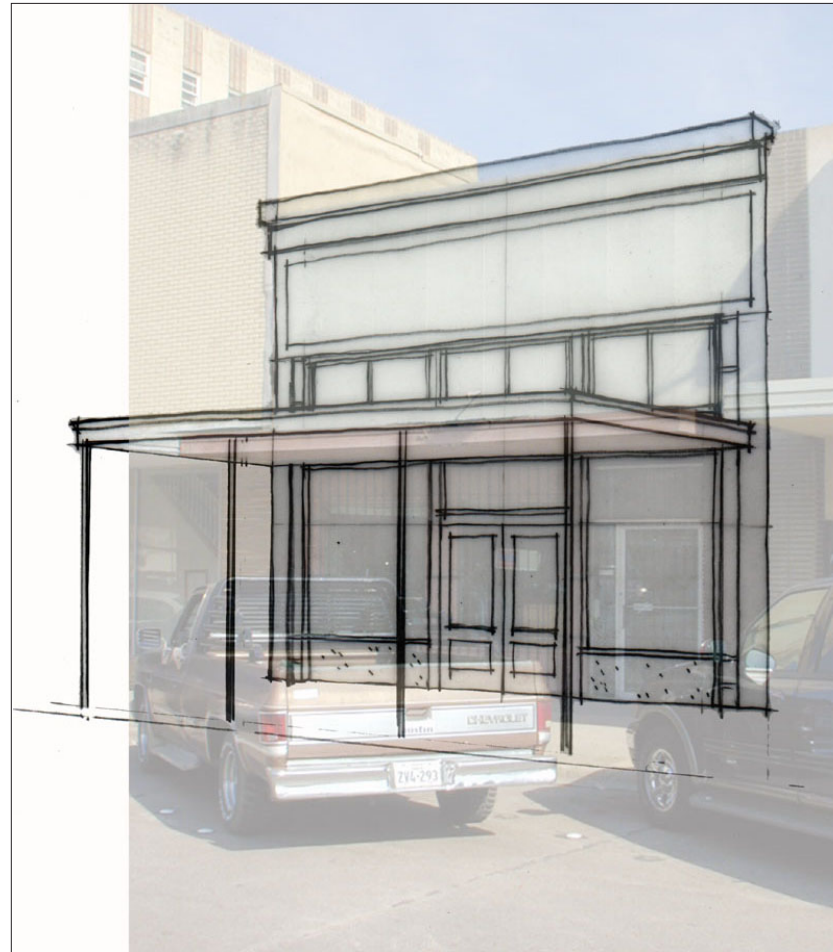
## 207 North Main Street

- Poor site drainage and conditions in alley
- Gutter leaks
- Disjointed downspout
- Poor downspout termination

- Regrade site to ensure that water drains properly away from the building.
- Inspect gutter system to ensure adequate drainage for the building.
- Replace or repair gutter system to ensure that they are free of leaks and properly jointed.
- Design drainage system so that water drains into an underground system.
- Investigate further the historical configuration of the building.
- Remove slipcover and restore east facade in a historically accurate manner.
- Replace canopy with one that is historically accurate.
- Insure that entrance is ADA compliant.

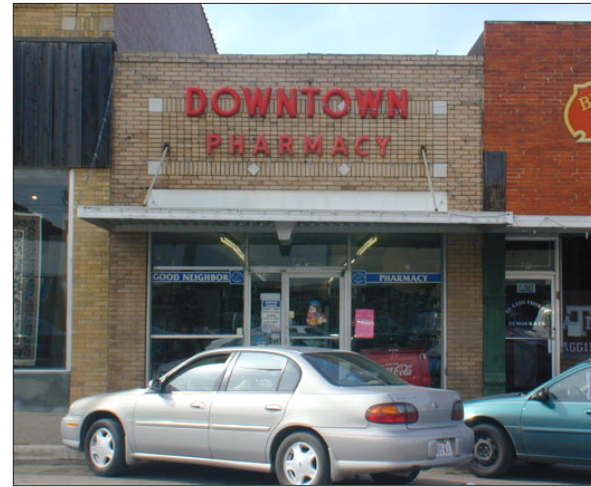
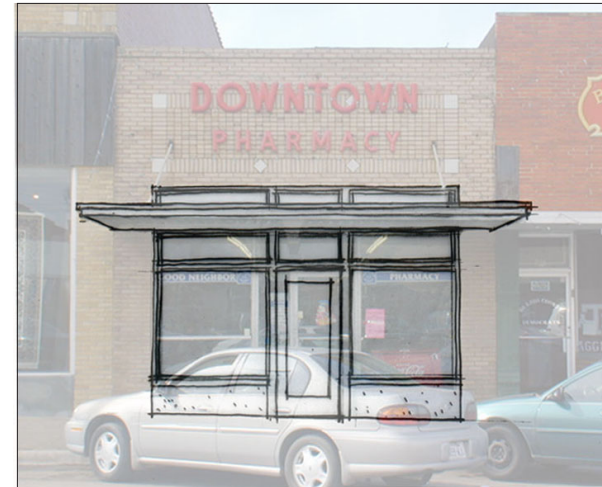
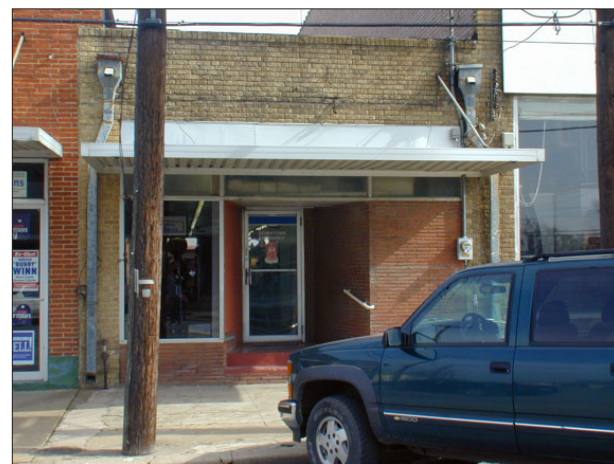
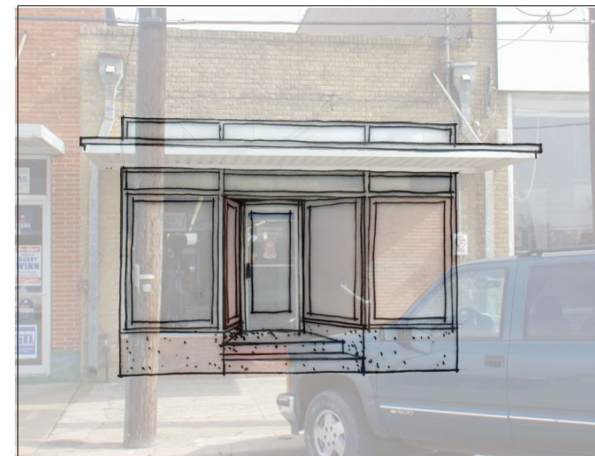
## 209 North Main Street

- Water deposited at the base of the building
- Conduit attached to building
- Mortar deterioration
- Biological staining
- Cracking through masonry
- Cracking along mortar joints
- Holes in masonry
- Vertical displacement due to corrosive metal lintel
- Building in need of cleaning
- Mortar deterioration

- Tie downspouts into an underground drainage system.
- Update utilities while ensuring code compliance.
- Clean building in a manner that does not harm the masonry or mortar.
- Patch holes in masonry with a masonry patching compound.
- Repoint masonry with mortar that matches the original in composition, color and profile.
- Remove corrosive lintel and replace it with a new metal lintel.
- Ensure that entries are ADA compliant.
- Replace incompatible storefronts with ones that are more historically accurate.
- Uncover transom and restore windows.

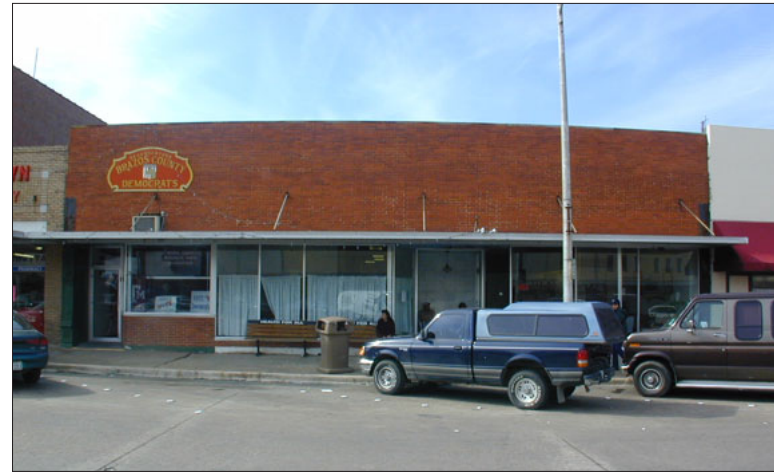
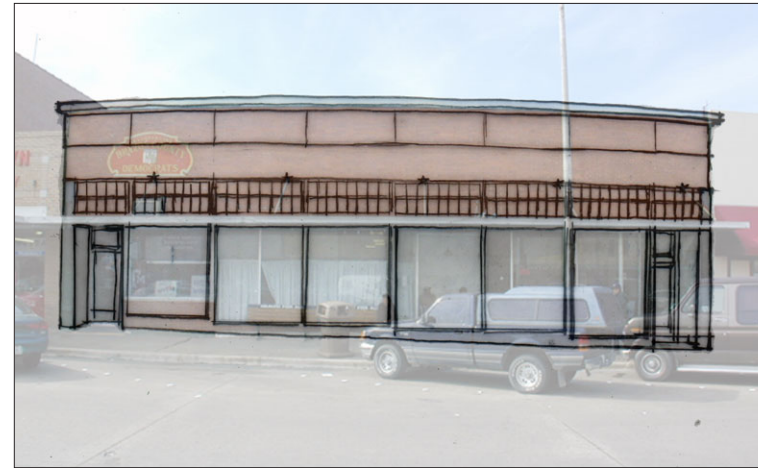
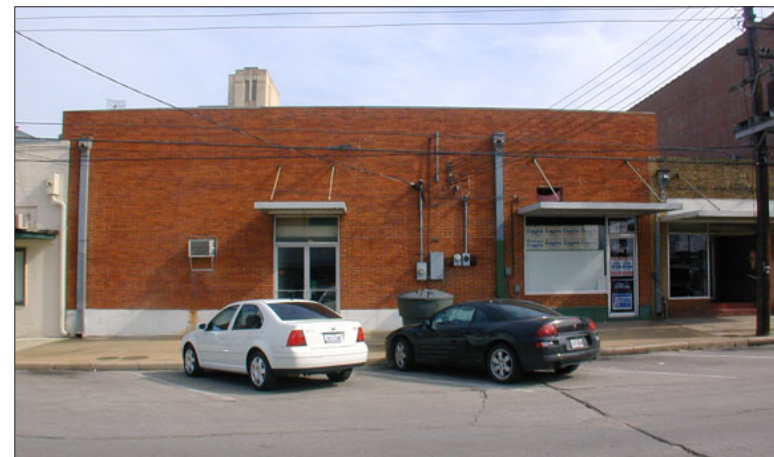
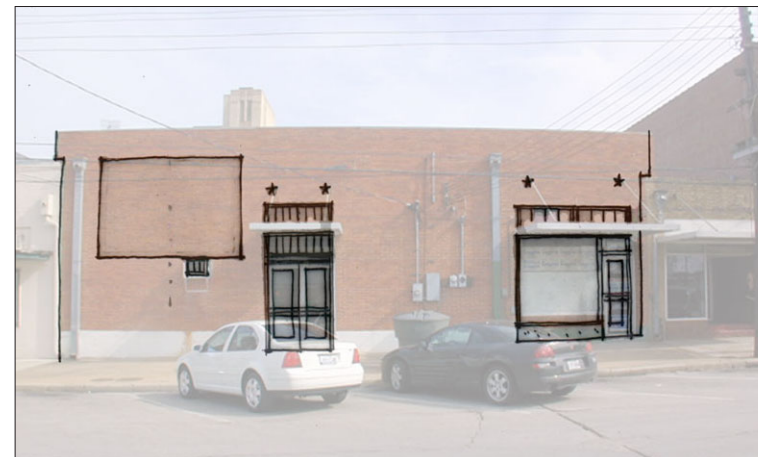
**210 North Main Street**

- Poor downspout termination
- Poorly configured utilities
- Biological staining
- Condensation from window unit air-conditioner staining facade

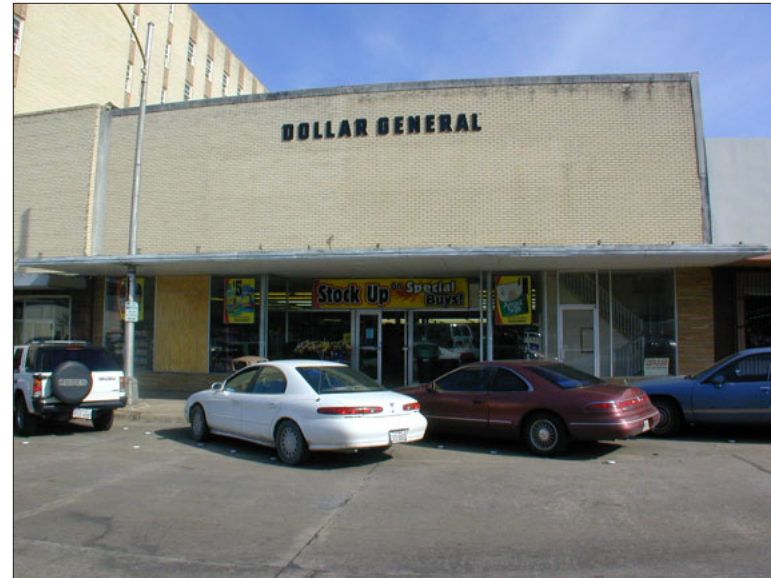
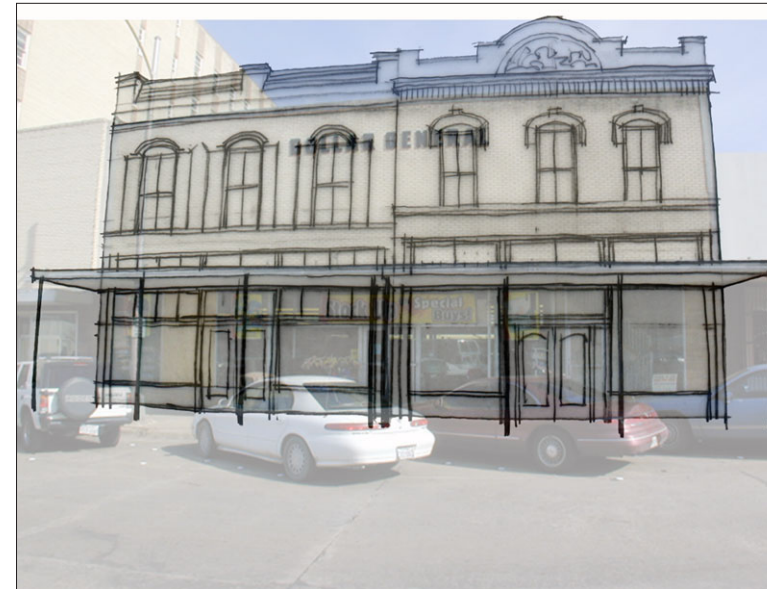
**212, 214, 216  
North Main Street**

- Poor downspout termination
- Masonry deterioration
- Mortar deterioration
- Biological staining
- Rust staining
- Cracking through stucco
- Deteriorated flashings on canopy
- Silver roofing paint on brick
- Building in need of cleaning
- Holes in masonry
- Tar drippings on brick
- Improper repointing

- Reconfigure downspouts so that water flows away from the building. If possible, connect downspouts to an underground drainage system.
- Repoint areas where mortar is deteriorated with a mortar matching the original in color, composition and profile.

- Clean building in the most gentle means possible.
- Paint any metal that is in contact with the building.
- Repair cracks in stucco with stucco matching the original in composition. Paint patches in stucco to match the original.

- Repoint areas that have been improperly repointed with mortar matching the original in color, composition and profile.
- Restore original window and door openings in a historically accurate manner.

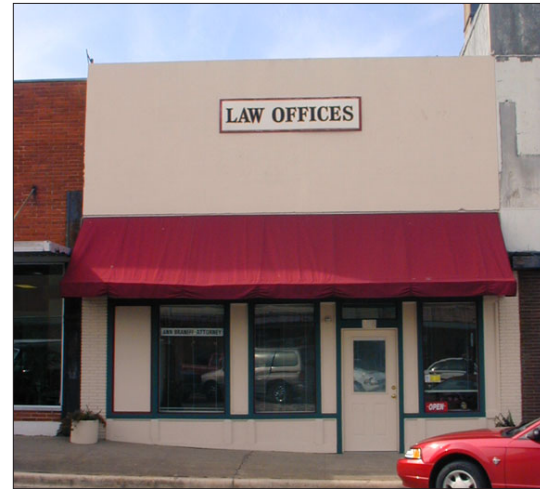
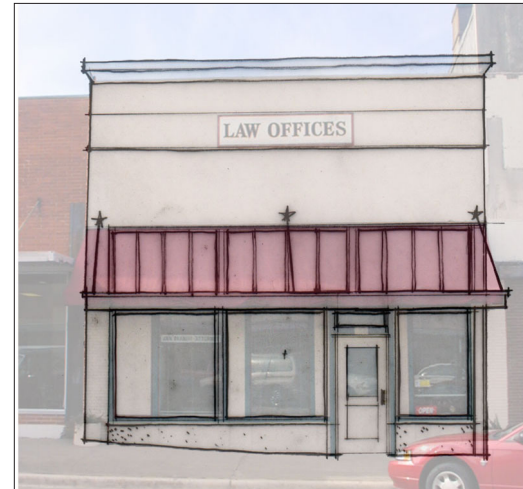
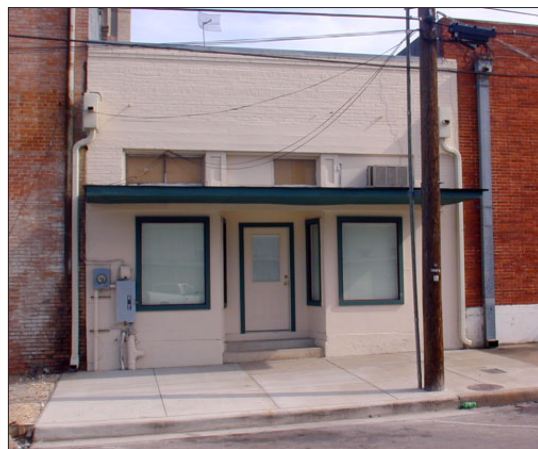
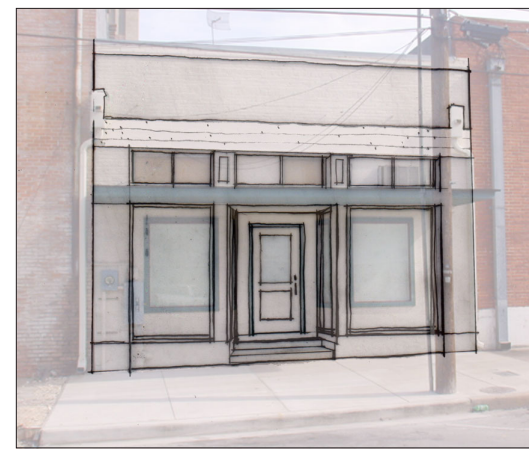
**217 North Main Street**

- Poor downspout termination
- Poor utility configuration
- Paint over brick

- Reconfigure downspout system so that water drains freely away from the building or into an underground drainage system.
- Update utilities while ensuring code compliance.
- Remove paint from masonry in the most gentle means possible.
- Restore and repair transom windows.
- Restore storefront and reconstruct canopy to reflect the original design.

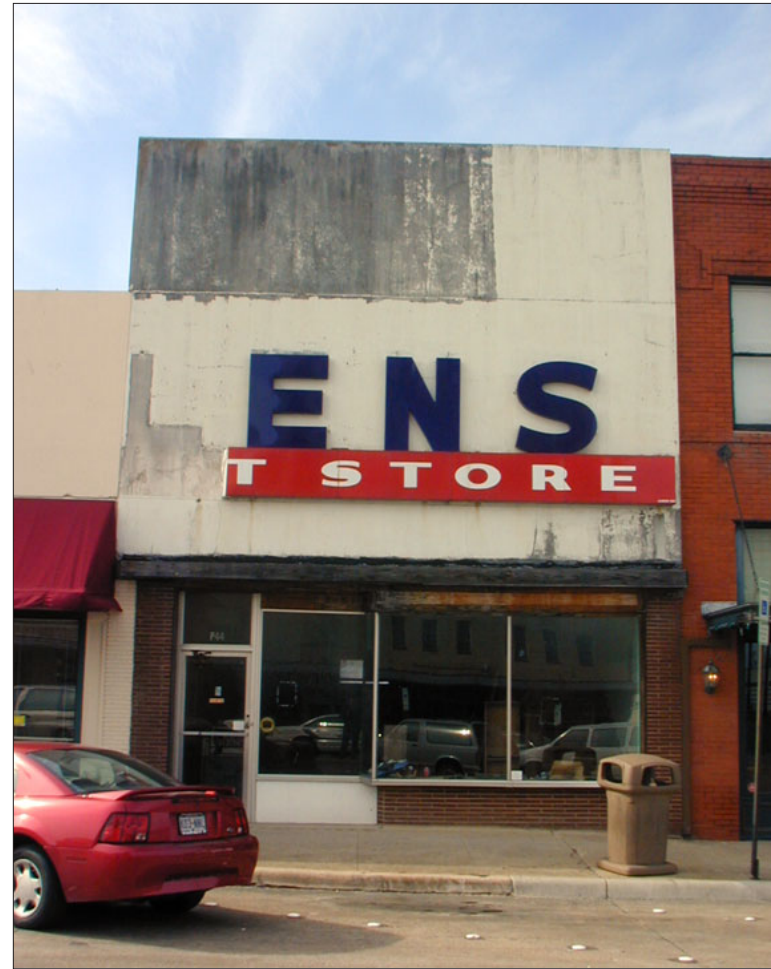
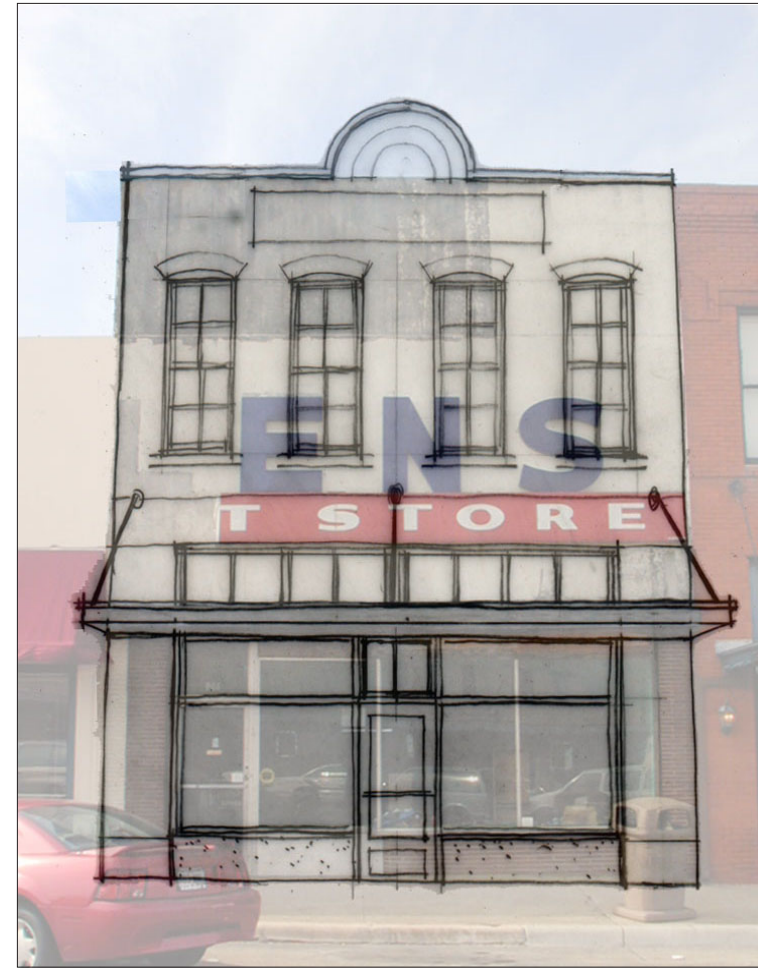
**219 North Main Street**

- Poor downspout termination resulting in mortar deterioration and biological growth
- Pipe penetrating brick
- Rust staining
- Holes in stucco
- Cracking through stucco
- Cracking along mortar joints
- Paint deterioration
- Biological staining
- Holes in masonry
- Building in need of cleaning

- Reconfigure downspout system so that water drains freely away from the building or into an underground drainage system.
- Update utilities while ensuring code compliance.
- Clean building in a manner that does not harm the masonry or mortar.
- Ensure that entry is ADA compliant.
- Patch holes in masonry with a masonry patching compound.
- Repoint in deteriorated areas with a mortar matching the original in color, composition and profile.
- Rehabilitate original windows and door.
- Paint adjoining exposed metal.
- Remove stucco storefront and reconstruct the storefront and transom in a historically accurate manner.
- Provide period style canopy.
- Reconstruct parapet to match original if possible.
