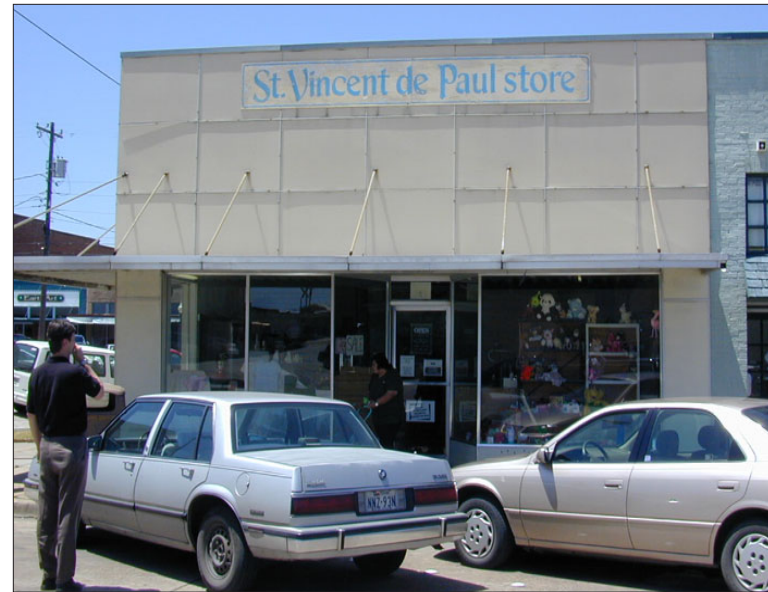
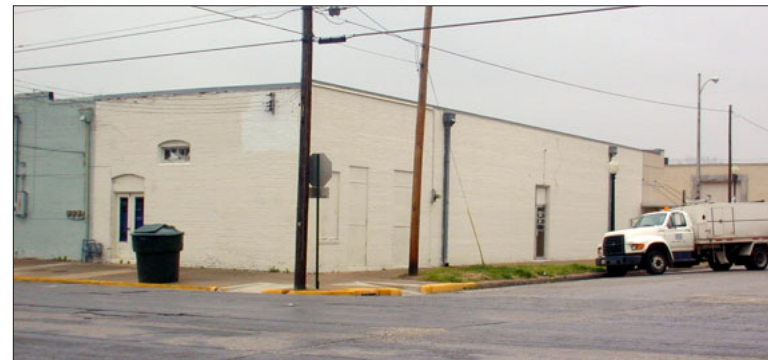
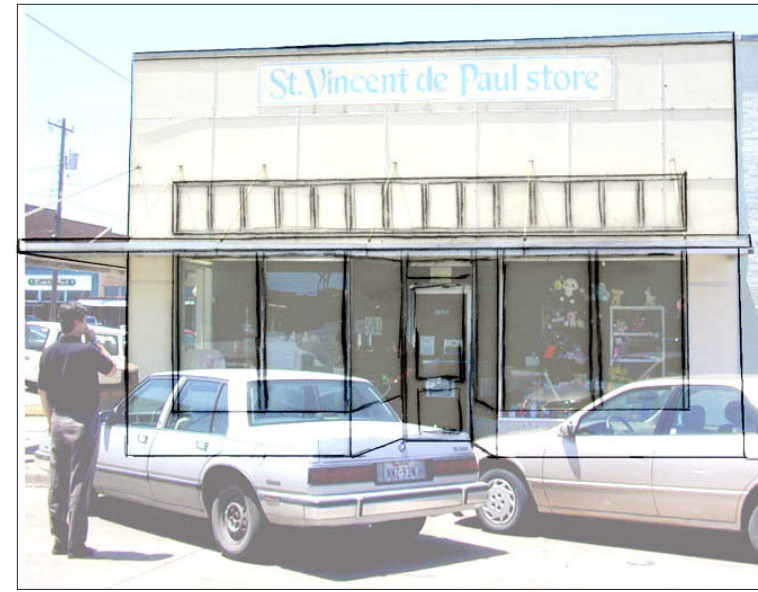
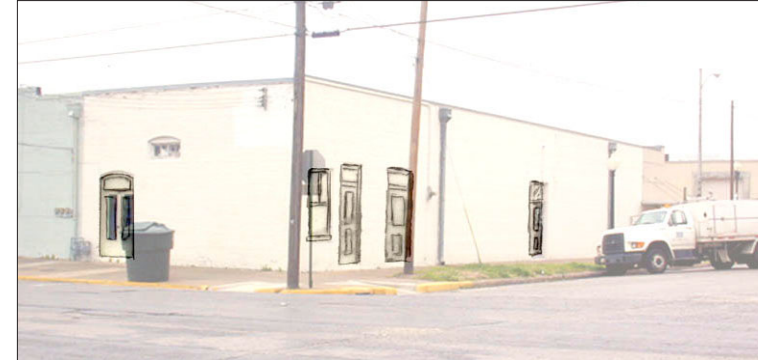
**222 North Main Street**

- Biological staining
- Rust staining
- Mortar deterioration
- Cracking along mortar joints
- Minor cracking through masonry
- Poorly configured utility service
- Building in need of cleaning
- Paint over brick
- Paint deterioration
- Wood rot
- Spalling
- Holes in masonry

- Determine cause of biological staining and growth and remedy if possible.
- Repoint deteriorated mortar joints with a mortar matching the original in composition, color and profile.

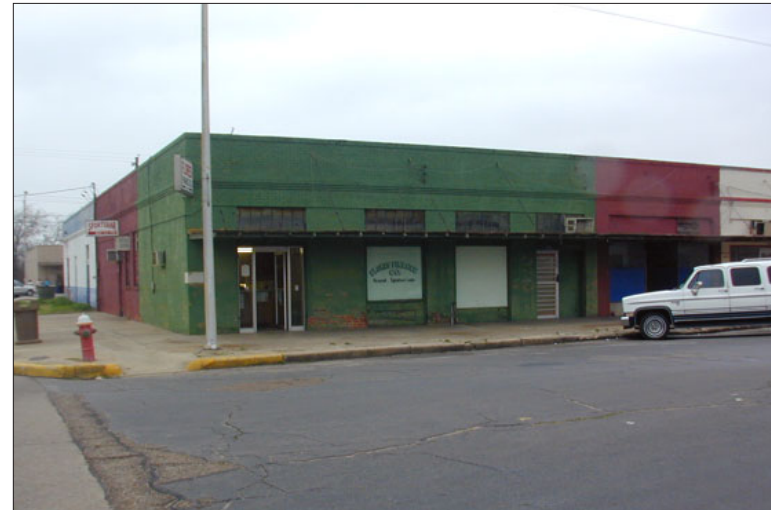
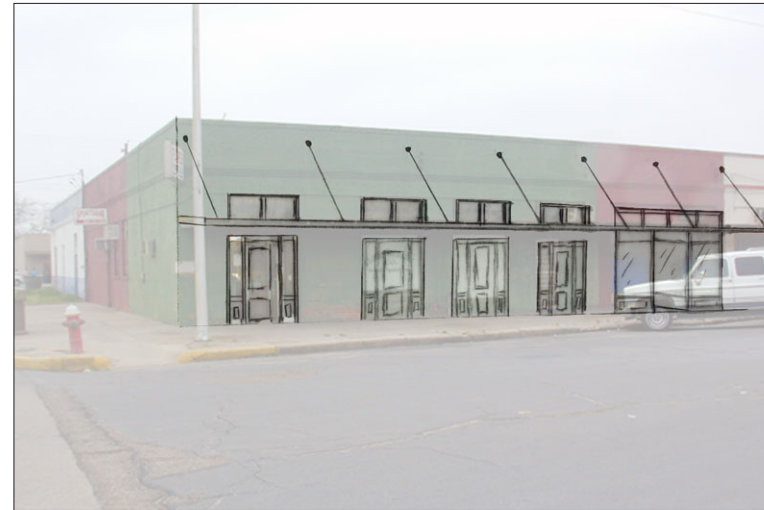
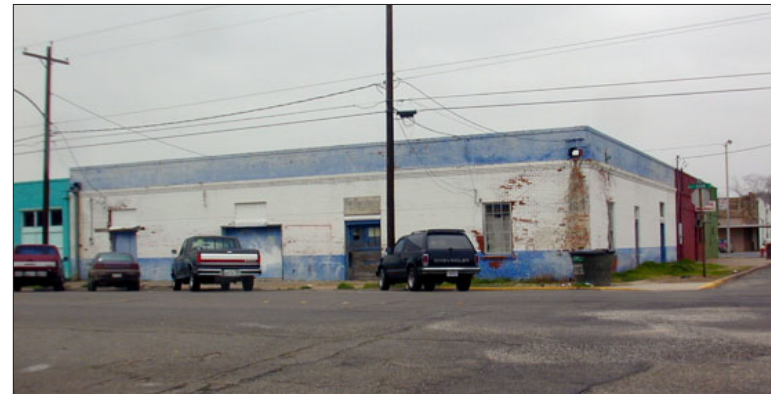
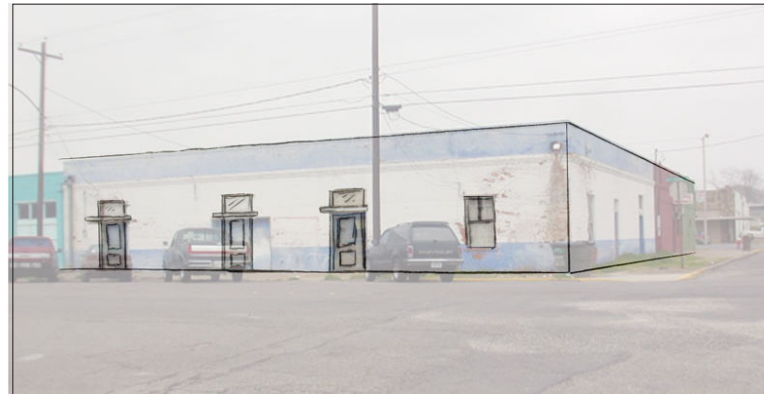
**300 North Main Street**

- Ponding and poor drainage conditions
- Poor downspout termination causing mortar and masonry deterioration
- Disjointed/Disconnected downspout causing mortar and masonry deterioration
- Conduit attached to the building
- Wood rot on canopy and building openings
- Mortar and masonry deterioration
- Cracking through masonry and mortar joints
- Efflorescence
- Poorly configured utility service
- Biological staining and growth
- Building in need of cleaning
- Transoms have been infilled
- Holes in masonry
- Exposed brick has been painted
- Door handles do not comply with ADA

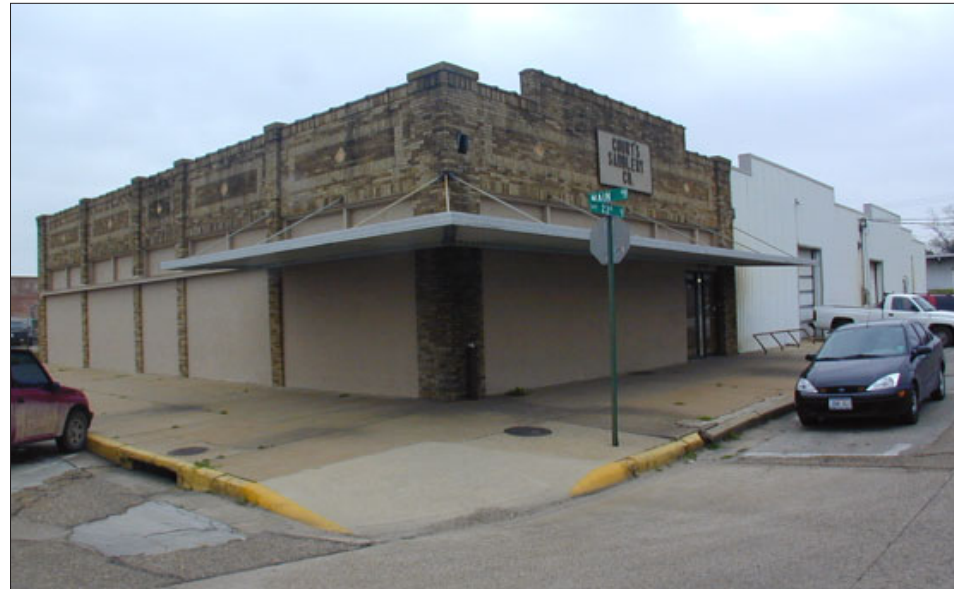
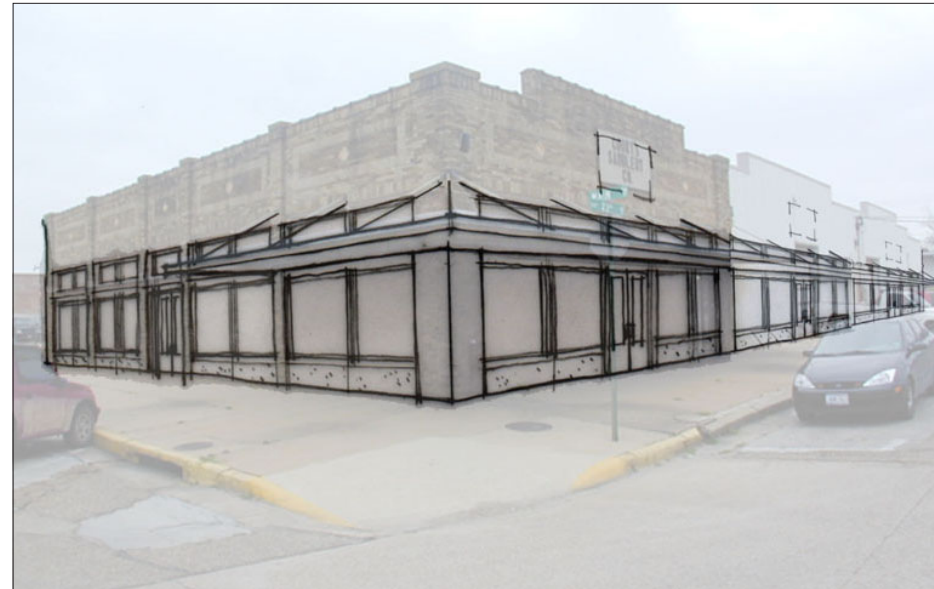
**400, 402, 404, 406  
North Main Street**

- Lack of positive drainage
- Scupper allow water to drain down the side of the building
- Conduit attached to building
- Rust staining
- Corrosive spikes and pins in masonry
- Biological staining
- Building in need of cleaning
- Holes in masonry
- Cracking through masonry and along mortar joints
- Paint deterioration
- Wood rot

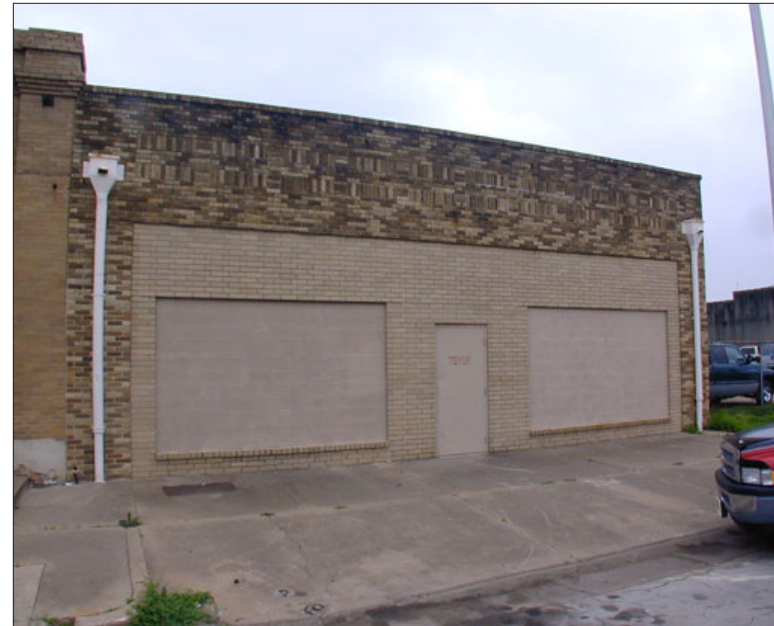
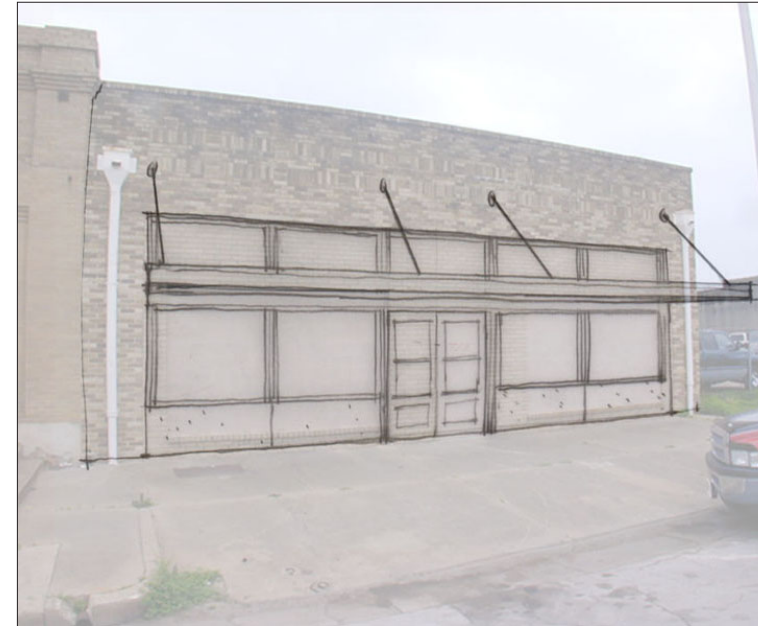
**401, 403  
North Main Street**

- Lack of positive drainage on east side
- Masonry and mortar deterioration, especially on the parapet wall
- Corrosive spikes and pins in masonry
- Biological staining
- Efflorescence
- Building in need of cleaning
- Cracking through masonry and along mortar joints
- Unsympathetic repointing and patching
- Metal lintel corroding
- Door handle does not comply with ADA standards

- Regrade site so that water drains away from the building.
- Update utilities while ensuring code compliance.
- Determine cause of mortar and masonry deterioration and repoint as necessary with mortar matching the original in composition, color and profile. Areas that have been unsympathetically pointed with Portland cement should be repointed with compatible mortar.
- Remove corrosive spikes and pins from masonry and patch with masonry patching compound.
- Clean building in a manner that does not harm the masonry or mortar.
- Depending on the corrosion of the metal lintel, it should either be painted to prevent further corrosion or replaced with a noncorrosive metal.
- Ensure that entry is ADA compliant.
- Remove masonry infill and provide period style storefront and canopy.

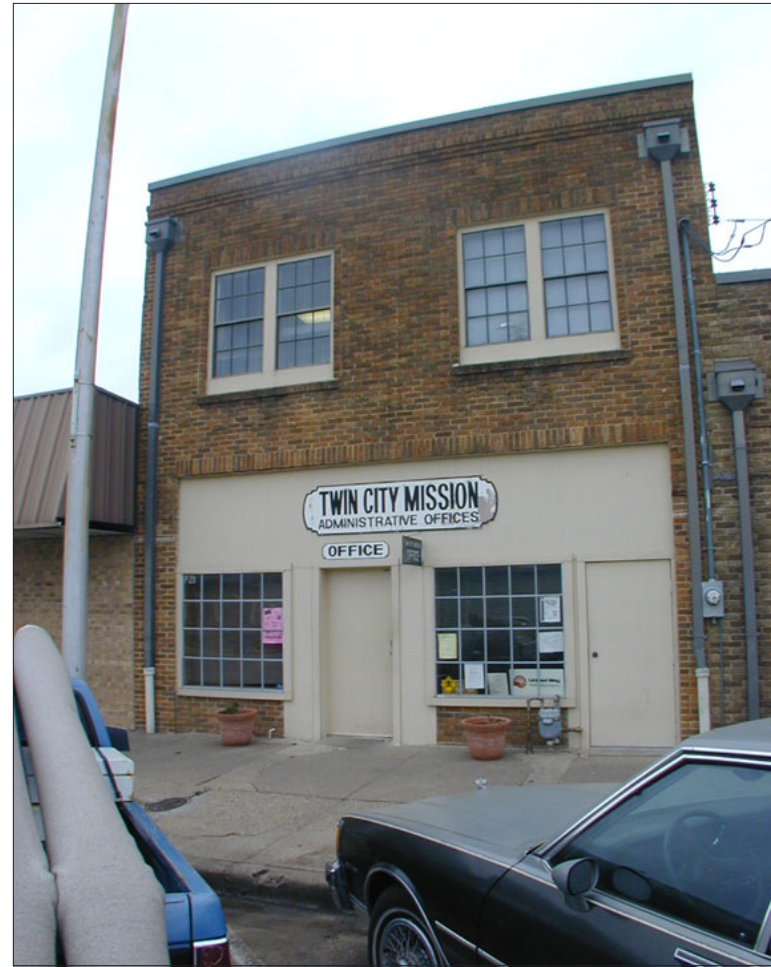
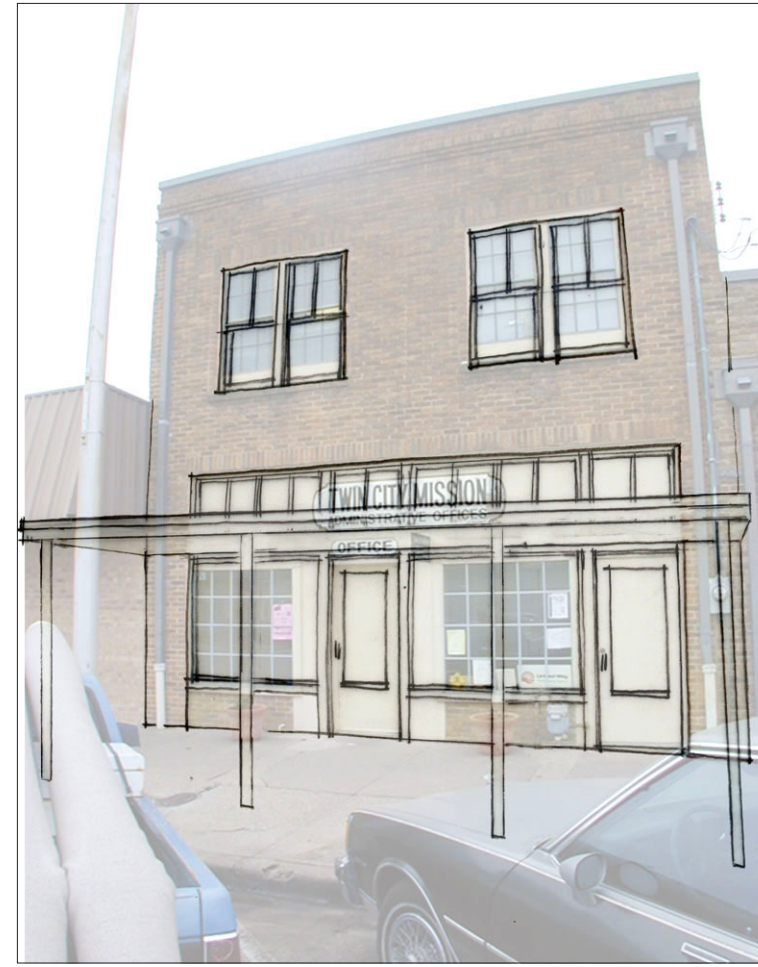
**419 North Main Street**

- Lack of positive drainage on west side
- Conduit attached to the building
- Mortar deterioration
- Corrosive spikes and pins in masonry
- Cracking through masonry and mortar joints
- Poorly configured utility service
- Biological staining
- Metal staining
- Building in need of cleaning
- Holes in masonry
- Unsympathetic patching and repointing with Portland cement compound
- Metal jacking of second story lintels causing vertical and horizontal displacement
- Door handles do not comply with ADA standards

- Update utilities while ensuring code compliance.
- Reconfigure electrical services and remove conduit from building's exterior.
- Determine cause of mortar and masonry deterioration and repoint as necessary with mortar matching the original in composition, color and profile. Areas that have been pointed or patched with Portland cement should be repointed with compatible mortar.
- Remove corrosive spikes and pins from masonry and patch with masonry patching compound.
- Clean building in a manner that does not harm the masonry or mortar.
- Fill holes in brick or areas that have been patched with Portland cement with masonry patching compound.
- Replace metal lintels and relay displaced brick.
- Ensure that entry is ADA compliant.
- Restore windows, entries and storefront.

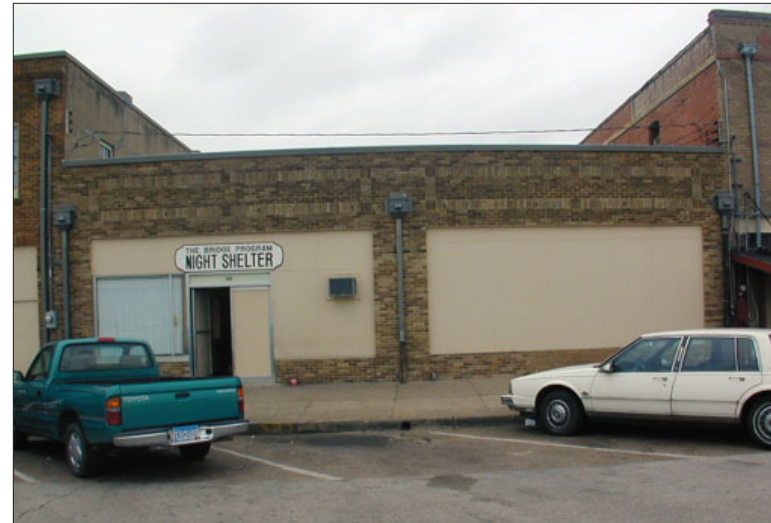
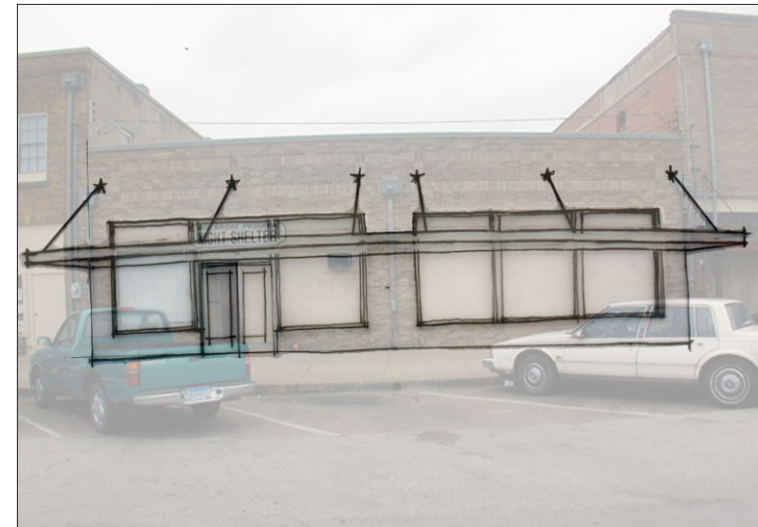
**506 North Main Street**

- Lack of positive drainage on west side
- Large amount of conduit attached to the building
- Corrosive spikes and pins in masonry
- Cracking through masonry and mortar joints
- Poorly configured utility service
- Biological staining
- Efflorescence
- Building in need of cleaning
- Holes in masonry
- Wood rot and paint deterioration noted on windows
- Unsympathetic patching and repointing with Portland cement compound

- Regrade site so that water drains away from the building.
- Update utilities while ensuring code compliance.
- Reconfigure electrical services and remove conduit from building's exterior.
- Remove corrosive spikes and pins from building and patch wholes with masonry patching compound.
- Determine cause of cracking through mortar and masonry and repoint as necessary with mortar matching the original in composition, color and profile. Areas that have been pointed or patched with Portland cement should be repointed with compatible mortar.
- Clean building in a manner that does not harm the masonry or mortar.
- Fill holes in brick or areas that have been patched with Portland cement with masonry patching compound.
- Ensure that entry is ADA compliant.
- Remove infill and restore windows, entries and storefront.
- Provide period style canopy.

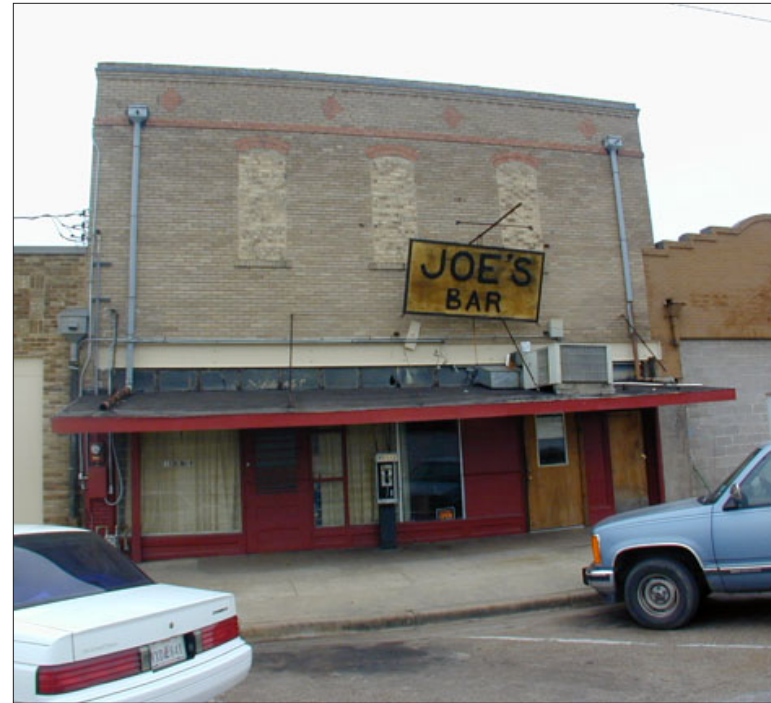
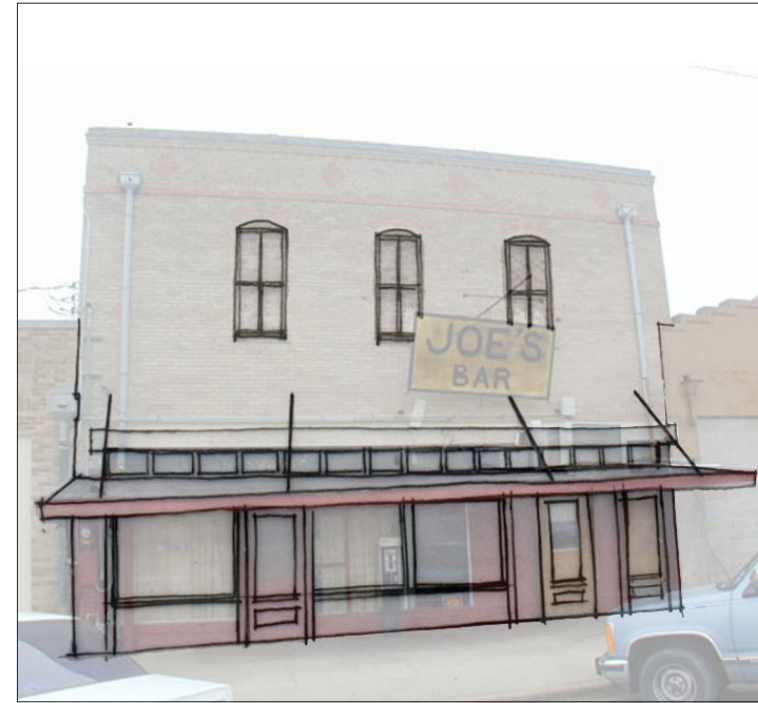
**508, 510  
North Main Street**

- Lack of positive drainage on west side
- Downspouts have been disconnected from underground drainage system so that water drains off of canopy
- Structural failure which includes differential settling, tie rodding, horizontal displacement and cracking through masonry and mortar noted, especially on the west and south facades.
- Masonry and mortar deterioration noted in parapet wall
- Spalling of brick
- Brick stringcourse has been altered to accommodate collector heads and downspouts
- Conduit attached to the building
- Corrosive spikes and pins in masonry
- Poorly configured utility service
- Biological staining
- Efflorescence
- Building in need of cleaning
- Holes in masonry
- Unsympathetic patching and repointing with Portland cement compound or caulk
- Trees growing too close to the base of the building
- Door handles and threshold do not comply with ADA standards

- Regrade site so that water drains away from the building.
- Attach downspouts to original underground drainage system.
- Have building evaluated by structural engineer to determine causes of structural failure.

- Reconstruct areas of stringcourse that have been damaged and replace collector and downspout with a more historic and sensitive version.
- Update utilities while ensuring code compliance.

- Reconfigure electrical services and remove conduit from building's exterior.
- Determine cause of mortar and masonry deterioration and repoint as necessary with mortar matching the original in composition, color and profile. Areas that have been pointed or patched with Portland cement should be repointed with compatible mortar.

- Remove corrosive spikes and pins from masonry and patch with masonry patching compound.
- Determine cause of efflorescence and remedy accordingly.
- Clean building in a manner that does not harm the masonry or mortar. Remove thin coat of Portland cement if possible.

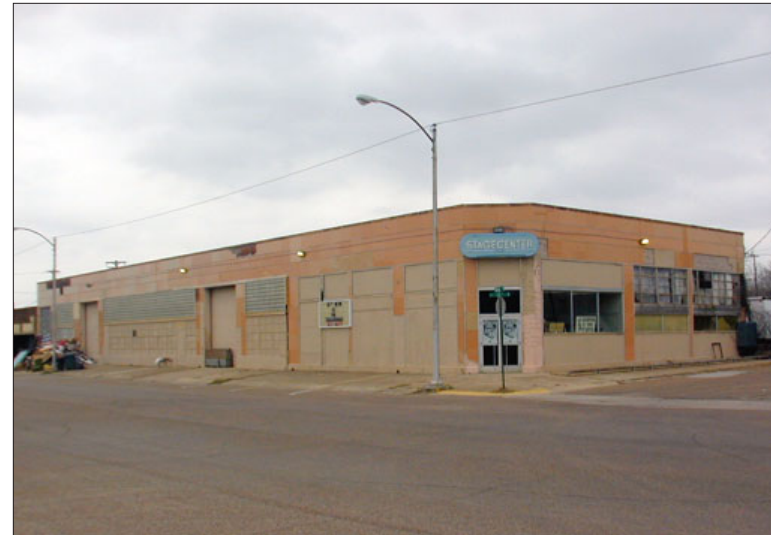
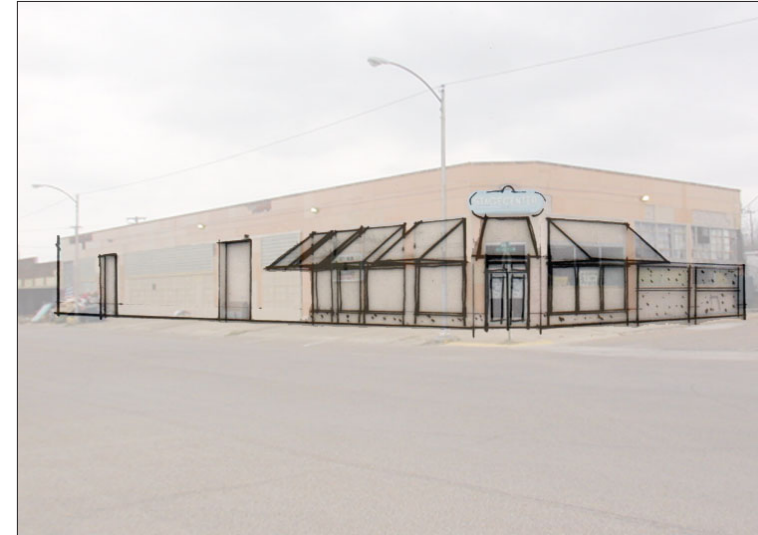
**607 North Main Street**

- Poor drainage conditions on east and south sides
- Drainage system was not visible
- Conduit attached to the building
- Minor efflorescence on east wall
- Poorly configured utility service
- Biological staining
- Building in need of cleaning
- Many window panes have been painted or infilled
- Several pieces of Carrerra glass have fallen off, exposing brick beneath
- Several windows are cracked or broken
- Holes in masonry
- Cast stone parapet cap exhibits staining and mortar deterioration
- Bay on west side has been infilled with concrete masonry units

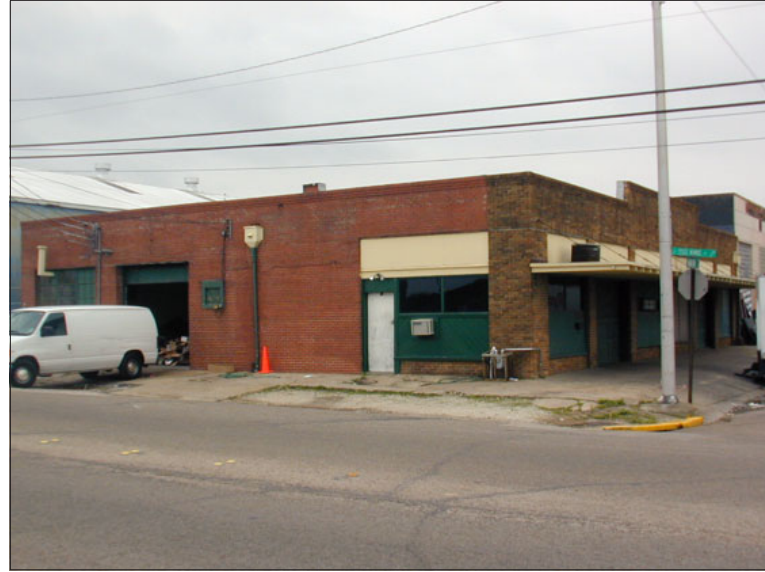
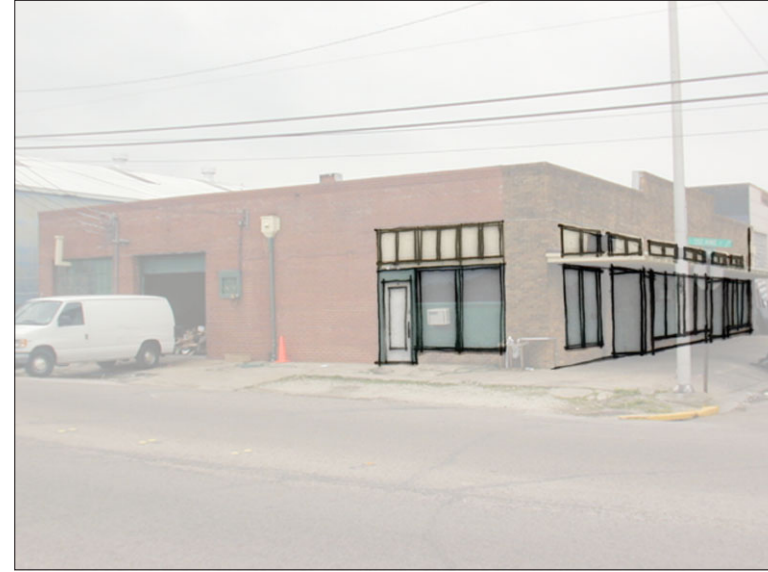
**701 North Main Street**

- Poor drainage conditions on east side
- Poor downspout termination
- Conduit attached to the building
- Wood rot on canopy and building openings
- Mortar deterioration
- Cracking through masonry and mortar joints
- Poorly configured utility service
- Biological staining and growth noted near downspout on north facade
- Building in need of cleaning
- Efflorescence
- Transoms have been infilled
- Holes in masonry
- Unsympathetic repointing with Portland cement mortar
- Poor patching
- Roofing compound covering large area of east wall
- Door handles and sidewalk do not comply with ADA standards

- Determine cause of efflorescence, remedy accordingly.
- Clean building in a manner that does not harm the masonry or mortar.
- Fill holes in brick or areas that have been patched with Portland cement with masonry patching compound.
