## Existing Condition

**Building name:** Temple Freda

**203 South Parker Street**

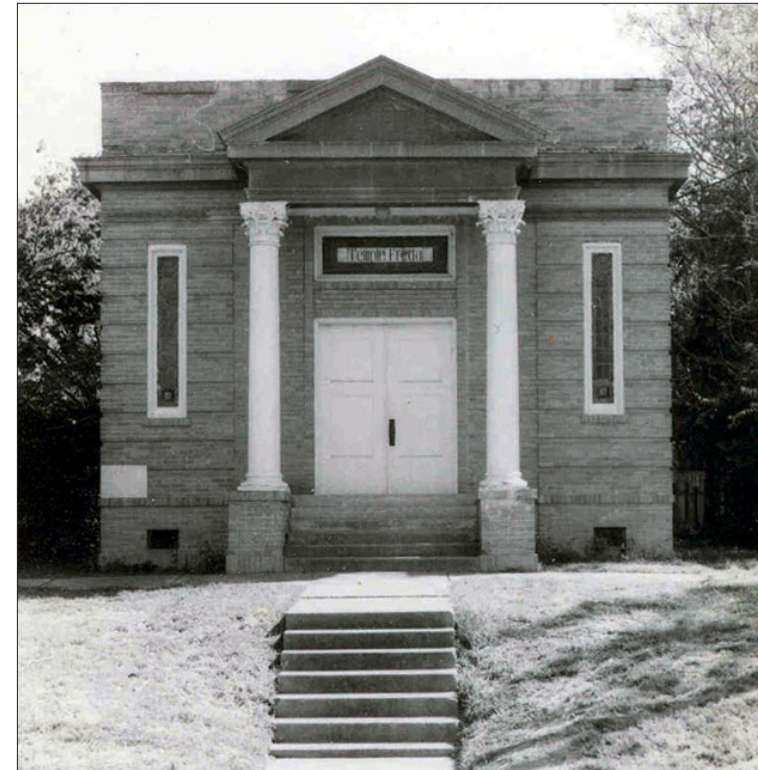
- Evidence of pooling in areas around building
- Lack of positive drainage on all sides
- Only one downspout, located on the east side, serves the entire building
- Differential settling
- Mortar deterioration
- Cracking through mortar joints
- Cracking through brick
- Stuccoed brick of parapet cap in poor condition
- Masonry deterioration
- Spalling
- Minor solder joint failure
- Minor rust and moisture infiltration on parapet cap
- Severe deterioration of stained glass windows
- Plant growth too close to building
- Biological Staining
- Efflorescence
- Building in need of cleaning
- Holes in masonry

- Regrade site to ensure proper drainage away from the building.
- Evaluate drainage system to determine if one downspout is adequate for the building. Ensure that all downspouts drain at a proper distance away from the building or into an underground drainage system.

- Have property evaluated by a structural engineer to determine cause and remedy for the excessive cracking.
- Repoint areas where mortar has deteriorated with mortar matching the original in composition, color and profile.

- Properly waterproof parapet cap. Work should preferably be undertaken by a waterproofing expert.
- Resolder any failed joints.
- Remove any corrosive spikes and pins from masonry. Patch all holes in masonry with a masonry patching compound.

- Paint any metal that is in contact with the masonry.
- Clean building in a manner that is not harmful to the brick or mortar.
- Remove plant growth that is located too close to the building.

- Restore column capitols.
- Have stained glass windows restored by an expert.
- Rebuild wing walls.
