# Drainage Master Plan Update

# Project: BU01 - Woodland Drive Crossing

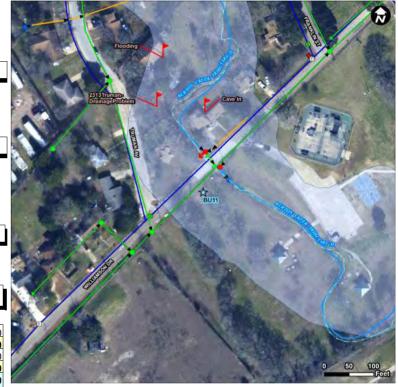
Williamson Street is classified as a local street based upon the City of Bryan Thoroughfare Plan. 3-10'x6' box culverts are proposed to replace the existing box culverts in order to convey the 50-year storm event per the TxDOT design requirement. Channel re-grading and widening may be necessary to mitigate any adverse impacts. Detailed design for the 100-year storm event has not been studied.

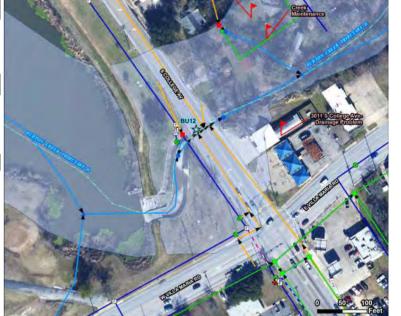
There are two existing 9'x7.5' box culverts that convey flow from Burton Creek Tributary D under South College Street. The crossing is located downstream of Country Club Lake. Commercial buildings and undeveloped land are adjacent to this crossing. South College Street begins flooding during the 25-year storm event, and the road is overtopped by a depth of 0.21 ft during the 100-year storm event.

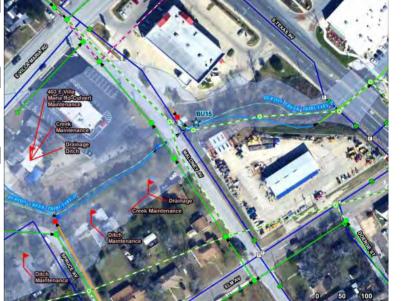
Maloney Road is classified as a local street based on the City of Bryan Thoroughfare Plan. Four 10'x8' box culverts are needed to replace the existing culverts in order to convey the 50-year storm event per the TxDOT design requirement. Channel re-grading and widening may be necessary to mitigate any adverse impacts. Detailed design for the 100-year storm event has not yet been studied.

There are five existing 54" diameter pipe culverts that convey flow from Burton Creek Tributary D beneath Maloney Road. Residential buildings are adjacent to this crossing. Maloney Road begins flooding during the 10-year storm event, and the road is overtopped by a depth of 4 ft during the 100-year storm event. The City also identified this area as having drainage issues.

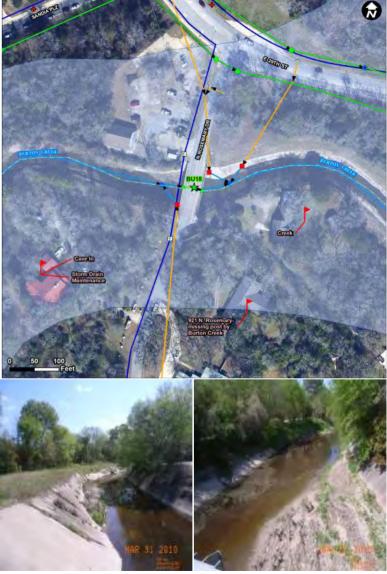
The slope paving panels with significant damage and grout panels with minor damage need to be removed and replaced. A concrete liner along the bottom of the channel for approximately 1200 LF is needed as well as a drop structure and riprap just downstream of the concrete liner to prevent future erosion of the channel.

The existing Burton Creek channel 150 ft upstream of 29th Street to 150 ft downstream of Rosemary Street has concrete paved 1.5:1 side slopes, 30 ft bottom width, and an earthen bottom. There are baffle blocks for energy dissipation downstream of the 29th Street Bridge. High velocities during the 100-year storm event cause severe erosion along the earthen channel bottom, which is causing the concrete paved side slopes to fail due to undermining of the slope toe-wall.

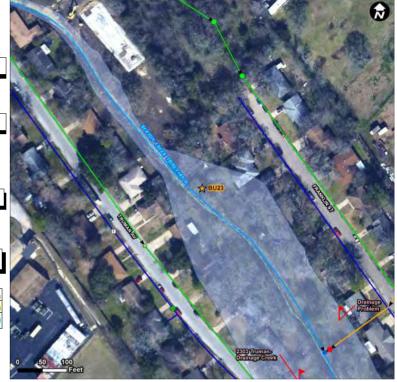
The existing Burton creek Tributary D channel is densely vegetated from Williamson Street to Duncan Street. Along the channel, some home owners and businesses have built structures over the channel, further restricting flow. Immediately upstream of Carson Street, the channel is enclosed in 3-24" diameter culverts located under a commercial building. The channel runs through a residential area.

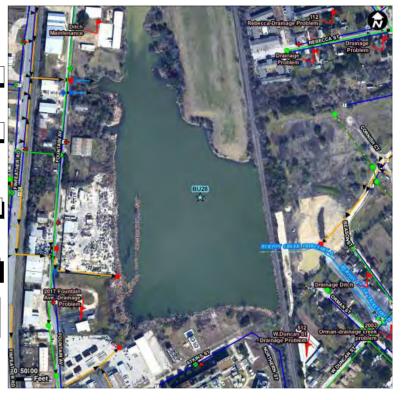
Finfeather Lake outfalls into Burton Creek Tributary D and is located on the northwest portion of the Burton Creek watershed. The lake is located west of the Union Pacific Railroad, and the railroad tracks run on top of the dam. Finfeather Lake is surrounded by commercial buildings and has a drainage area of approximately 243 acres. The City identified general flooding around the lake.

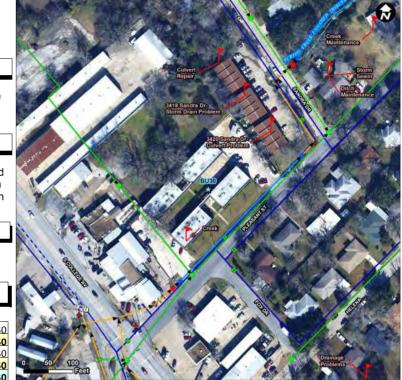
The Farm Patch store located on Pleasant Road between Sandra and South College Ave is experiencing flooding of approximately 0.5 ft, according to the City of Bryan flooding and erosion issues database. The area is mainly commercial, and runoff is drained through a system of streets, storm drain, and a drainage swale along Pleasant Road. The Thompson "Storm Water Modeling and Infrastructure Mapping Project" project number O4071 identifies the existing system near the intersection of College Avenue and Pleasant Street as flooding during the 10-year storm event.

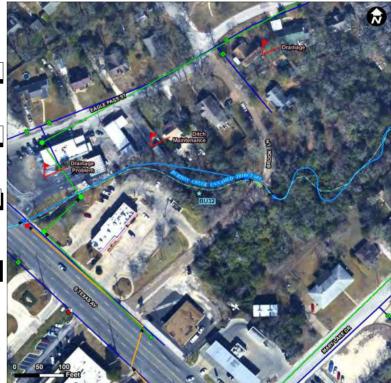
A study of approximately 2500 LF of Burton Creek Tributary 5 channel is needed as well as a design phase for culvert and/or channel improvements to assess existing flooding in the area and propose improvements. Spatial constraints due to buildings on either side of the stream may cause design complications.

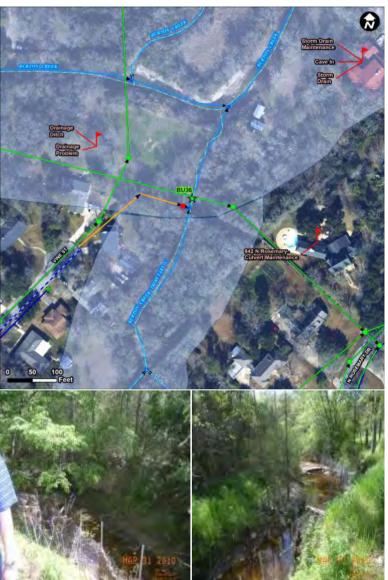
Erosion control is needed along approximately 870 LF of Burton Creek Tributary C near 827 Vine Street to prevent property damage due to further erosion of the channel. Included in the project is channel assessment, study and design to improve the current conditions and prevent future erosion.

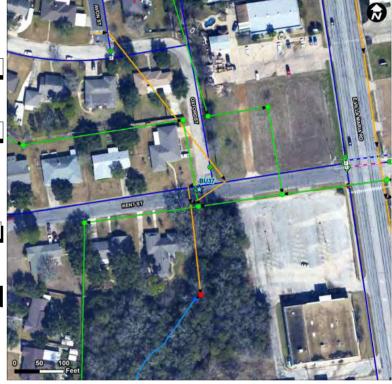
The intersection of Kent and Oxford Streets is located in a medium density residential neighborhood. Runoff from all directions flows to this intersection and there is a small creek to the south of the intersection and ponds approximately 6 to 12 inches. There is an existing system that outfalls into this creek. Runoff collects at the low point and causes general flooding near the intersection, according to the City of Bryan flooding and erosion issues database. The Thompson "Storm Water Modeling and Infrastructure Mapping Project" project number O4080 identified Oxford Street and Kent Street as flooding during the 10-year storm event.

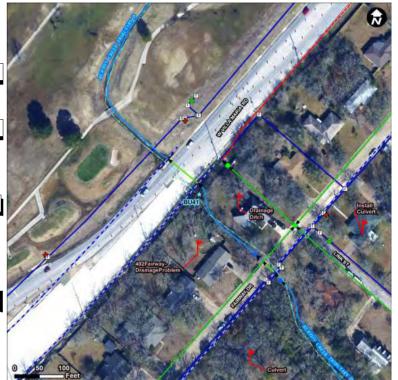
A study and detailed design of the area is proposed to assess the flooding and design improvements to prevent flooding. This design includes approximately 1,500 LF of channel improvements.

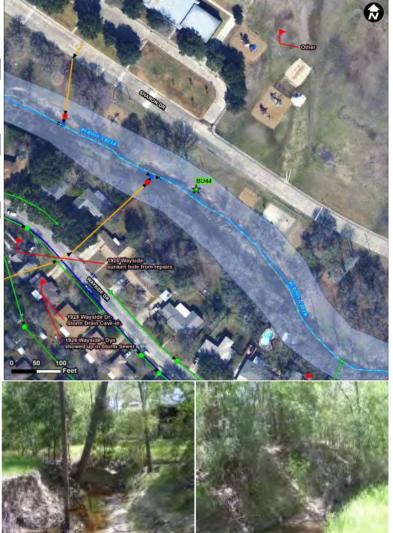
The existing channel is earthen and overgrown. There is dense vegetation within the overbanks and channel, which causes limited access to the channel. Structural encroachments occur along the channel and riprap and concrete rubble has been installed in various parts to control erosion.

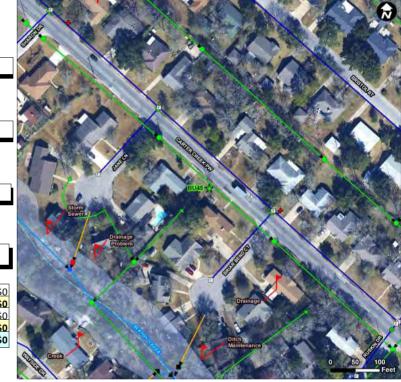
The existing channel is earthen and overgrown. There is dense vegetation within the overbanks and channel, which causes limited access to the channel. Structural encroachments occur along the channel, riprap and concrete rubble has been installed in various parts to control erosion.

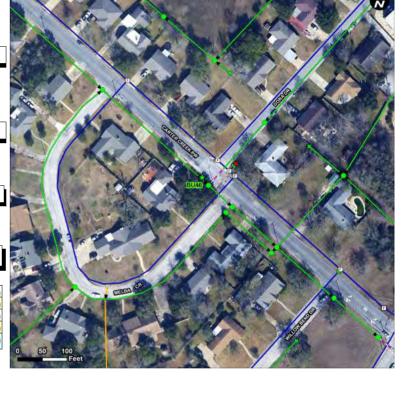
The existing channel is earthen and overgrown. There is dense vegetation within the overbanks and channel, which causes limited access to the channel. Structural encroachments occur along the channel and riprap and concrete rubble has been installed in various parts to control erosion.

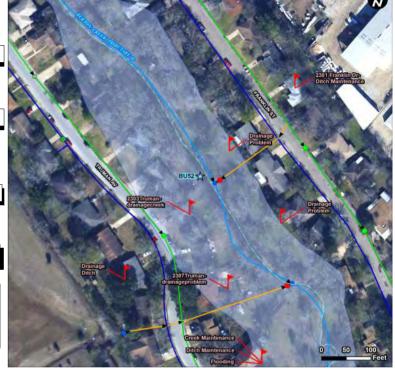
There is an existing storm sewer system between Franklin Street and Truman Avenue that outfalls into Burton Creek Tributary D. The sewer system services Franklin Avenue and the residential homes surrounding it. According to the City, the inlet needs to be replaced. The Thompson "Storm Water Modeling and Infrastructure Mapping Project" project number O4002 identified the sewer system as undersized and causing flooding during the 10-year storm event.
