**BUILDING AND STANDARDS COMMISSION
STAFF REPORT**

Case #1829 – 606 West 17th Street

Dangerous Structures Survey Report

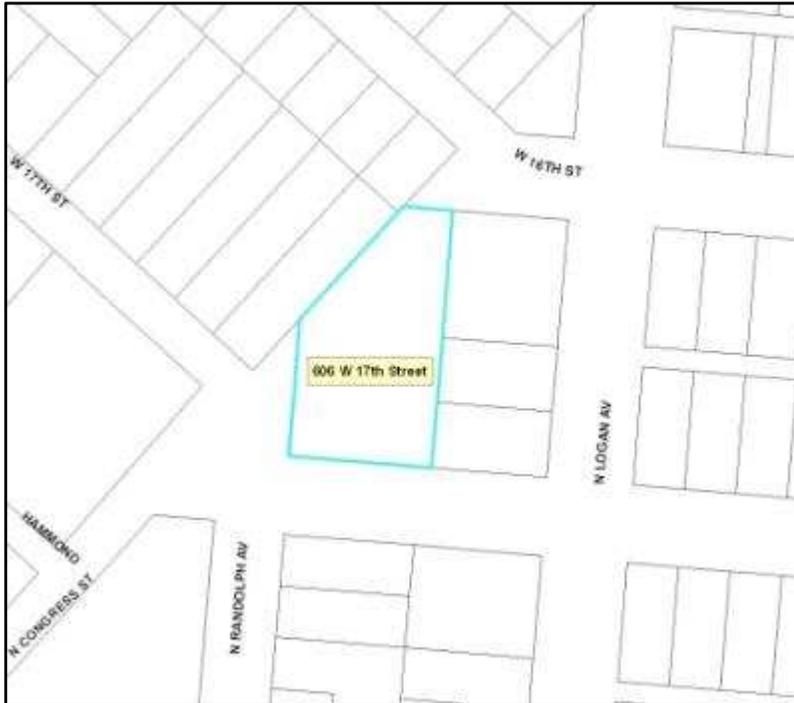
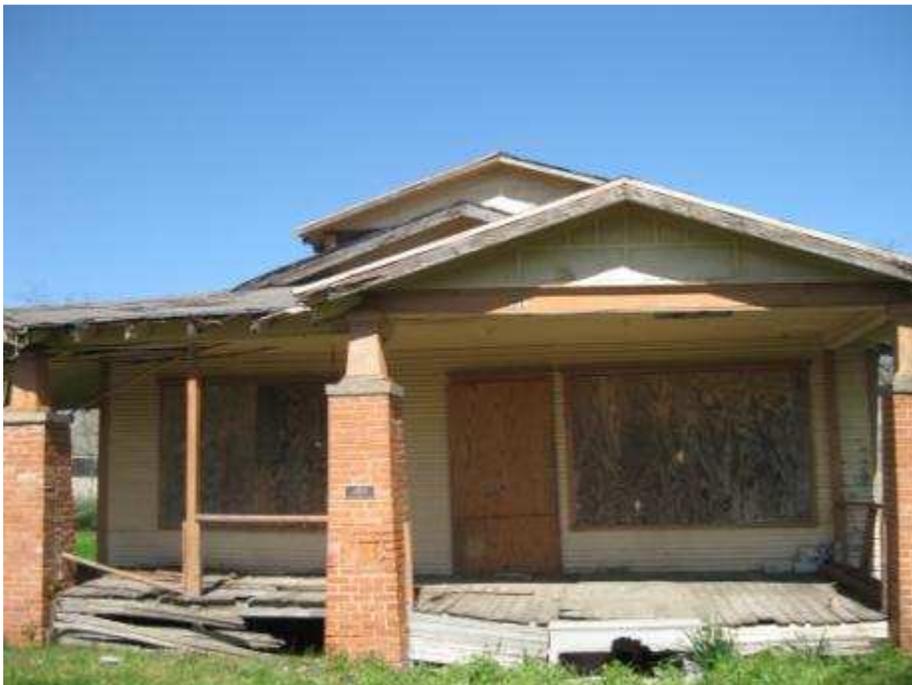
This structure was brought to the attention of Code Enforcement by the Chief Building Official and the Fire Marshal because of its dilapidated condition in August 2011. Exterior of the structure has a failing porch. In addition, Code Enforcement received a citizen concern regarding the structure's back door being unsecured. The structure is not currently occupied.

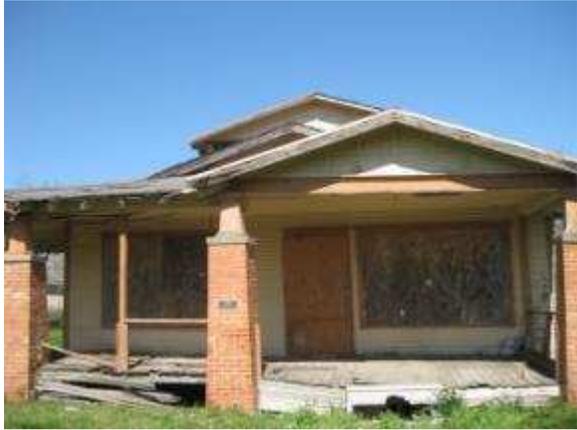
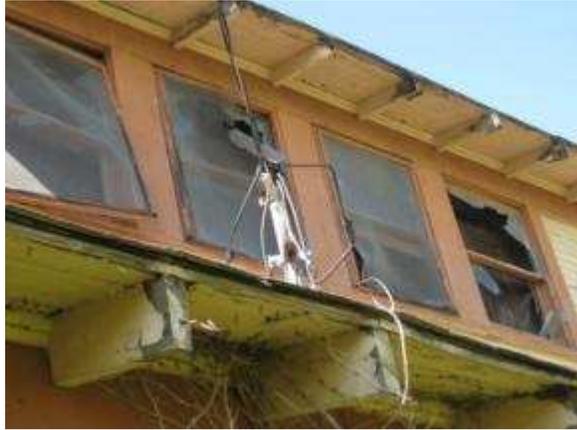
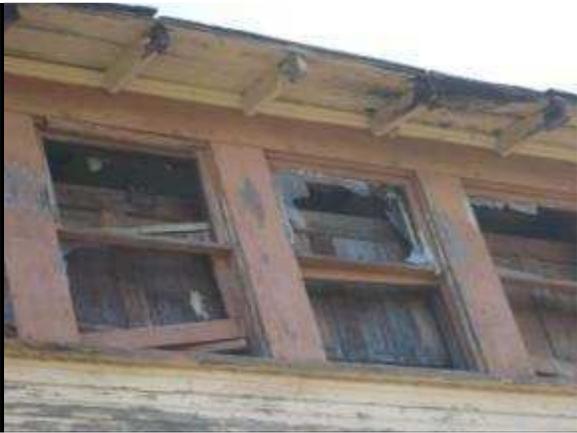
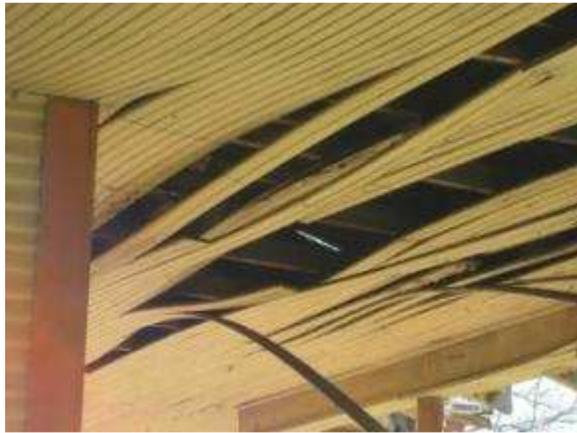
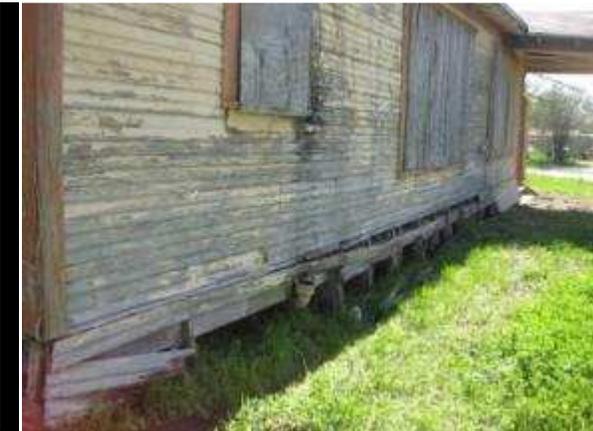
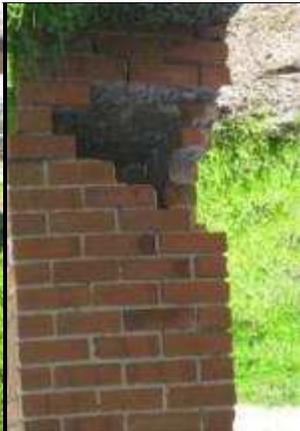
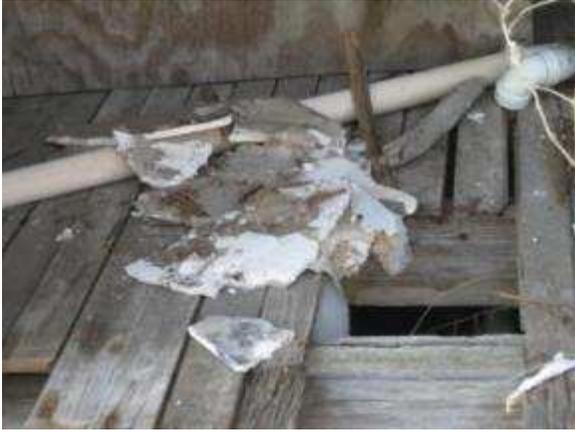
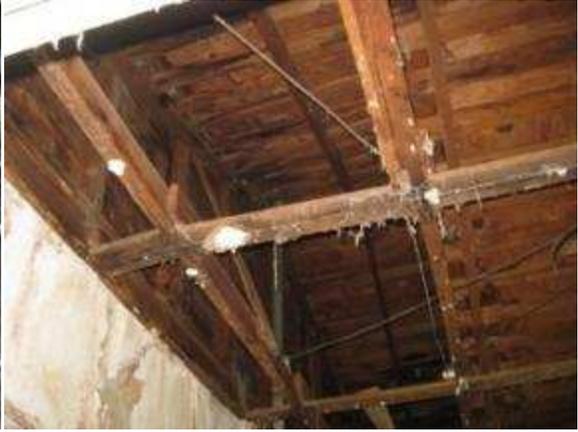
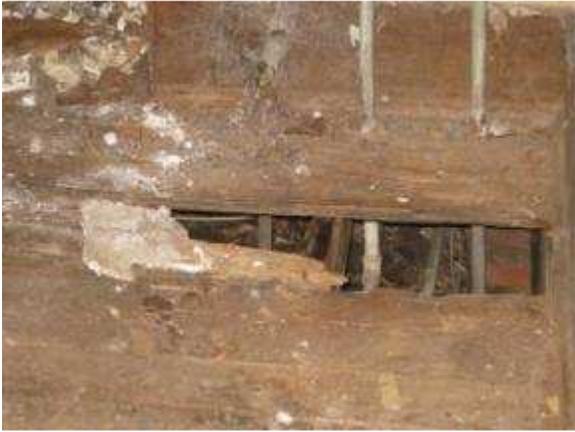
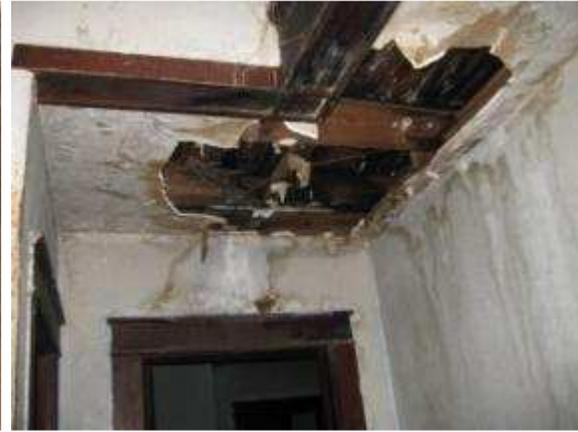
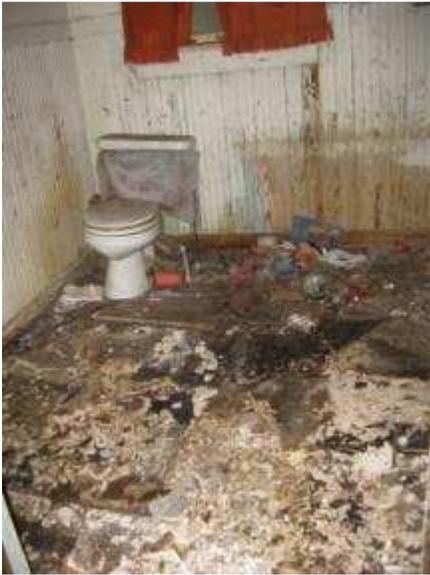
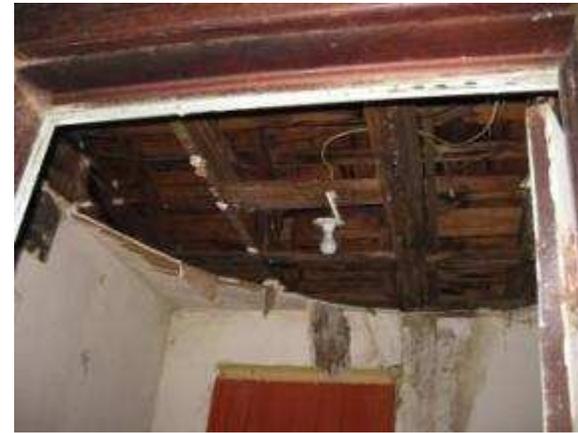
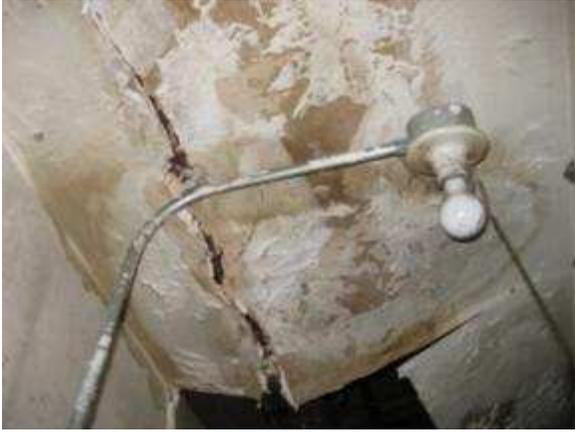
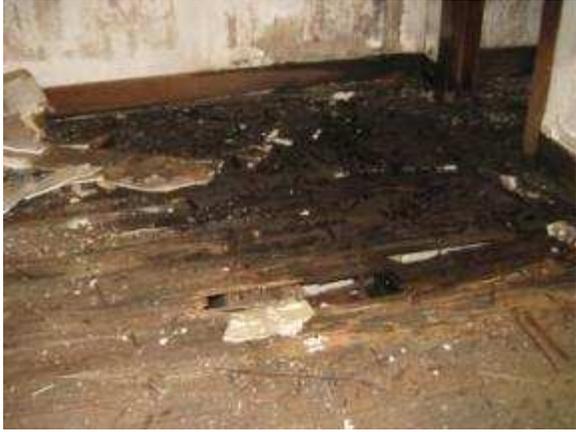
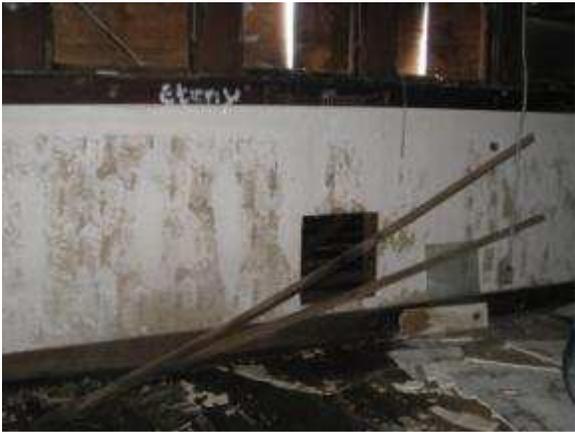
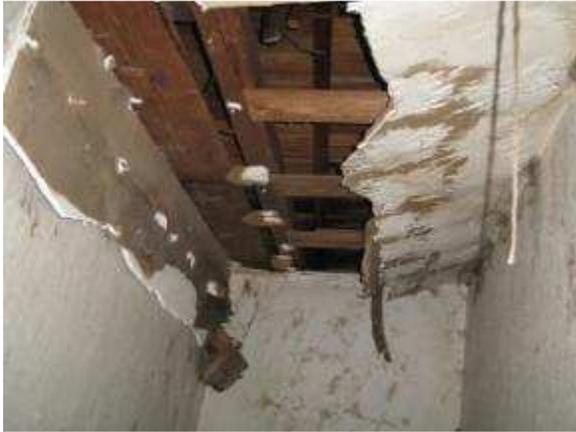
PICTURES: 606 W 17th St

COMMENTS (1) NATIONAL HISTORIC REGISTER (2) 2ND FLOOR - CEILING DOWN DUE TO EXTENSIVE ROOF LEAKS (3) 1ST FLOOR CEILING DOWN DUE TO EXTENSIVE ROOF LEAKS (4) BACK PORCH FRAMING ROTTEN (5) FRONT PORCH FRAMING ROTTEN (6) HOLES/DAMAGE TO SIDING (7) CARPORT BRICK COLUMNS ARE DAMAGED (8) PORCH CEILING FALLING (9) ROTTEN EAVES & OVERHANGS. (10) NEEDS NEW ROOF (11) WINDOWS MISSING GLASS /BOARDED UP (KEMP HOUSE)

Brick porch support columns cracked, leaning
 Holes in Rear
 Holes / Rotten flooring
 unsafe electrical
 Rotten porch
 open ceiling

<u>Deadline</u>	<u>Task</u>
30 Days	Obtain building permit, Repair foundation and level house.
60 Days	Install new footings for the masonry columns and rebuild masonry columns at carport and porch. Repair wall, floor, and roof framing. Re-point fire place and chimney masonry. Install new roof deck and roof finish.
180 Days	Repair siding Repair porch floor finishes. Repair original windows. Licensed electrician obtain electrical permit and re-wire house to current code. Licensed plumber obtain plumbing permit and re plumb house to current code. Licensed HVAC contractor obtain mechanical permit and install code compliant HVAC system.
240 Days	Repair porch and carport ceiling finishes.

- Insulate exterior walls to current code.
- Repair interior wall and ceiling finishes.
- Repair exterior trim and paint
- Repair interior trim work.
- Install plumbing fixtures, electrical fixtures, casework, etc.
- Complete all city final inspections and obtain new certificate of occupancy.
