**BUILDING AND STANDARDS COMMISSION  
STAFF REPORT**

**Case #1937- 1227 Eureka Street**

# Dangerous Structures Survey Report

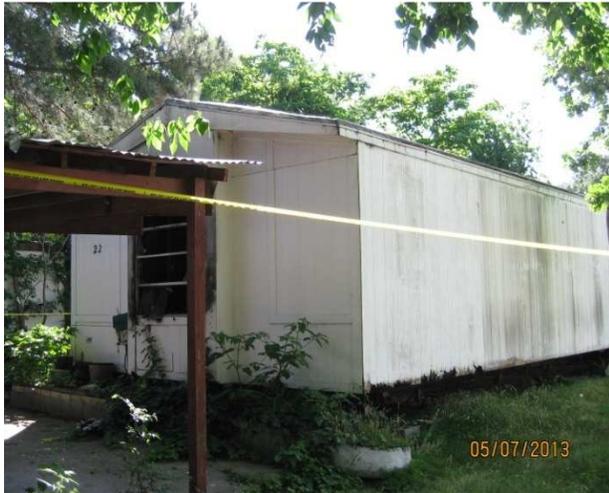
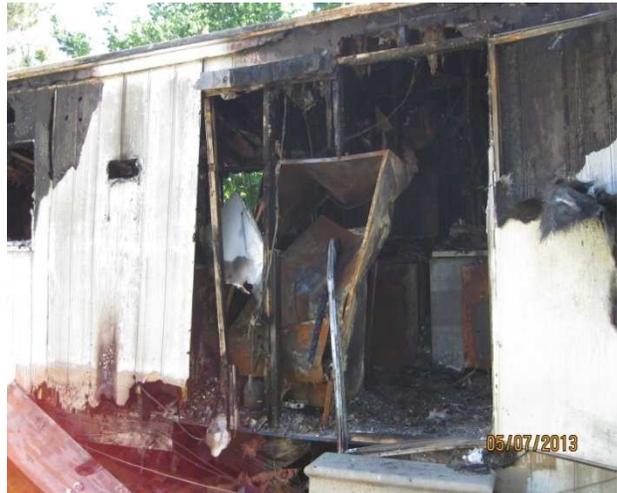
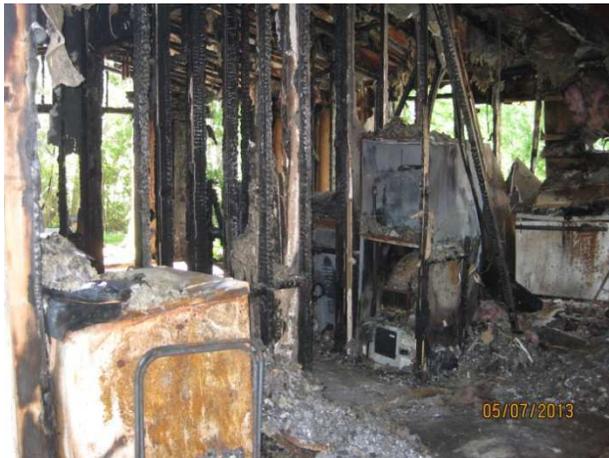
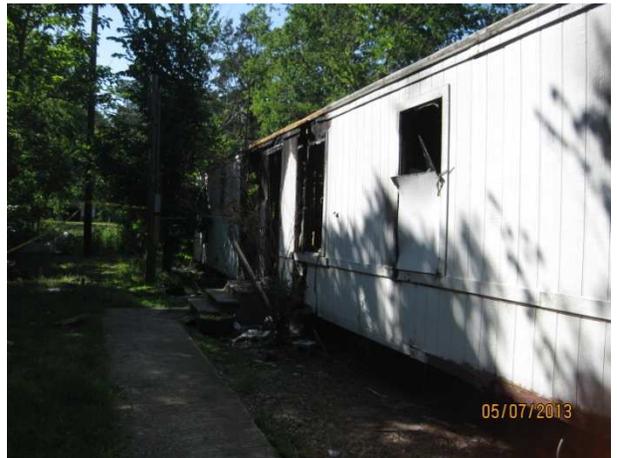
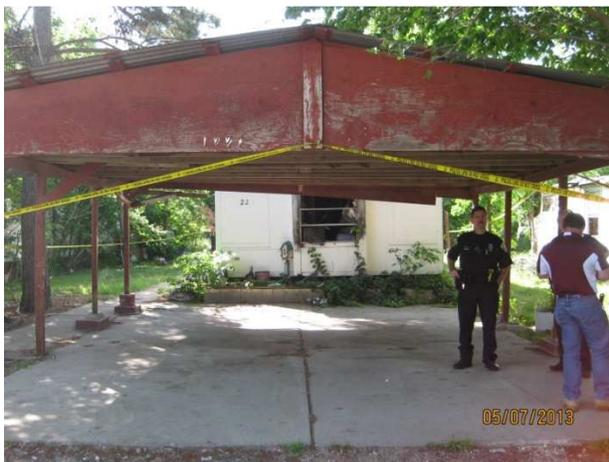
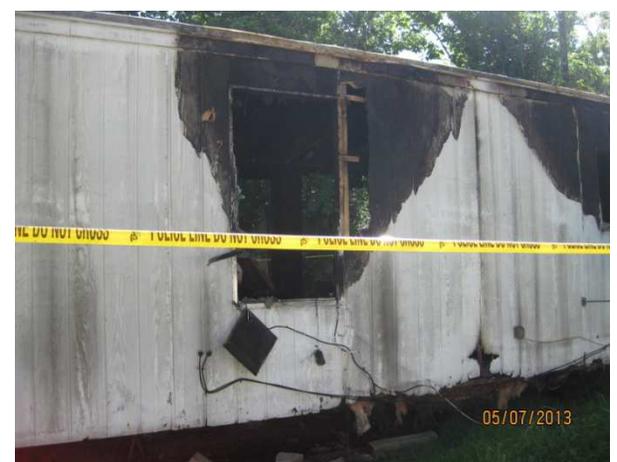
PICTURES:

This structure had a fire on March 6, 2013 that basically gutted the interior of the structure. The accessory structure is a carport that sits between the street and the house and encroaches into the minimum required 25-foot front building setback. There are no records of any building permits ever having been issued for the carport structure.

COMMENTS (1) EXTENSIVE FIRE DAMAGE TO MOBILE HOME

(2) CARPORT IN FRONT SET BACK - SPANS OF CEILING JOIST APPROX TO EXCEED ALLOWABLE SPANS/SPACING PER CODE - DEFLECTION NOTICABLE - BRACING NOT ADEQUATE.

(3) MOBILE HOME HAS SIGNS OF PREVIOUS ROT AT STRUCTURAL COMPONENTS PRIOR TO FIRE

structure fire  
Smoke, heat and fire damage through out  
structure  
walls, floor, ceiling burned out  
electrical burned out

- vacate the building within \_\_\_\_ days.
- secure the building  and accessory structure(s) from unauthorized entry within 30 days.
- demolish/remove the building and accessory structure within 30 days.**
- demolish/remove or  repair the building  and accessory structure(s) within \_\_\_\_ days, in accordance with the schedule below:
