**BUILDING AND STANDARDS COMMISSION  
STAFF REPORT**

**April 23, 2012**

**Case #1720 – 1800 South Texas Avenue**

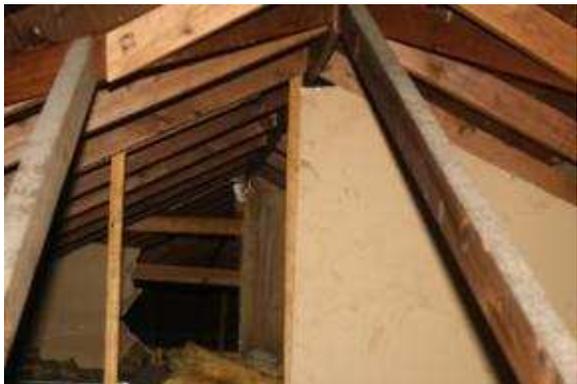
Marijuana found in this unit
